Glider Club

Building Inspection

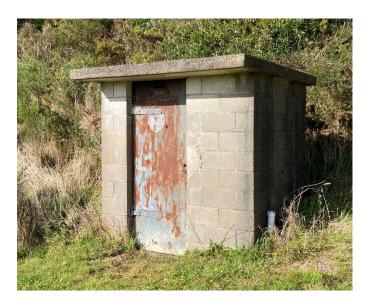
Fuel Store

Building is in reasonable condition and would only take minor maintenance to bring up to good condition. It is not suitable for its current purpose of fuel store.

- Un filled block walls
- Holes in block cladding
- No bund in case of fuel leak
- No ventilation
- Roof physically connected
- Disconnected data cables for unknown purpose
- Concrete roof weathered, but appears to be watertight still
- Surface rust on metal door
- Poor quality repair on interior block work

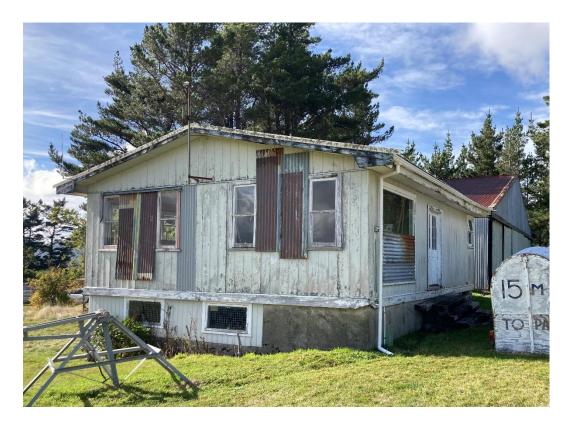
Club Room

The building is in poor condition with the subfloor, exterior wall paint, external windows and doors, and plumbing being the major issues. While not economical to bring up to healthy homes standards, repairs could be undertaken to bring it up to a suitable standard for a club rooms. A rough estimate for a bare minimum repair would be at least \$215,000 and would include the following:

- Many bearers joins not supported
- Piles not attached to bearers
- Significant packers between bearers and piles the NZS3604 allow no tolerance for this
 6.6.6.1

Pile tops shall be at a level to support bearers without packing.

- Basement room lock and unable to be inspected
- Broken windows
- Rotten window frames
- Poorly fitting window casements and external doors
- Asbestos wall cladding

- Holes in cladding
- Roof replaced with coloursteel 10-15 years ago and in good condition
- All cladding needs a clean and paint
- Storm water not compliant or missing or broken

- No drainage between subfloor and basement
- Sewer pipe broken
- Sewer pipe supports significantly corroded
- Toilet and basin not vented
- Grey water goes into drainage trench. This may be discharged into a soak pit in some cases, but must not be discharged on top of the ground

- Zip is only hot water and not tested
- Low pressure cold water from external header tanks
- Main water tank cracked and leaking
- Septic system old, but functions

- Septic drain field condition unknown
- Septic suitable for no more than 10-15 people per day with no grey water, 5-10 if grey water was included
- Cold water not drinking water standard. Roof water, no filters or first flush diverter

- Lino may contain asbestos
- Fireplace rusted through and should be replaced
- Power cables exposed.
- All electrical should be checked by an electrician

- Cracks in internal cladding that show significant moment in past
- Trim missing in toilet room

Re-pile \$40k
Bearers \$20k
Paint and repairs \$40k
Gutters \$15k
Soak pit \$10k
Waste system repair \$5k
Windows \$50k
Access stairs \$5k
Drinking water upgrades to household supply \$20k
Fireplace replace - \$10k

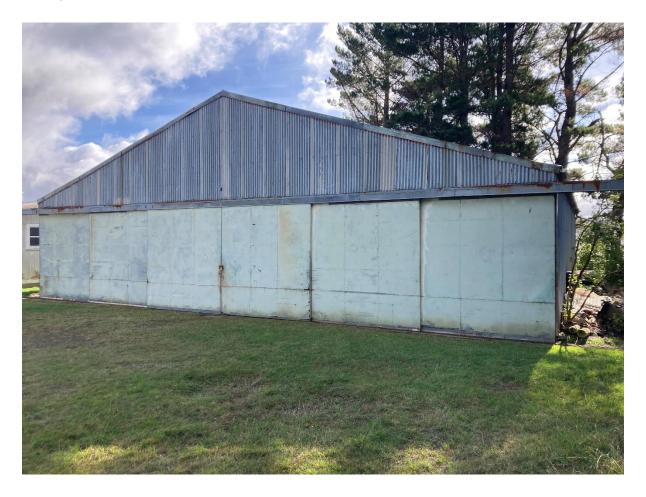
Hangar

The Hanger is in average condition for its age. The major issue is the roof that may need to be replaced, otherwise only corrosion treatment and minor maintenance required.

- Surface rust across entire roof
- Ridge flashing beyond repair
- Several small holes in roof and wall cladding
- Minor surface rust on wall cladding
- Rust caused by building supplies and earth piled up too high around bottom of wall cladding
- Steel portal frames has minor surface rust around bracing
- Electrics not compliant, recommend electrician inspection
- Gutter not operational
- Corrosion has caused loss of section on section of door frames
- Exposed internal power cable outside
- Footing and slab visible is in good condition
- Roofing paper to stop condensation has many holes

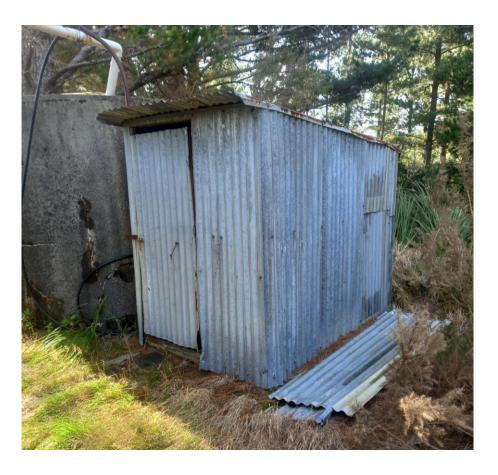
Generator Room

This shed is in poor condition. It is recommended to be replaced.

- Both wall and roof cladding rusted through in places with many holes.
- Open cavity in back wall to let out exhaust.
- Frame of the door is rusted and missing bottom rail.
- Electrical work does likely not comply, would recommend having a qualified electrician.
- Split in concrete floor.
- Signs of moisture in timber framing.
- Spacing of timber frames not to any sort of modern standard.
- Door latch is broken.
