Inanga spawning habitats in the greater Wellington Region

Part 2

Wairarapa

Publication No. WRC/RP-T-02/65
www.gw.govt.nz

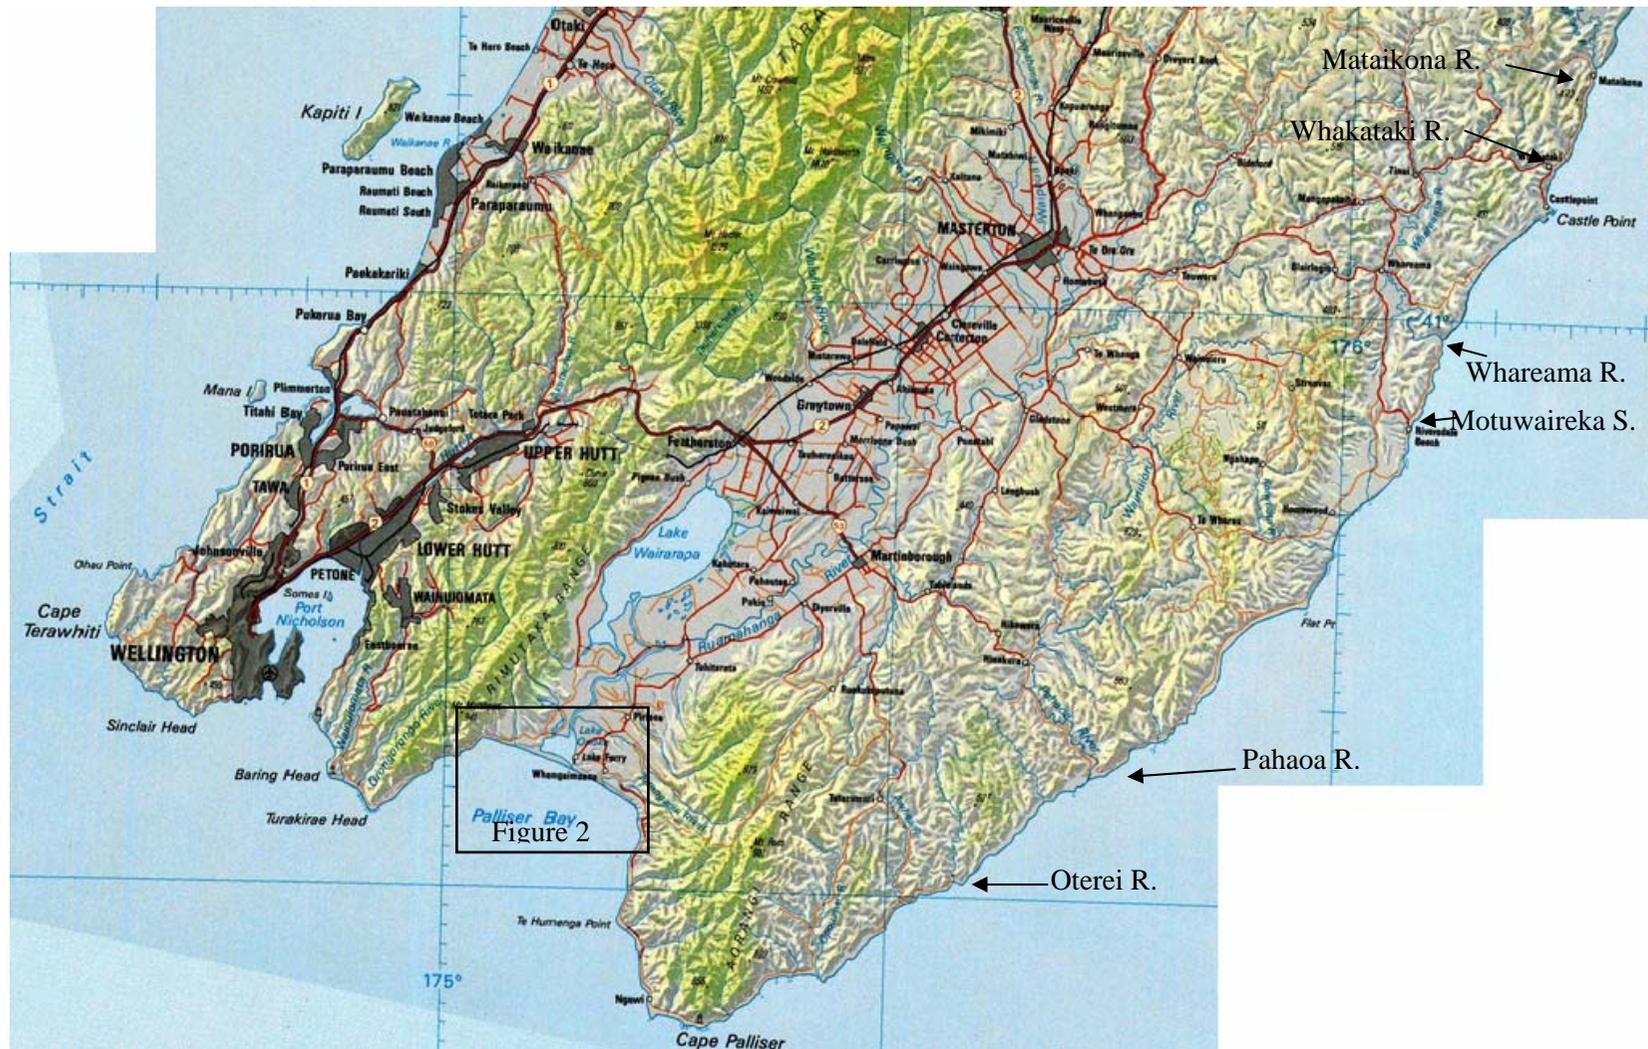
Figure 1: The 12 surveyed water bodies surveyed in the Wairarapa part of the Wellington Region. For clarity, the boxed region is depicted in Figure 2.

The first report (Taylor and Kelly, 2001), completed in the 2001/2002 financial year, focussed on catchments east of the Rimutaka and Tararua Ranges; specifically some selected catchments in the Wellington City suburbs, Hutt Valley, and Kapiti coast north to Waikanae. In contrast, this document will present results from selected catchments to the west of the Rimutaka and Tararua Ranges, that includes parts of the lower Ruamahanga catchment (Lake Onoke subcatchment), and the western seaboard of the North Island north to Castlepoint. Catchments discussed in the report are presented in Figures 1 and 2.

- Carry out surveys of whitebait spawning habitat in the 14 rivers specified by the GWRC (Figs. 1, 2).
- Collect field information that will assist with mapping and describing identified whitebait spawning habitats.
- Prepare a report (including in electronic form) that maps and describes whitebait spawning habitat, including any information that is relevant to management/restoration.

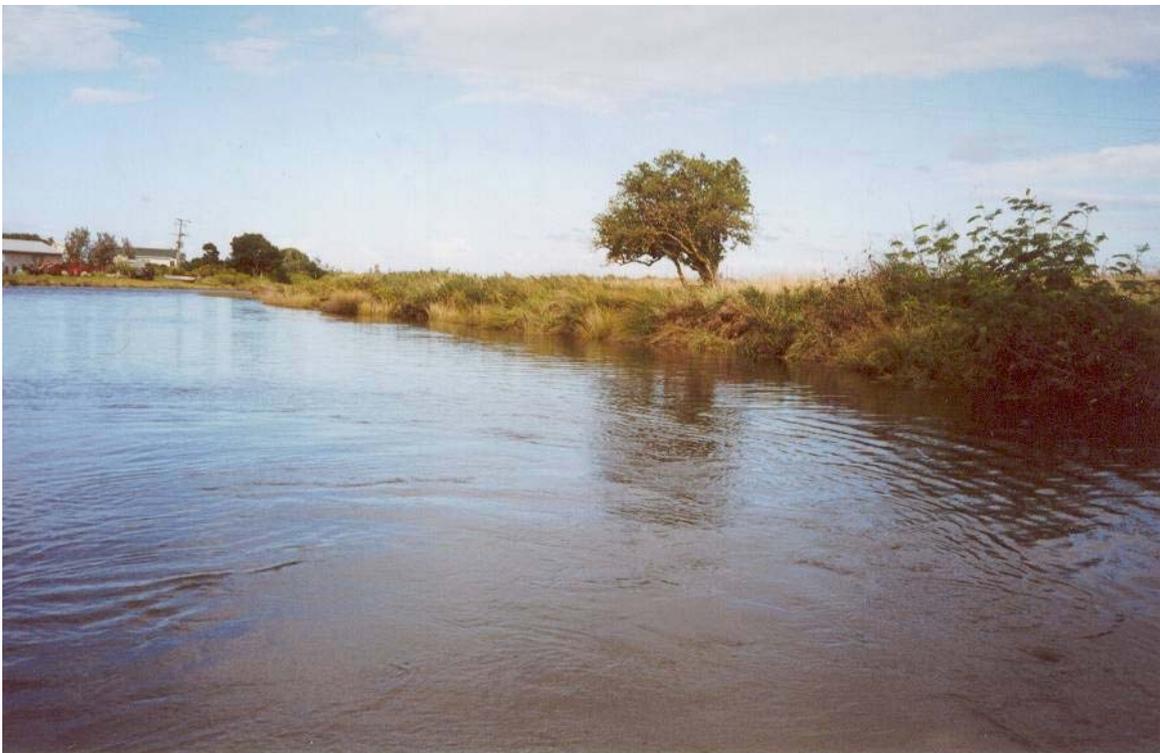
Figure 4: A long reach of tall fescue vegetation on the true right bank of the Whakataki River, arrowed in Figure 3.

Generally, the true right bank offered the best potential for inanga spawning, with a long reach of *Festuca* grass (Figs 3, 4). The opposite bank upstream of the township was quite heavily grazed to the waterline, and bank pugging could conceivably be a problem at normal water levels. Further upstream, but below the road bridge, suitable ungrazed habitat included 2 small raupo beds on the true left bank, and a section of the river which contained gently-shelved sections on both banks. A maturing female inanga was captured downstream of the road bridge. This fish was evidently still approaching spawning condition this season.

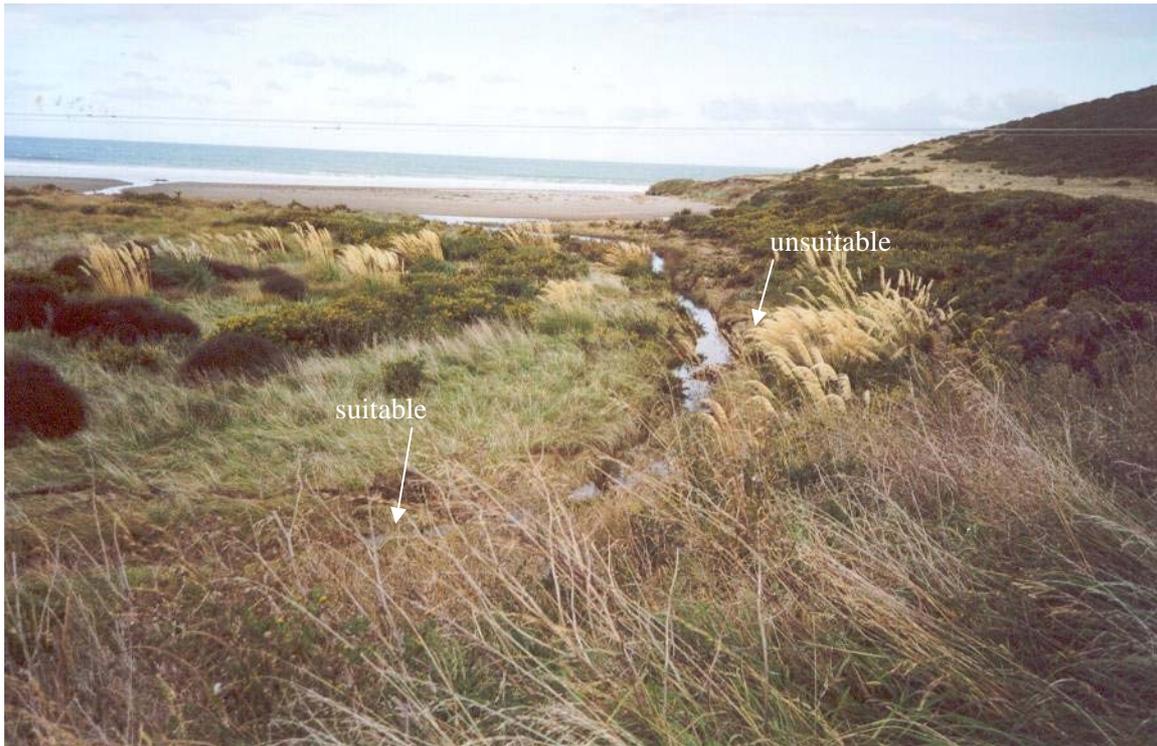
Figure 5: Suitable spawning area in a spring-fed tributary of the Whakataki River. Suitability was restricted to areas close to the spring heads, and away from the sandy beach.

A spring-fed wetland complex joins the Whakataki River from the south. Most of the riparian vegetation, while superficially suitable, emerged from a base of pure sand, a substrate generally too porous to support inanga egg development. However, some areas closer to the springheads, and further from the beach, had a moisture-retentive soil structure (Fig. 5), and were considered more suitable.

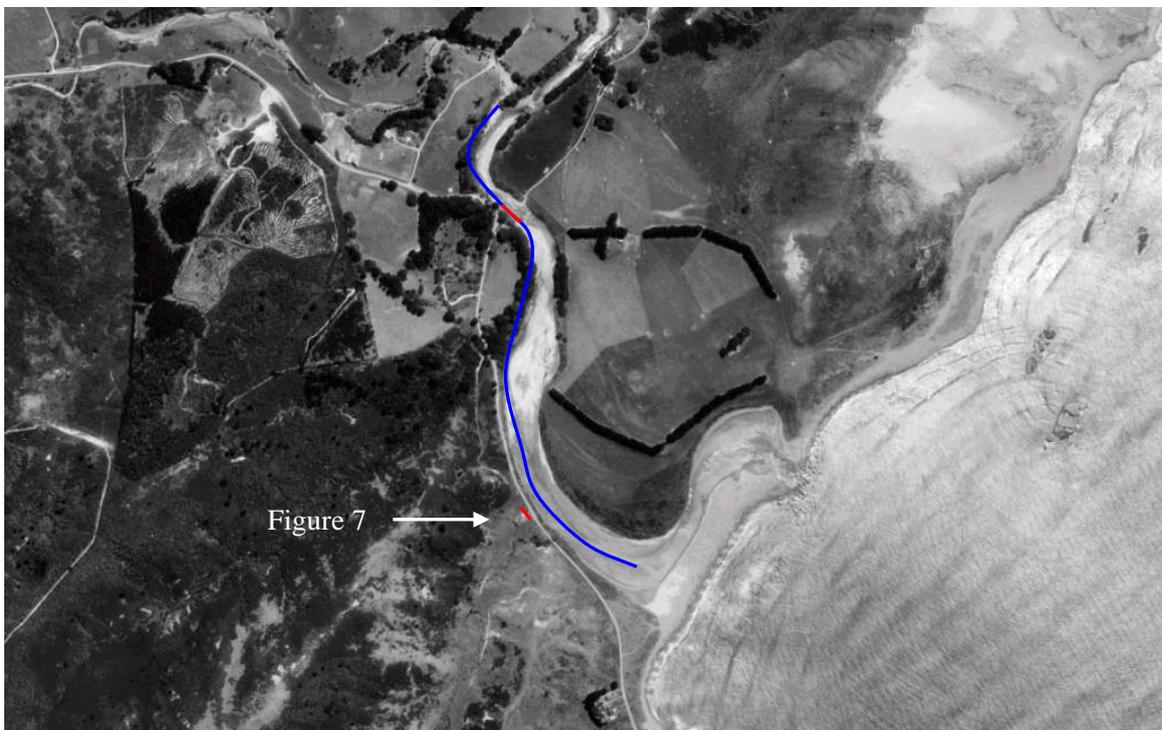
Figure 6: Lower reaches of the Mataikona River. The blue track shows the extent of the spawning survey, whereas the red track indicates the area of suitable spawning vegetation.

Based on our survey, spawning habitat appeared to be quite limited in this catchment. The riparian grasses were generally unsuitably sparse, and rooted into steep clay banks. Some limited areas of marginal habitat with a shallower profile and better soil structure were found on the outside of the river meanders (Figs. 6 and 7). A spent inanga (i.e. one that had spawned) was observed just upstream

of the habitat depicted in Figure 6. A tributary entered on the true right bank at the upstream limit of the survey, but this was considered to be unsuitable.

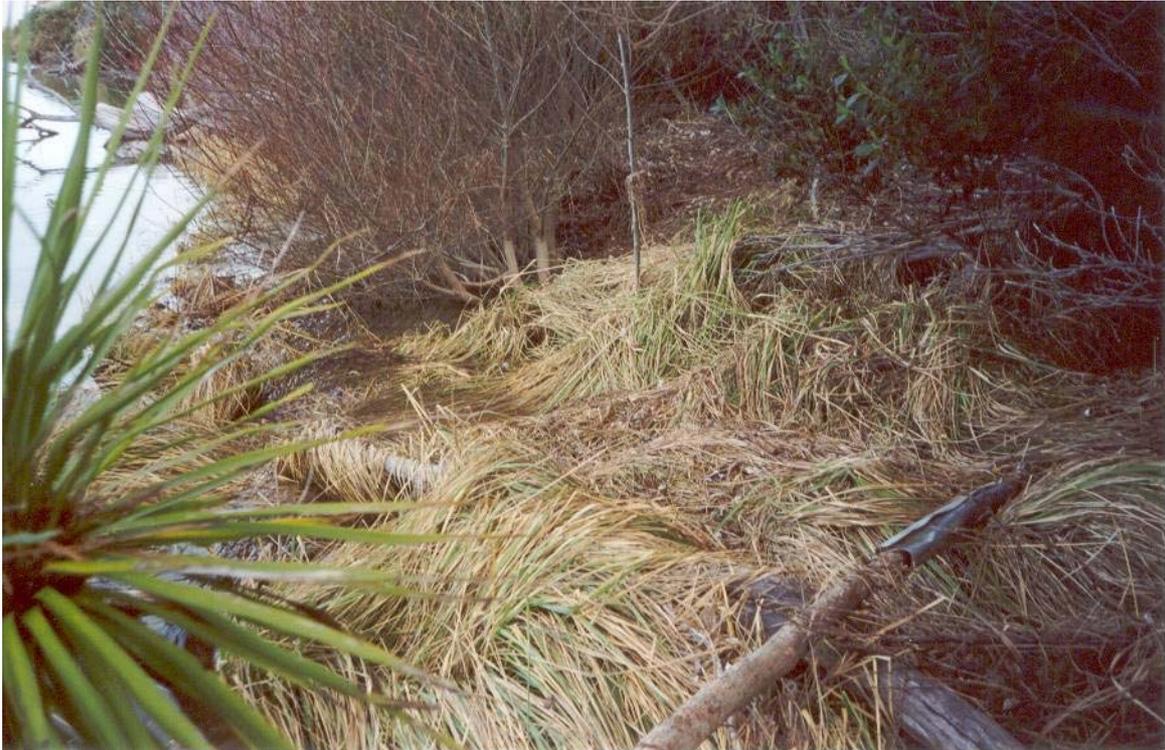
Figure 7: There were limited areas of suitable spawning vegetation on the Mataikona River. This is one such area, where a mixture of tall fescue, and creeping jenny grasses grew from a shallow shelf on the outside bend of the river. Bank damage and driftwood piles from flooding were common.

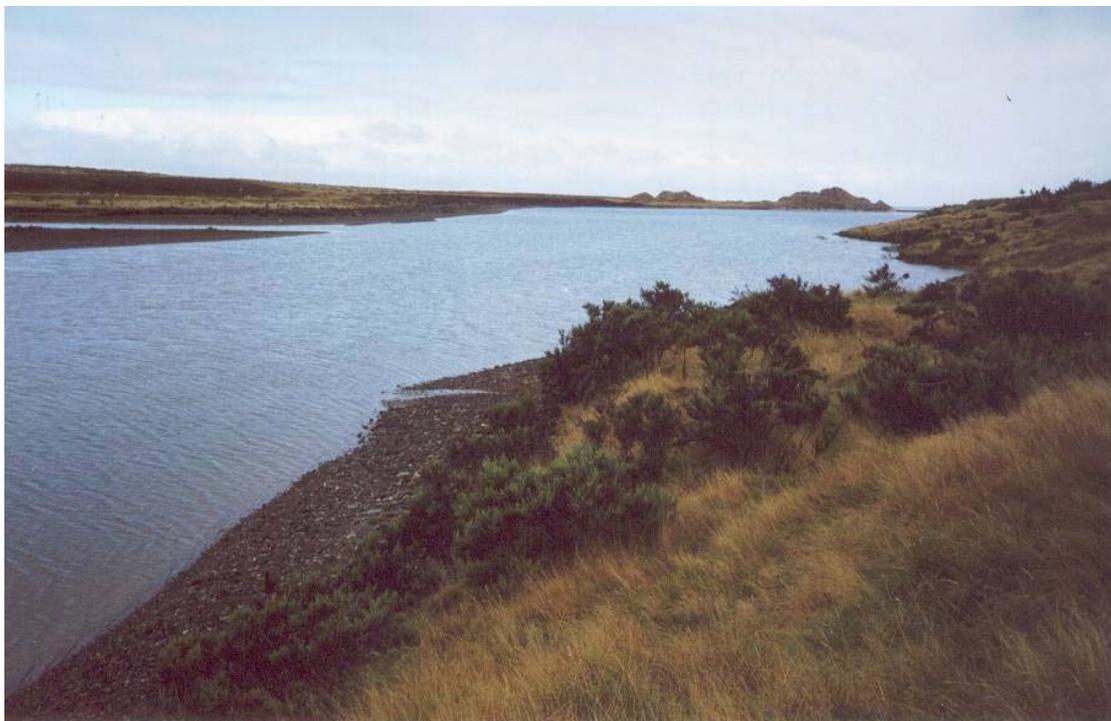
Figure 8: The lower reaches of the Pahaoa River at low tide. Much of the lower river was gravel-banked with little inter-tidal riparian vegetation.

The Pahaoa River was open to the sea at the time of the survey, and the water was salty at the surface (and presumably throughout the water column), even at low tide. This river had little spawning habitat as most of the tidally-influenced habitat was comprised of un-vegetated gravels (Fig. 8), with very dry grasses above the tidal level. The very dry lower reaches were surveyed on foot and although a close inspection of the opposite (true left) bank was not possible, it was apparent even from a distance that all of this bank was dry, steep, and entirely unsuitable. The extent of the foot survey is shown in Fig. 9.

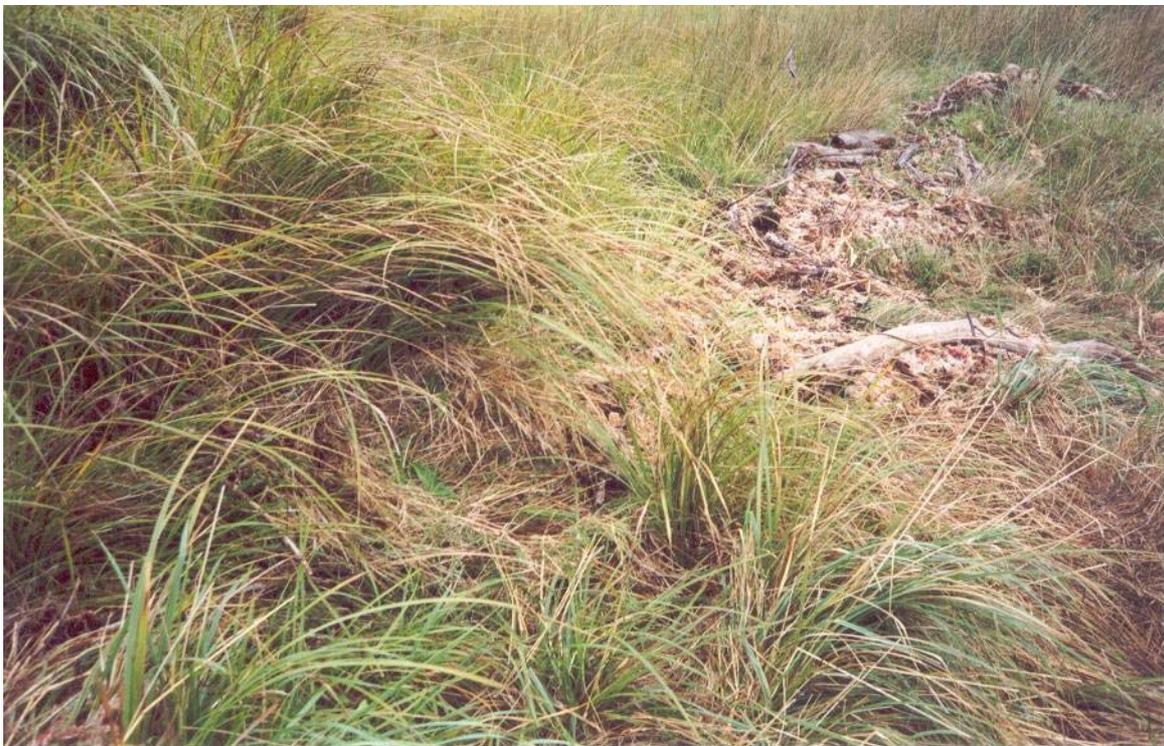
Figure 10: Highly suitable spawning vegetation on the true right bank of the Pahaoa River. Note the line of tide line of driftwood through the vegetation.

Despite the dryness of the surrounding environment, seepage from a hillside had facilitated growth of a lush sward of pasture grasses (creeping bent), growing through native toetoe grass on the true right bank (Fig. 10). The growth extended upstream over a distance of approximately 280m, although suitable vegetation was patchy near the upstream limit. Presumably other seepages along the true right bank had facilitated the growth of good vegetation along this reach.

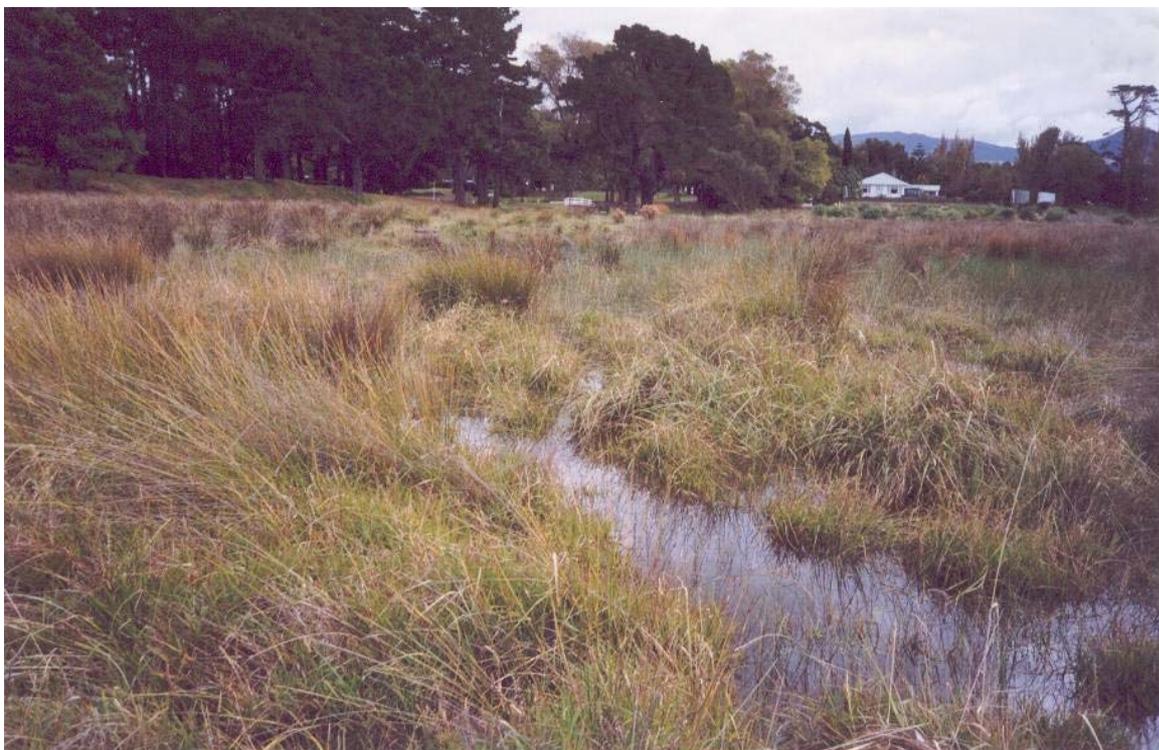
Figure 12: Suitable spawning vegetation, comprising of mixture of native rushes and pasture grass near the mouth of the Motuwaireka Stream. A school of inanga were seen amongst this vegetation. Cattle sign was evident in this DOC-owned land.

It was clear that there was an abundance of suitable inanga spawning habitat throughout the lower catchment. In the lower-most reaches, this consisted of an area of native rushes and pasture grass on the true left bank near the sea (Fig. 12), and small raupo beds along the true right bank (Figs. 12 and

13). A shoal of adult inanga was seen amongst the flooded grasses on the true left bank, but high water levels precluded an egg search at this location. Cattle had access to this area during normal dry conditions, (evidenced by droppings), although the land has DOC tenure.

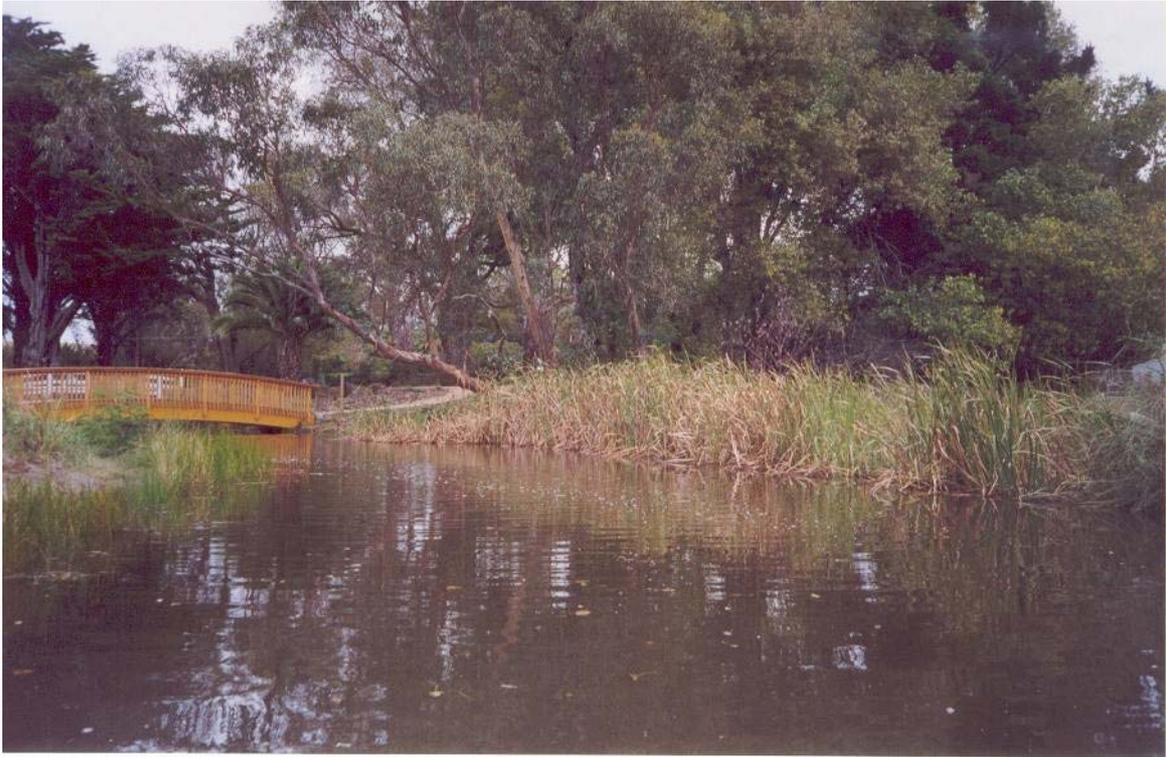
Figure 13: Raupo beds close to the sea, such as this example on Motuwaireka Stream (photo centre and right), are frequently used by spawning inanga.

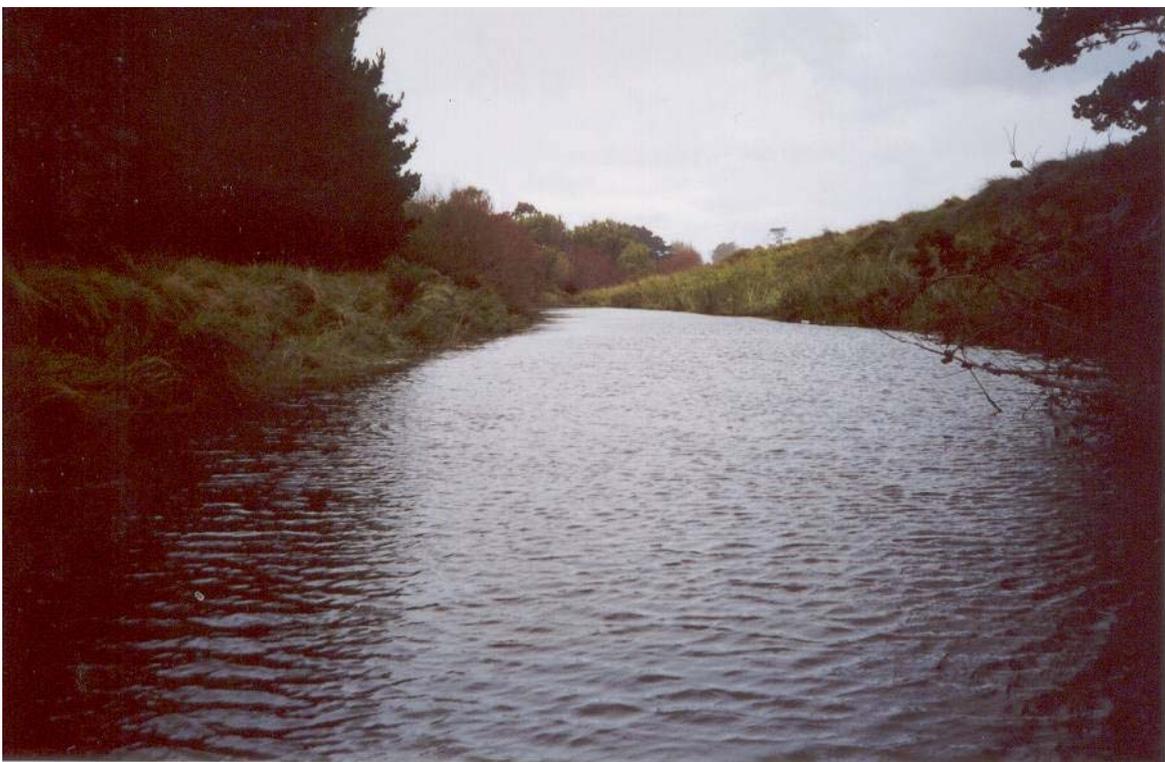
Figure 14: The extensive fenced and ungrazed reaches of the Motuwaireka Stream, near the upper limits of the surveyed area, looking downstream. These grasses offered good spawning potential.

Further upstream, the stream formed a deep wide channel, banked with long pasture grass apparently inaccessible to stock (Fig. 14). This area was also considered to be good spawning habitat, but given the abundance of suitable vegetation further downstream, this area may not be heavily utilised by spawning inanga.

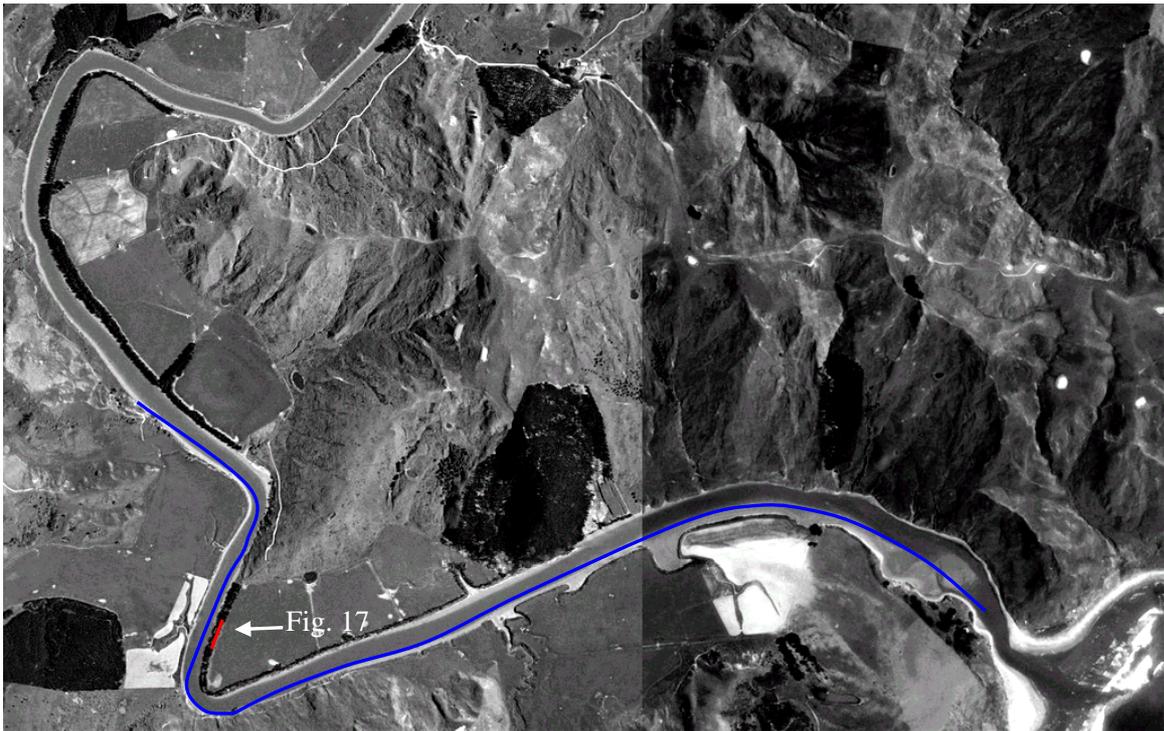
Figure 15: The lower Whareama River. The blue line indicates the extent of the boat survey (5.1 km), and the red section an area of suitable vegetation. The river mouth is in the lower right corner of the photograph.

The Whareama River is a substantial waterway which discharges 9 km north of the Motuwaireka River. At the time of the boat survey, the river mouth was open, and the tide high and rising. A considerable amount of driftwood and kelp lining the lower river attested to recent heavy seas. Remarkably, the river was salty at the surface, (and estuarine crab-holes present) even 5 km upstream from the sea, the upstream limit of the survey (Fig. 15). Thus the 'saltwater wedge' endpoint must extend even further upstream. Unfortunately, constraints on boat operating range precluded further inland incursion. It may be beneficial to resurvey this substantial river using a vessel with greater range and boat speed.

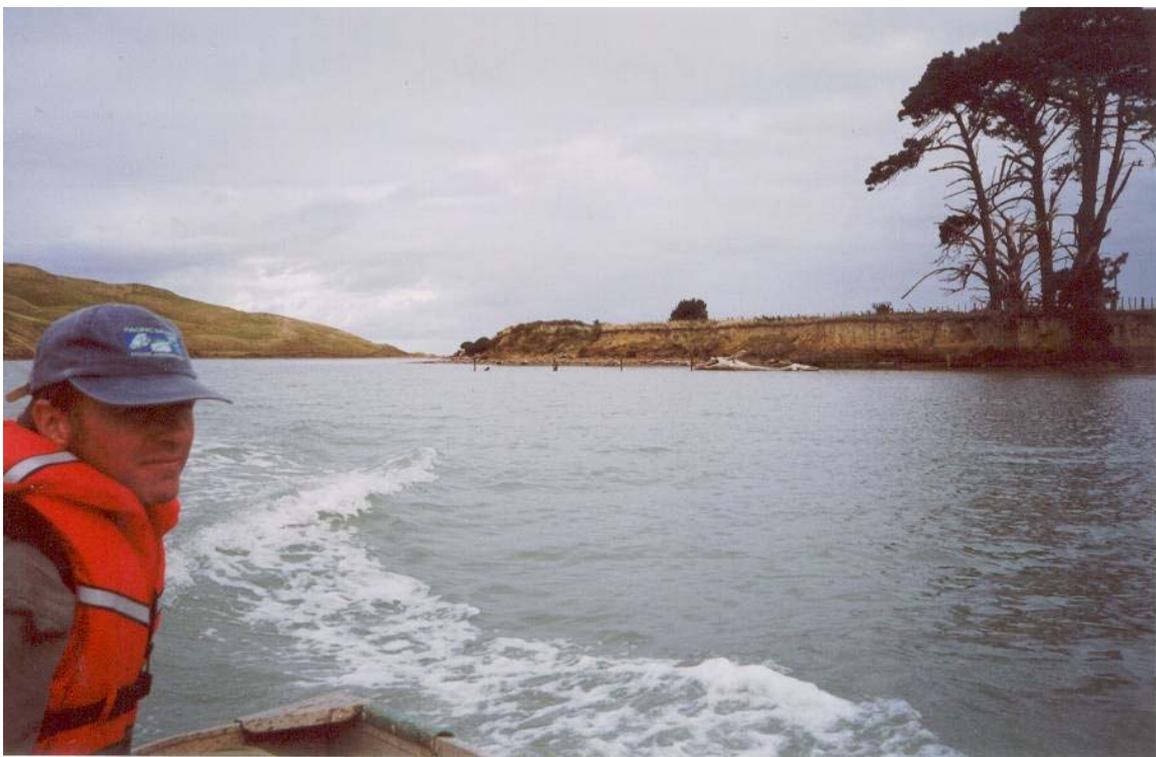
Figure 16: The lower Whareama River looking downstream towards the fishing village. The river banks in many areas in this location are dry, steep, eroded, and offering little spawning potential.

While a good proportion of the banks along the lower reaches were dry, steep, and eroded (Fig. 16), there were some good reaches of suitable spawning habitat. In particular, one area on the true left bank (Fig. 17) was bordered by a young pine plantation, and fenced from stock. However the trees were pruned, allowing good light levels to promote a lush grassy sward of *Festuca* grasses. The extent to which this and other sites will be utilised will depend on the availability of suitable vegetation in the vicinity of the 'saltwater wedge'. A local resident spoke of the considerable size of the whitebait catches taken from the Whareama River near the main road bridge (18.5 km upstream from the sea). Available aerial photos of the area upstream of our survey indicated improving riparian tree cover, more fertile and extensive river flats and a sinusoidal river course. Thus, the sluggish flows and richer soils could provide more suitable spawning vegetation.

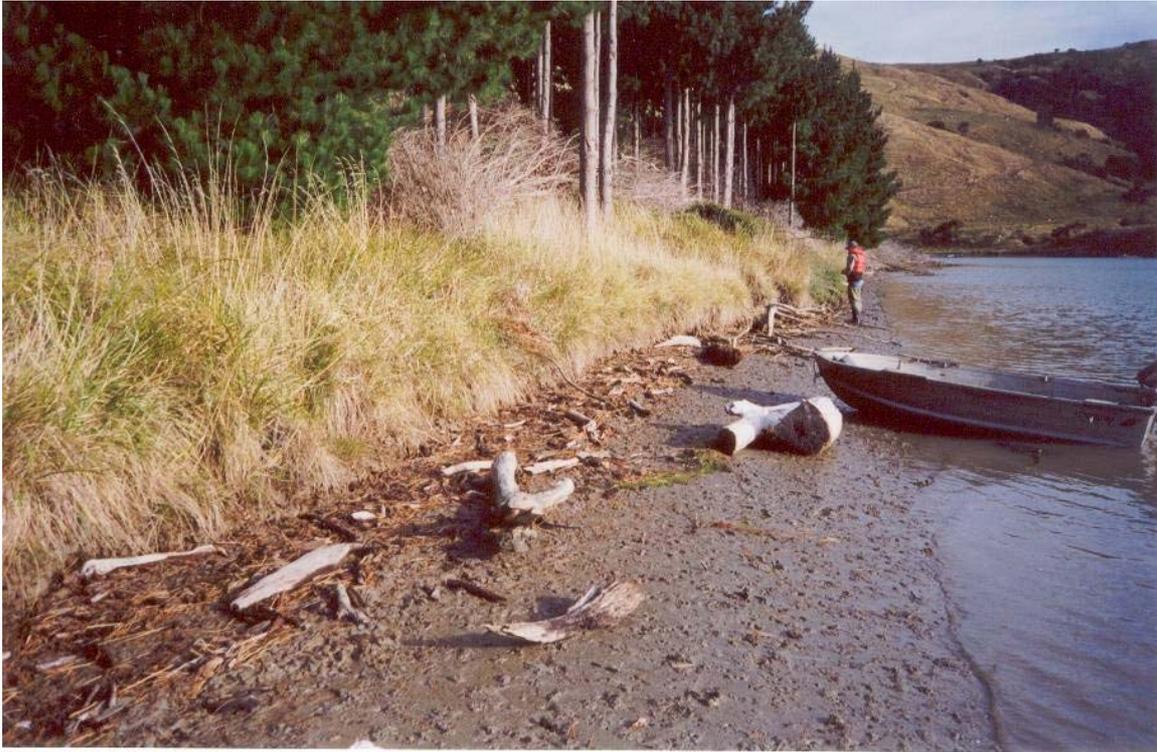
Figure 17: A relatively rare example of stable grassy bank on the lower Whareama River. Even 3.5 km upstream driftwood, kelp, and estuarine crab holes were common.

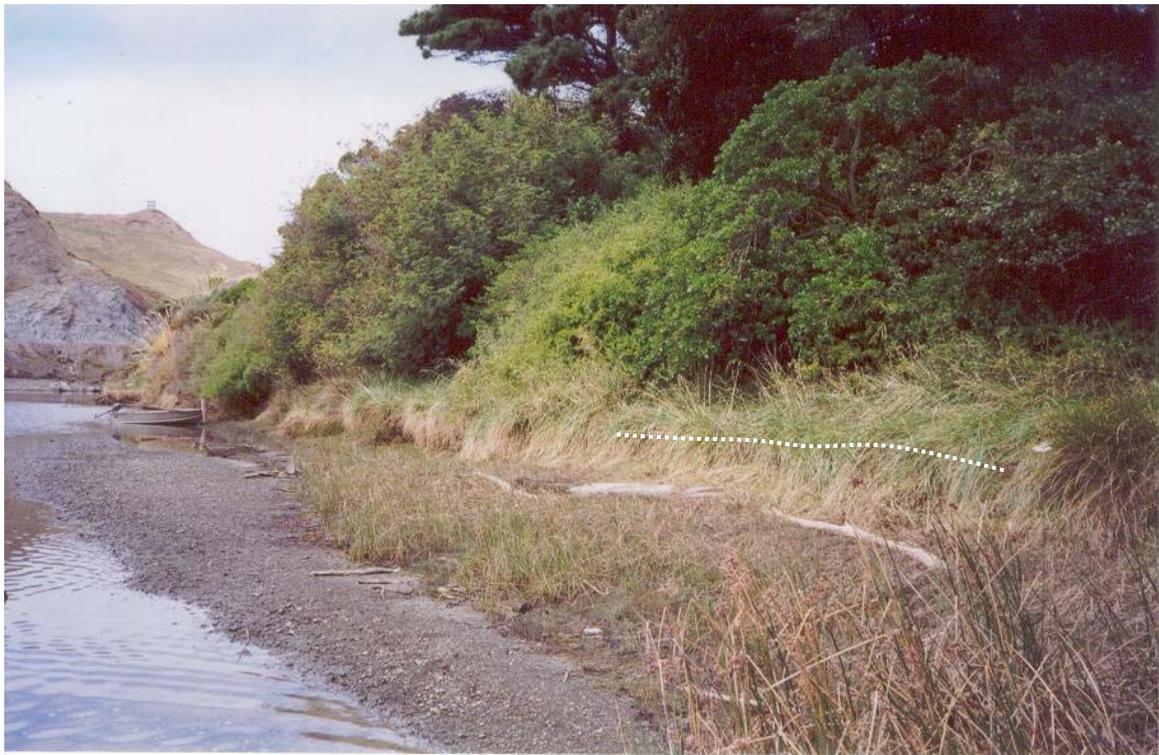
Figure 20: Inanga spawning grounds on the Oterei Stream. The dashed line indicates the elevation at which eggs were found.

The third area with suitable vegetation was found back on the true right bank (Fig. 20) along a shallow terrace of tall fescue. On this occasion inanga eggs were found in quite high densities extending over an area of approximately 11m in length x 0.8m in width.

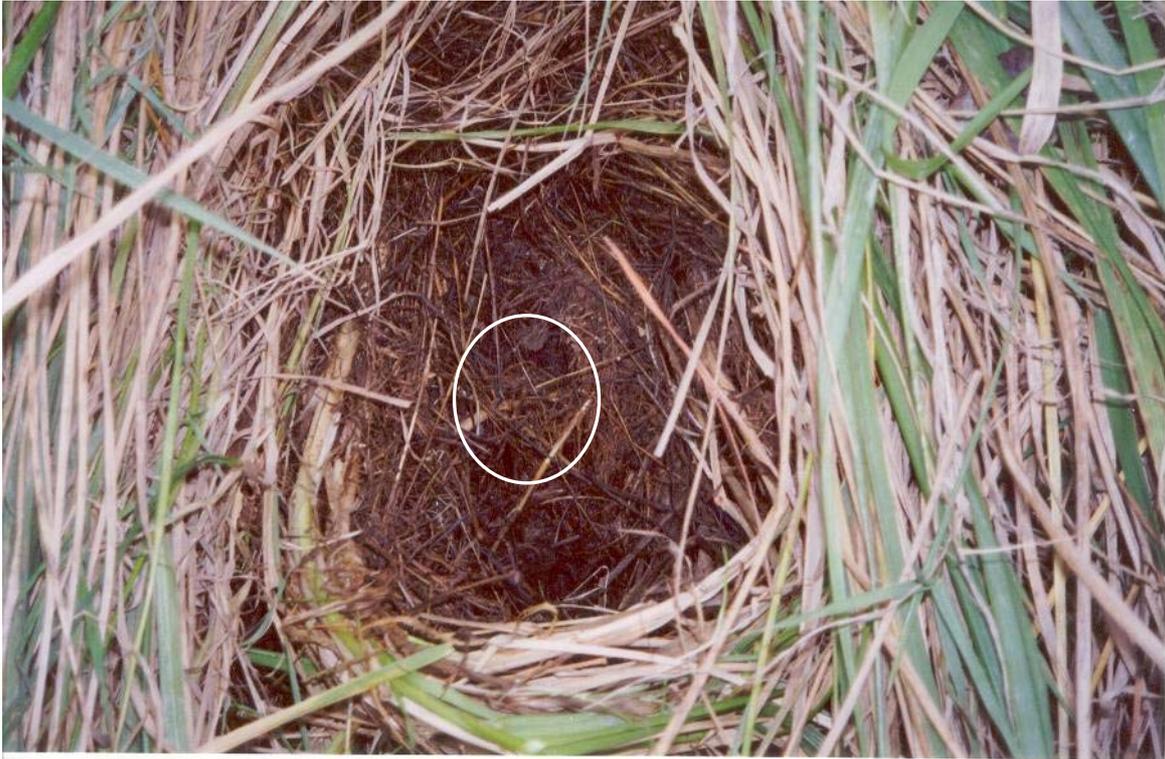
Figure 21: A cluster of inanga eggs from Oterei Stream. The circled zone encompasses some of the more conspicuous eggs, which are slightly less than 1mm in diameter. In this situation, eggs adhere to the root hairs of pasture grasses.

Two samples of eggs were obtained from separate areas for evaluating developmental stage, and by back-calculation, the dates of spawning (Table 1). Two developmental stages were evident in the samples for the Oterei Stream; eggs at stage 17 (eyes silvered), and another, younger, stage (eyes grey). Assuming a uniform developmental temperature of approximately 14°C, and thus an embryonic development period of 6 and 8 days respectively, these eggs resulted from two separate spawning events around the dates of 2 April and 4 April.

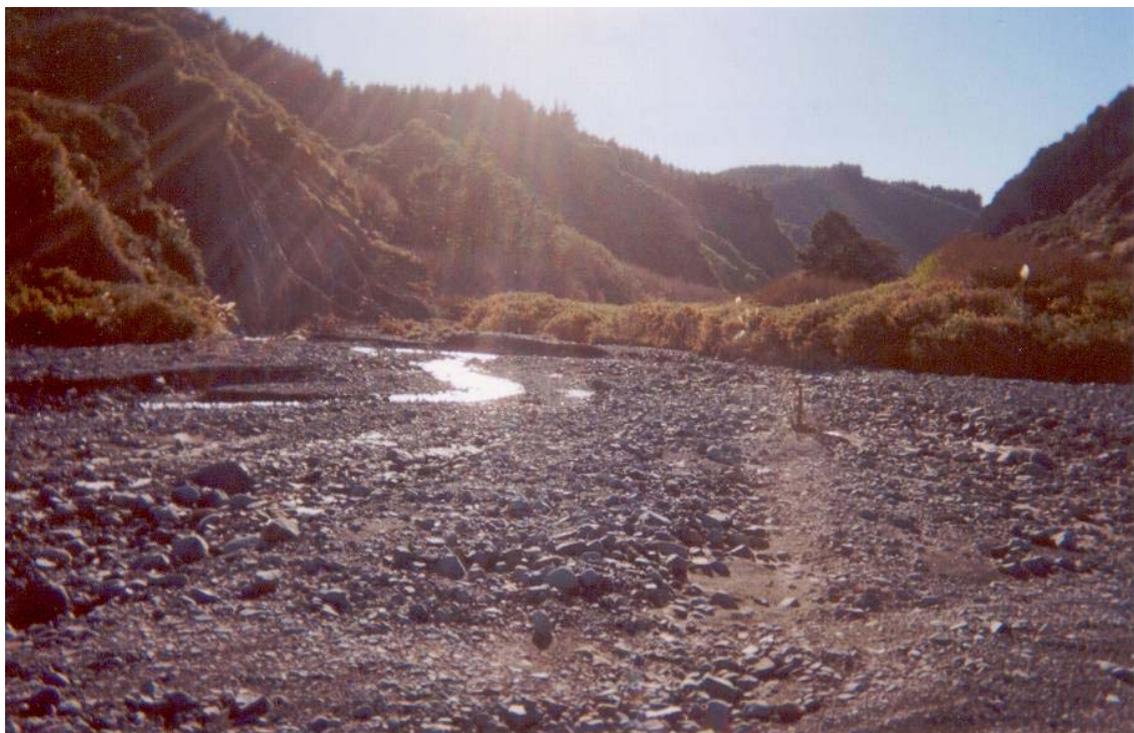
Figure 24: The gravel bed of the lower Hurupi Stream.

Both of these small waterways drain the Western foothills of the Aorangi Range, and are short, steep and unsuitable for inanga rearing (Figs. 24, 25). They lack spring-fed tributaries in the lower reaches, and have a stony riverbed and floodplain. Consequently, they lack riparian vegetation that would be flooded on a tidal periodic basis, and thus are also unsuitable for inanga spawning.

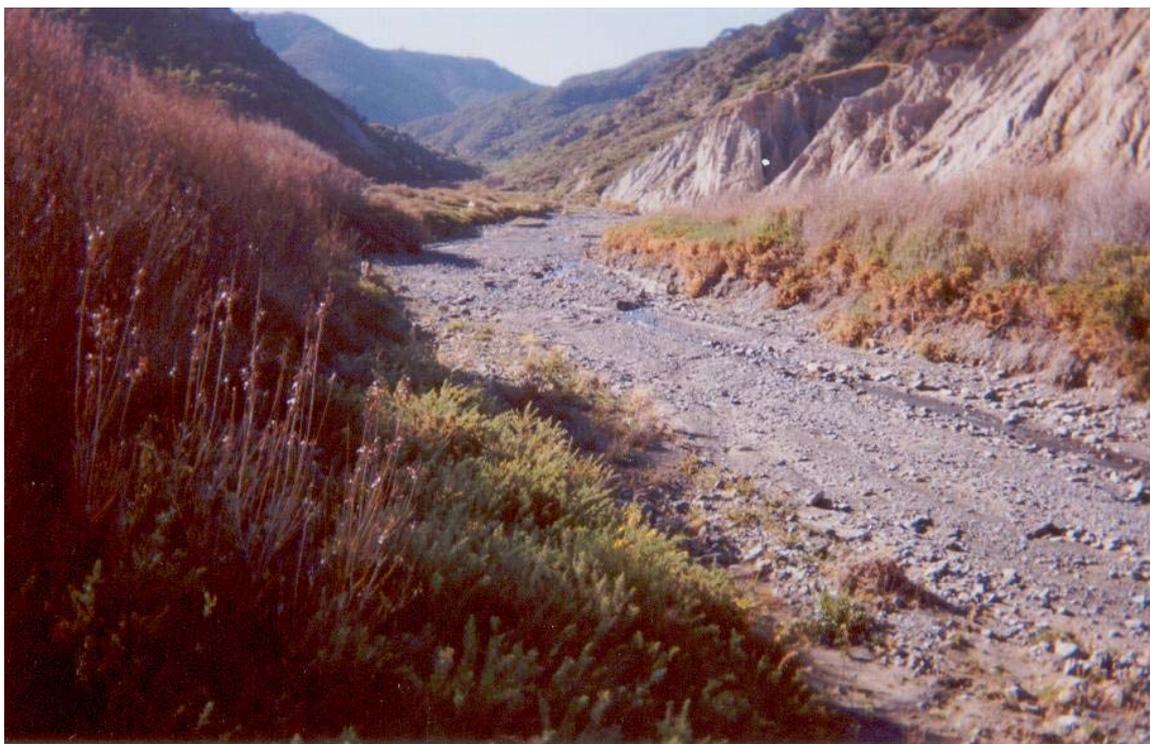
Figure 25: The lower reaches of the Putangirua Stream.

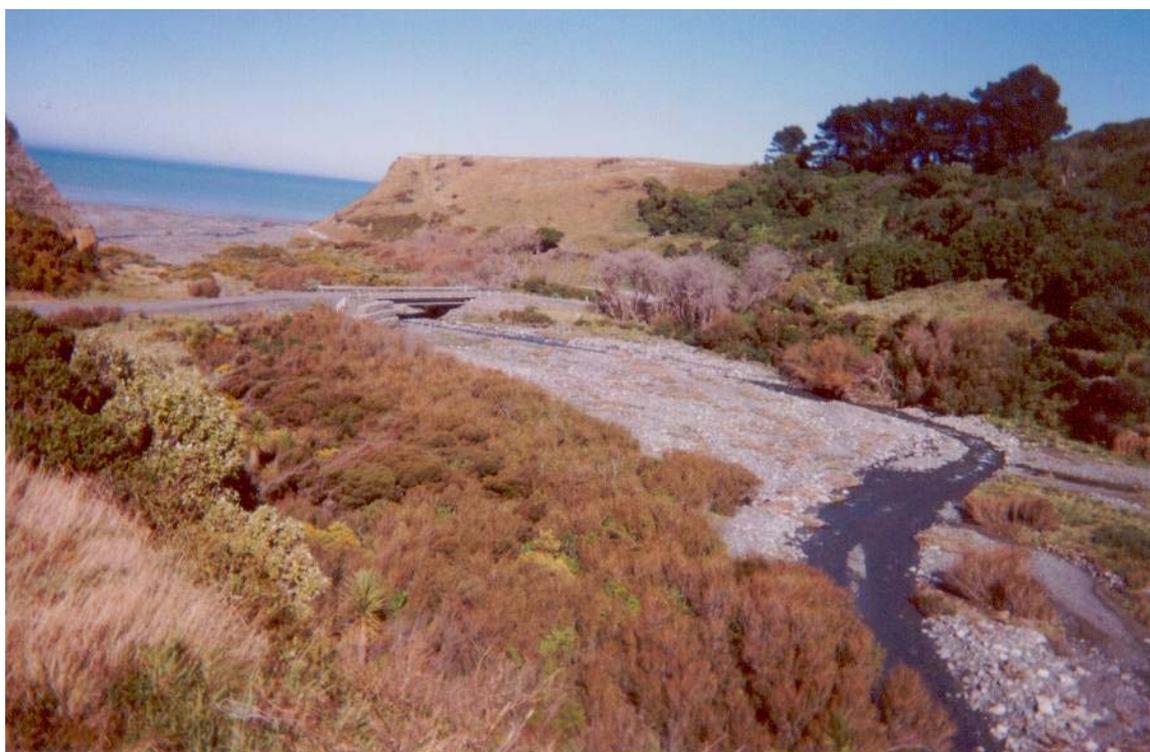
Figure 26: Wharepapa Stream, looking downstream towards the mouth.

These two waterways drain the south-eastern flanks of the Rimutaka Range, and discharge into Palliser Bay, west of the Ruamahanga River (Figs. 26-28). These two systems are also unsuitable for inanga spawning and rearing; the tidally-influenced margins of both lacked riparian vegetation of any description, and the lower reaches of the Wharekauhau Stream was comprised of unstable-looking braids.

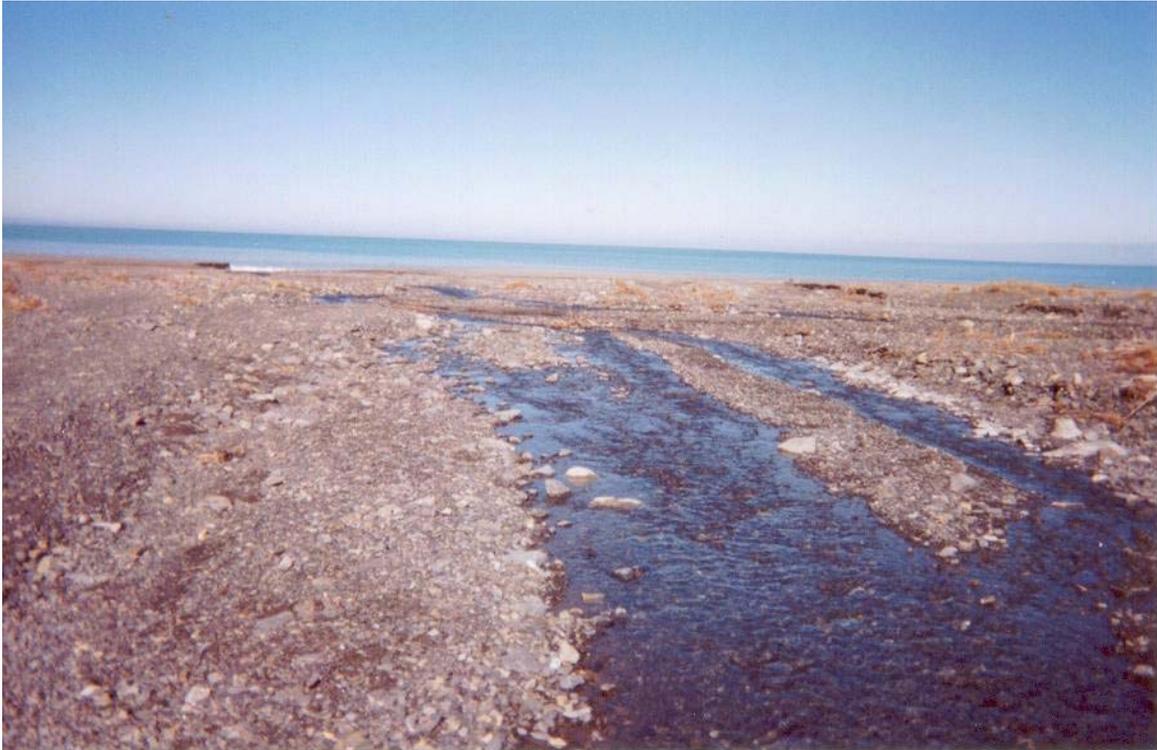
Figure 27: Wharekauhau Stream, looking downstream. The mouth looked nearly closed at the time of the survey.

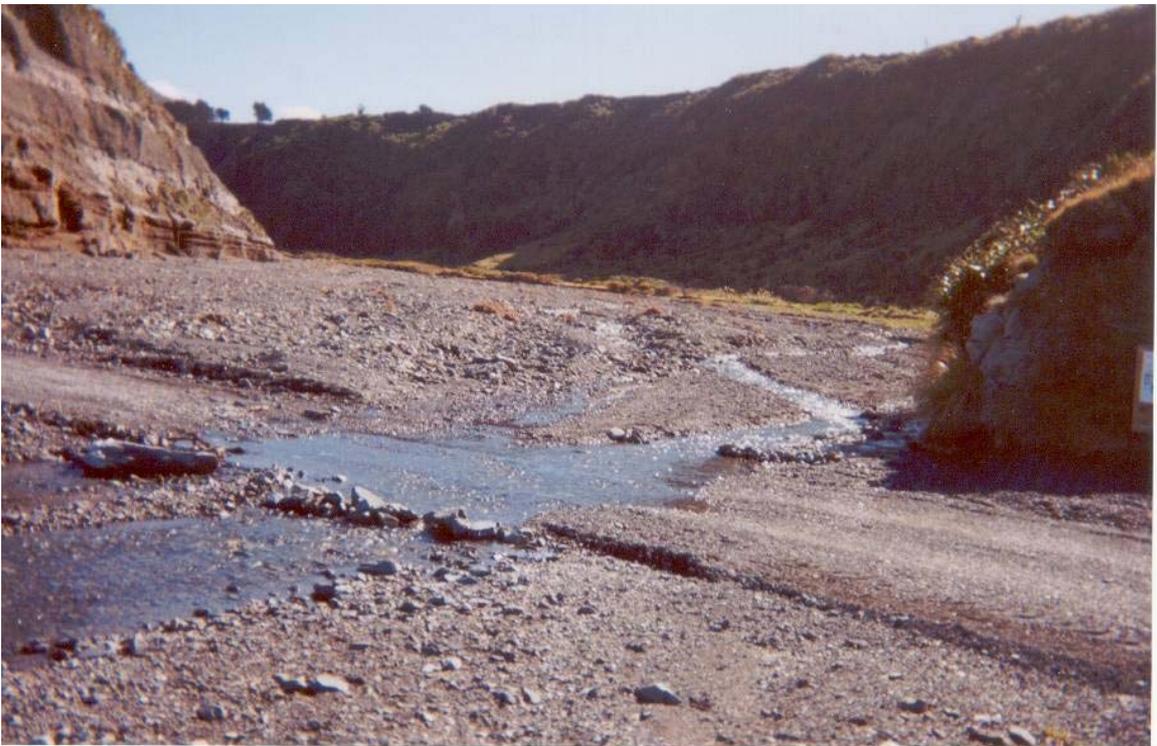
Figure 28: Wharekauhau Stream, looking upstream. Note the unstable braids which constitute the lower reaches. This habitat lacks the stability and grassy margins which are associated with inanga spawning habitat.

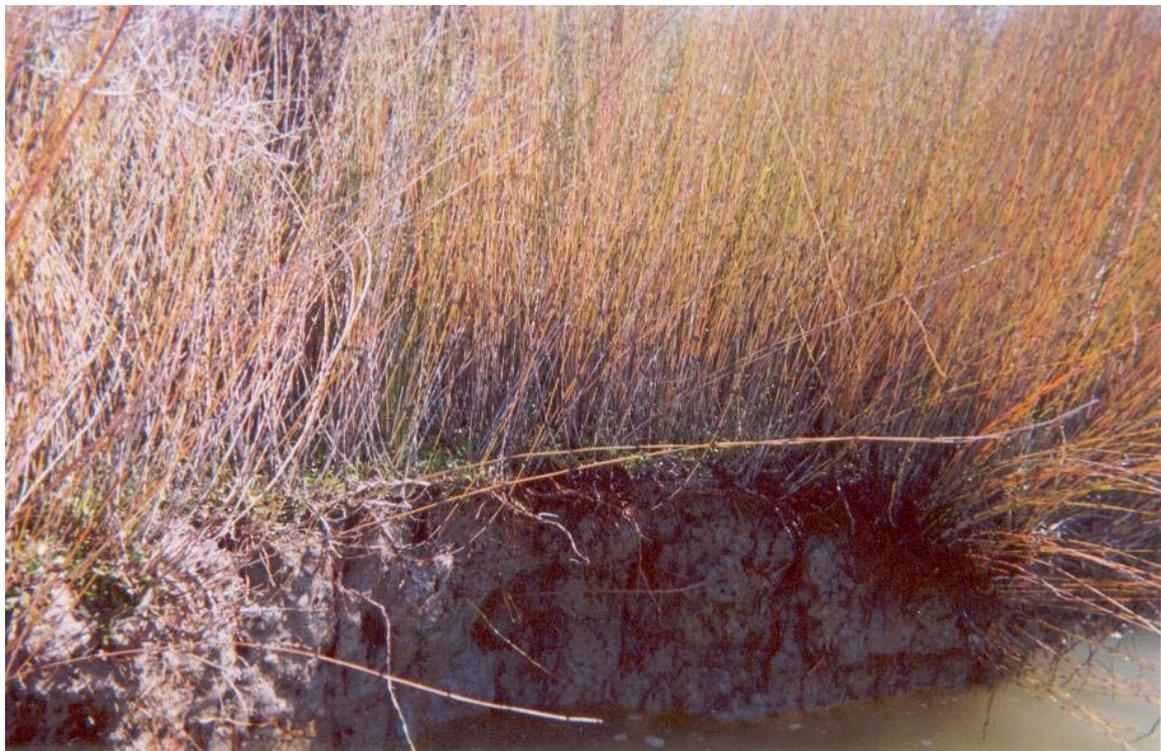
Figure 30: Native rush vegetation typical along the western shore of Lake Onoke. The vertical banks are probably due to wave-cut induced by the prevailing winds.

adhere, with the lake margins emerging vertically 30cm above the current lake level (Fig. 30). Two channelised drain inlets were examined in the vicinity, with riparian vegetation composed of a mixture of tall fescue and Mercer grass. However, this vegetation generally lacked a root mat which spawning inanga seem to prefer.
