Inanga spawning habitats in the greater Wellington Region

Part 2

Wairarapa

Publication No. WRC/RP-T-02/65
www.gw.govt.nz

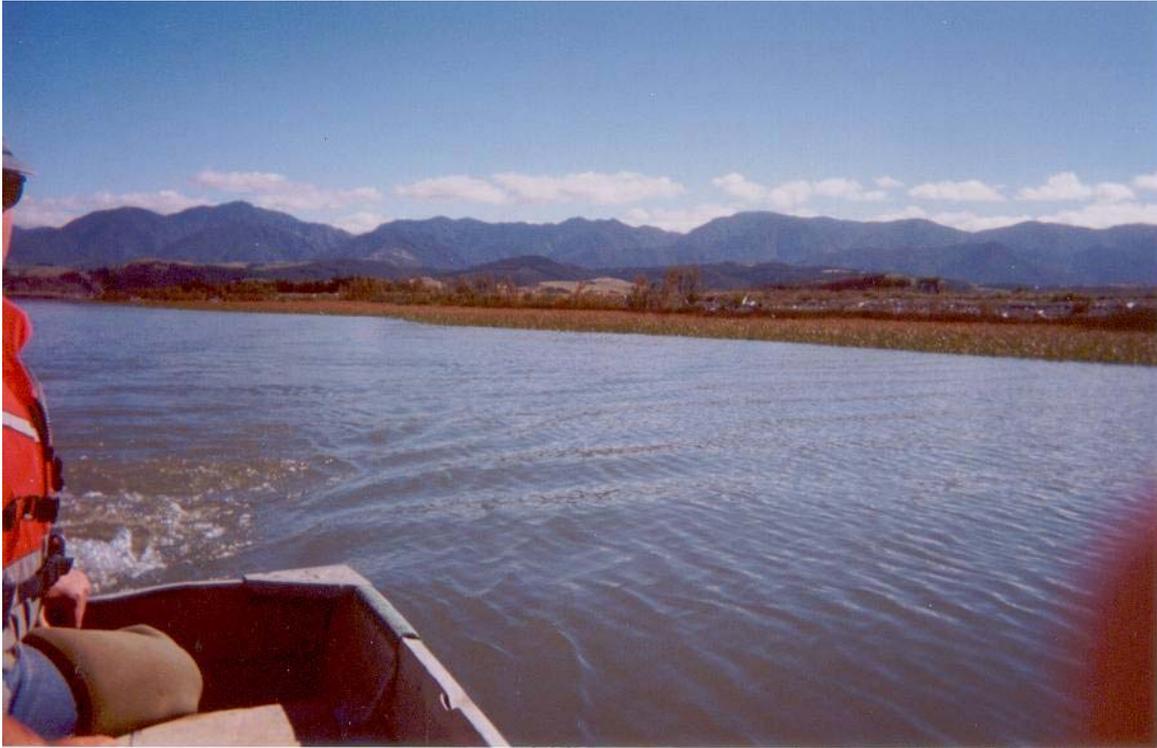
Figure 31: Emergent grass growing out over the sheltered lake waters. Some suitable spawning vegetation may exist in this inaccessible area.

The Lake Pounui outlet, which was discharging at the time, is controlled by flap valves. The vegetation downstream of the flap valves was found to be unsuitable for inanga spawning. East of the outlet, the lake edge consists of an artificial straight gravel beach for 1.6 km. In the sheltered shallows of the bay west of the Ruamahanga River mouth, a floating (probably exotic) grass mat, impenetrable for our vessel, prevented access to the lake margin. Such areas may offer spawning potential, although owing to its inaccessibility, we cannot comment of its suitability (Fig. 31).

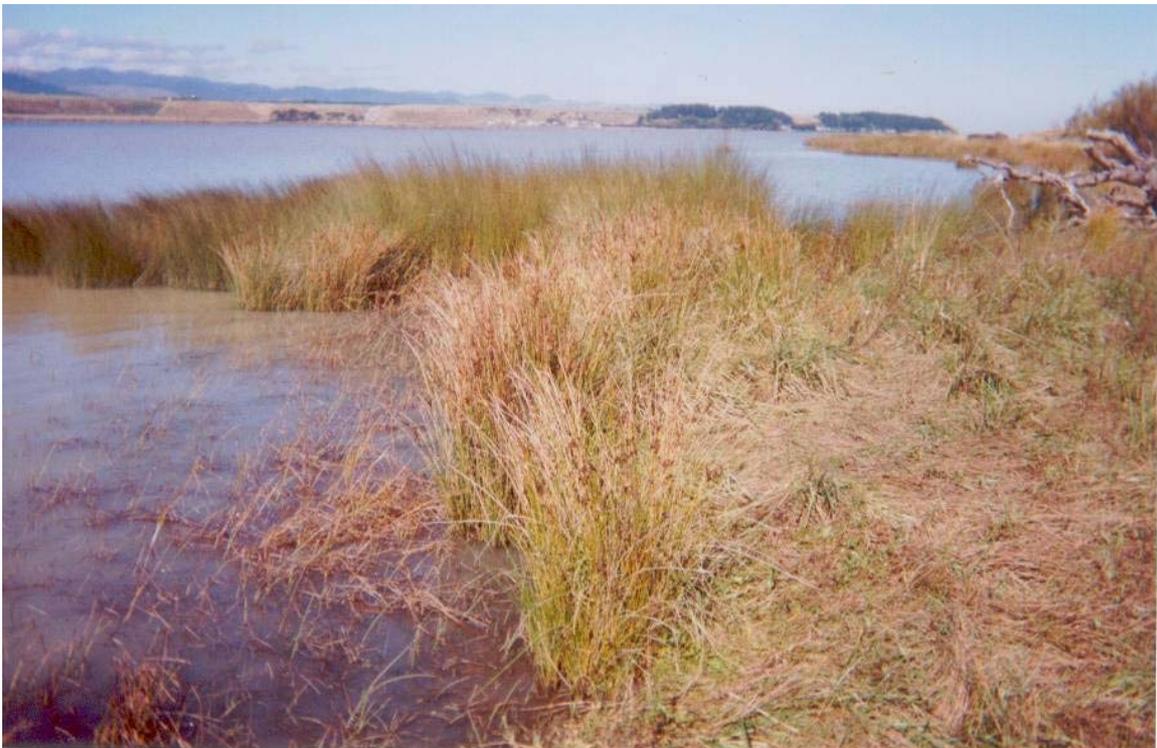
Figure 32: Thin grass cover on the true right bank of the Ruamahanga River looking downstream. Lake Ferry is discernable across the lake in the back ground.

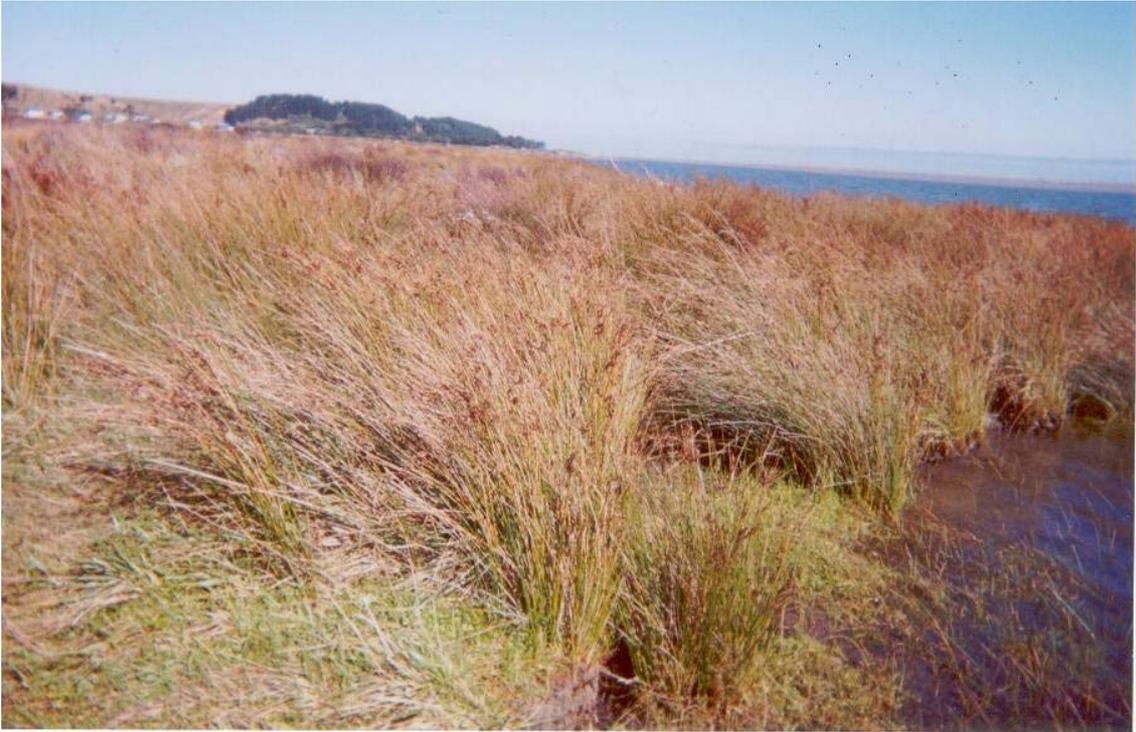
Figure 33: Suitable spawning vegetation north, and looking towards, Lake Ferry. Spring water rises amongst the vegetation here and the spring feeders supports lush vegetation at this location.

The eastern side of Lake Onoke has clearly the most suitable inanga spawning vegetation, which generally increases in suitability with distance away from the Ruamahanga River outlet, and towards Lake Ferry (Figs. 29 and 33). A 470m section of lake edge, fed by a number of springs, discharges directly into the lake, or enters waterways in this area. Inanga spawning was recorded here by DOC (in 1999) in a spring-fed stream (Fig. 34). On this occasion, large schools of inanga were observed, but a search failed to locate any eggs. The outlet of the stream was closed to the lake at the time, due to low lake levels, and the stream was comprised entirely of fresh water. Lake water in the vicinity was quite fresh (0.8 mS.cm^{-1}), probably due to spring-water infusion, in contrast to the far side of the lake where the water was brackish (5.0 mS.cm^{-1}). Land tenure in the suitable area is privately held (T.H. Warren) to the lake edge, and although the inshore areas were grazed, the area where inanga have been observed spawning was not impacted by stock. Further towards the mouth, the riparian zone was too stony to support inanga spawning.

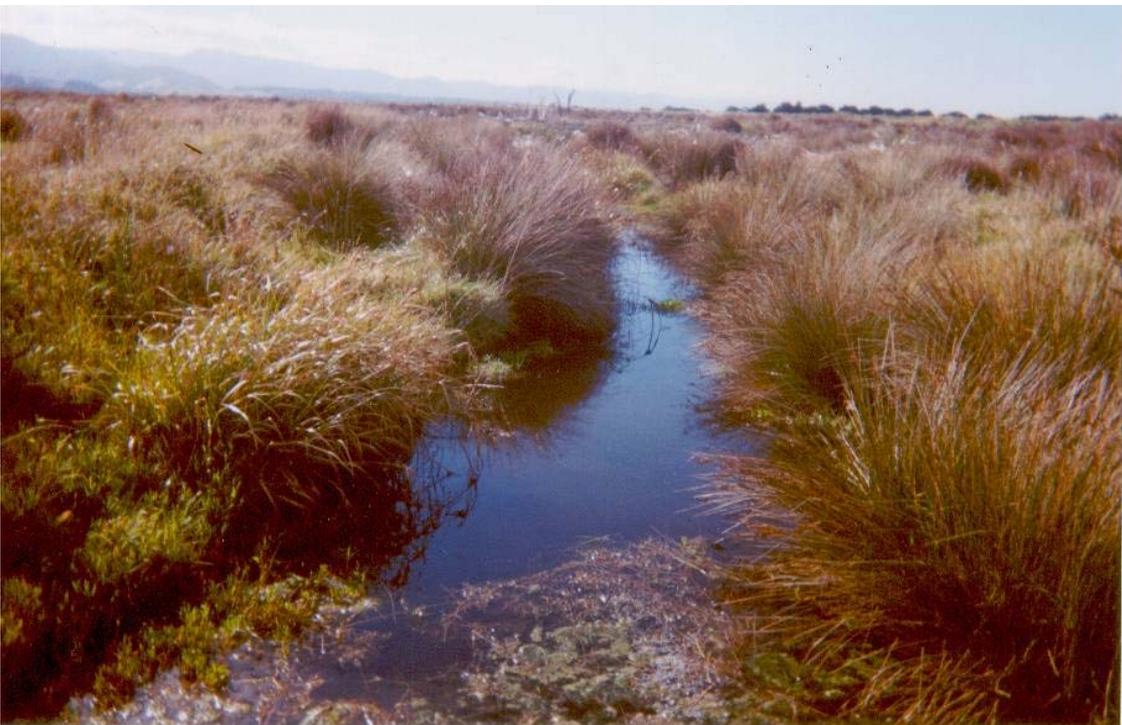
Figure 34: Spawning was recorded from this clear spring-fed stream in 1999. However, at the time of this survey, the stream was occluded from Lake Onoke by low lake levels, and although large shoals of inanga were observed here, no eggs were found.

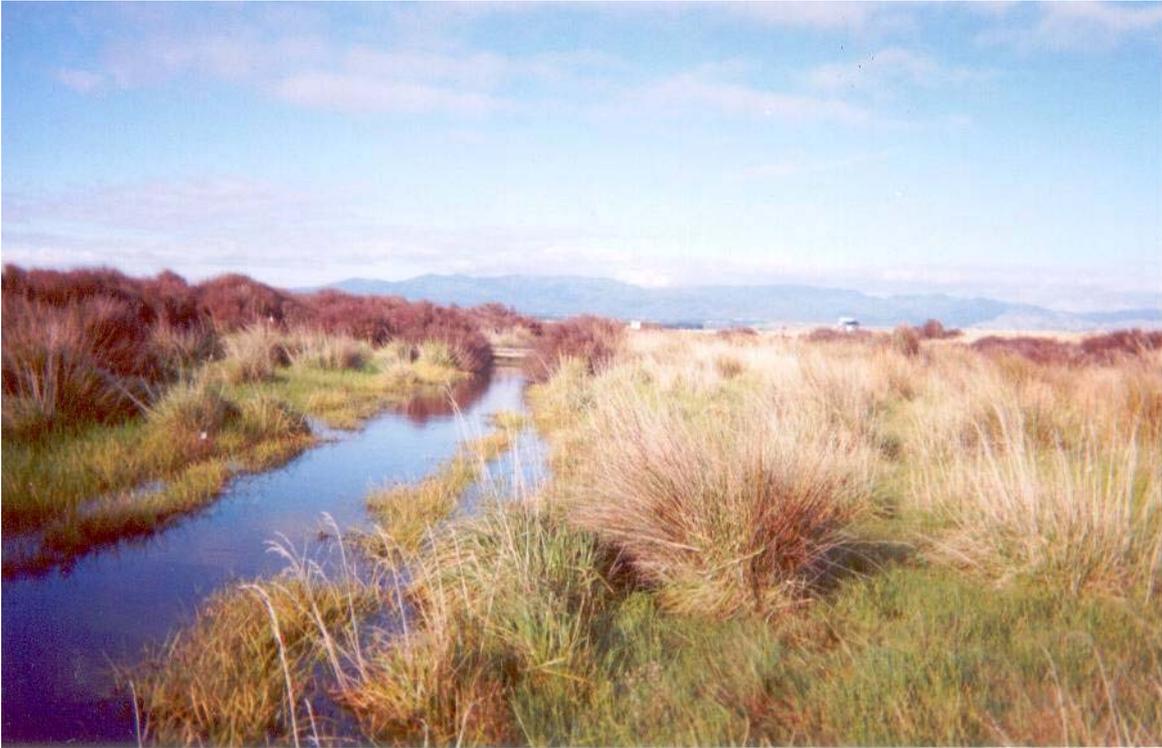
Figure 35: Lake Pounui outlet upstream of the flap-valve outlet to Lake Onoke. The grassy vegetation here was excellent for spawning, but the gates may inhibit spawning if they seal completely.

The Lake Pounui Stream outlet was assessed for spawning suitability by a foot survey over several hundred metres upstream of the flap valve outlet on the northern edge of Lake Onoke. Generally, this area had very good suitability for inanga spawning (Fig. 35), although the flap valve gates may inhibit spawning activity by restricting spawning shoal movement, and/or confusing physiological cues. At the time of writing, land tenure for this area was unknown.
