Effects of Flood Protection Activities on Aquatic and Riparian Ecology in the Wainuiomata River

Greater Wellington Regional Council (Flood Protection)

December 2016

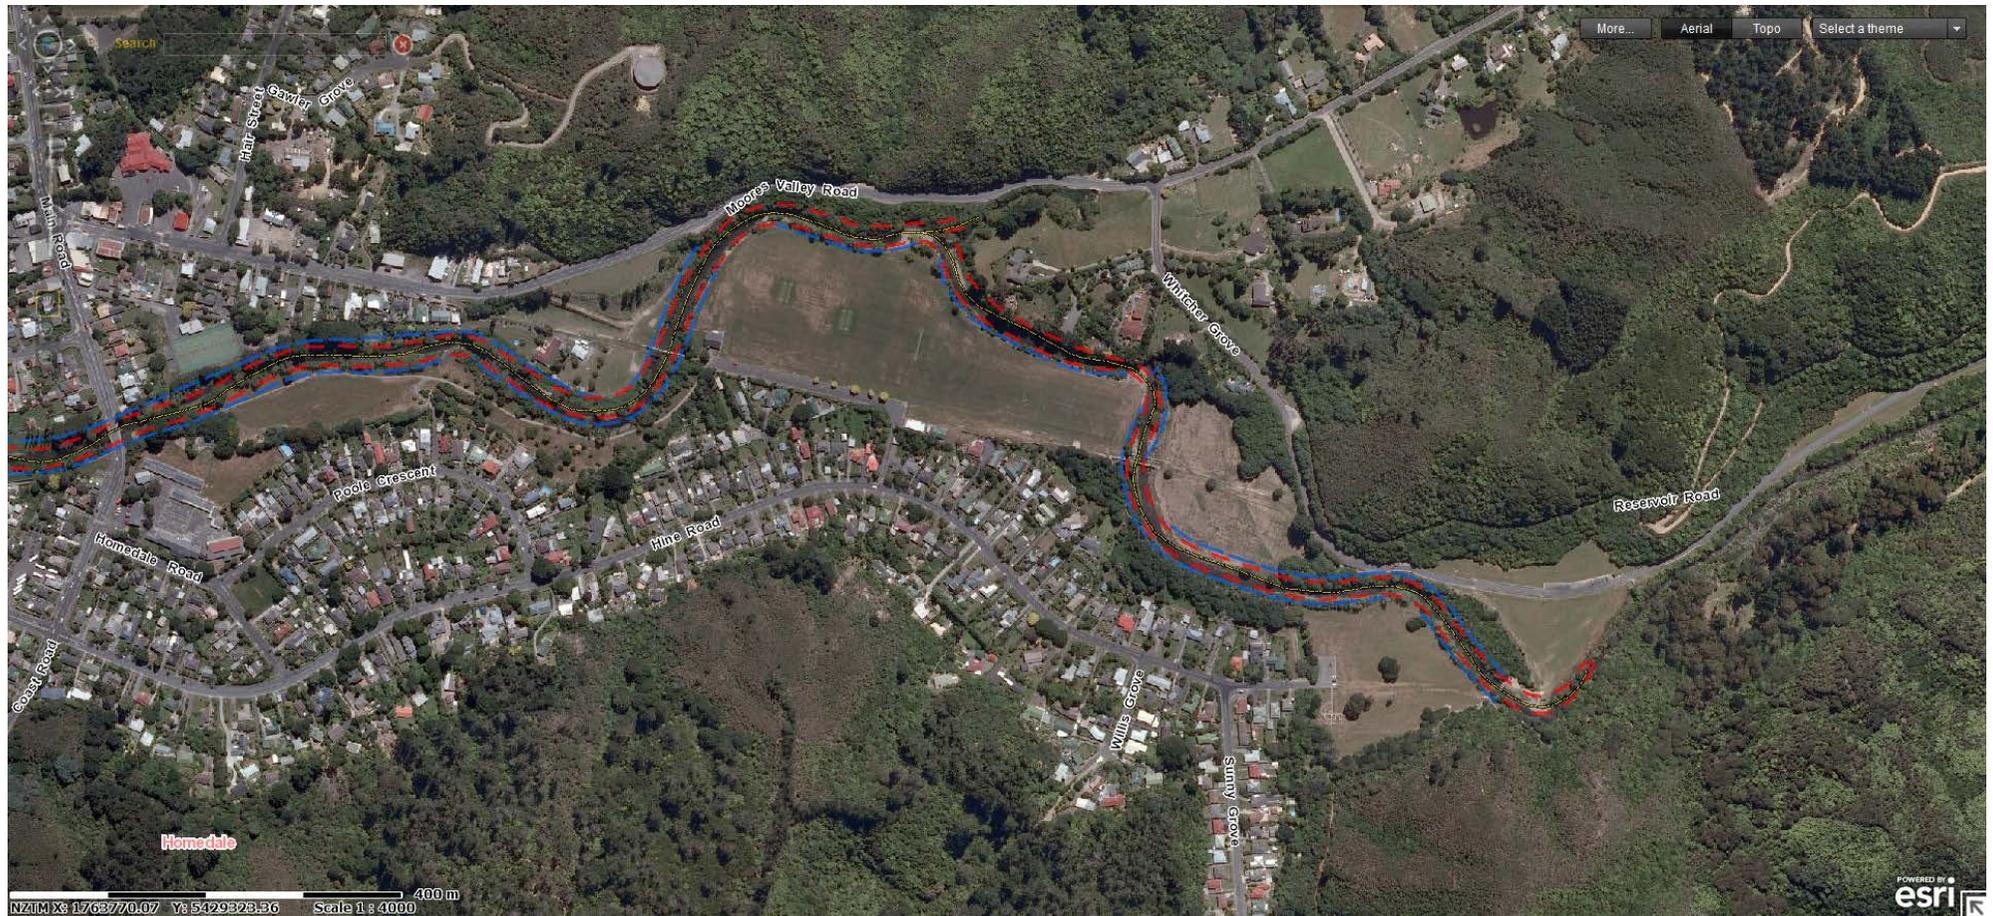
Figure 3-1: View of Wainuiomata application area (upper reach) showing design channel (red dash) and buffer zone (blue dash)

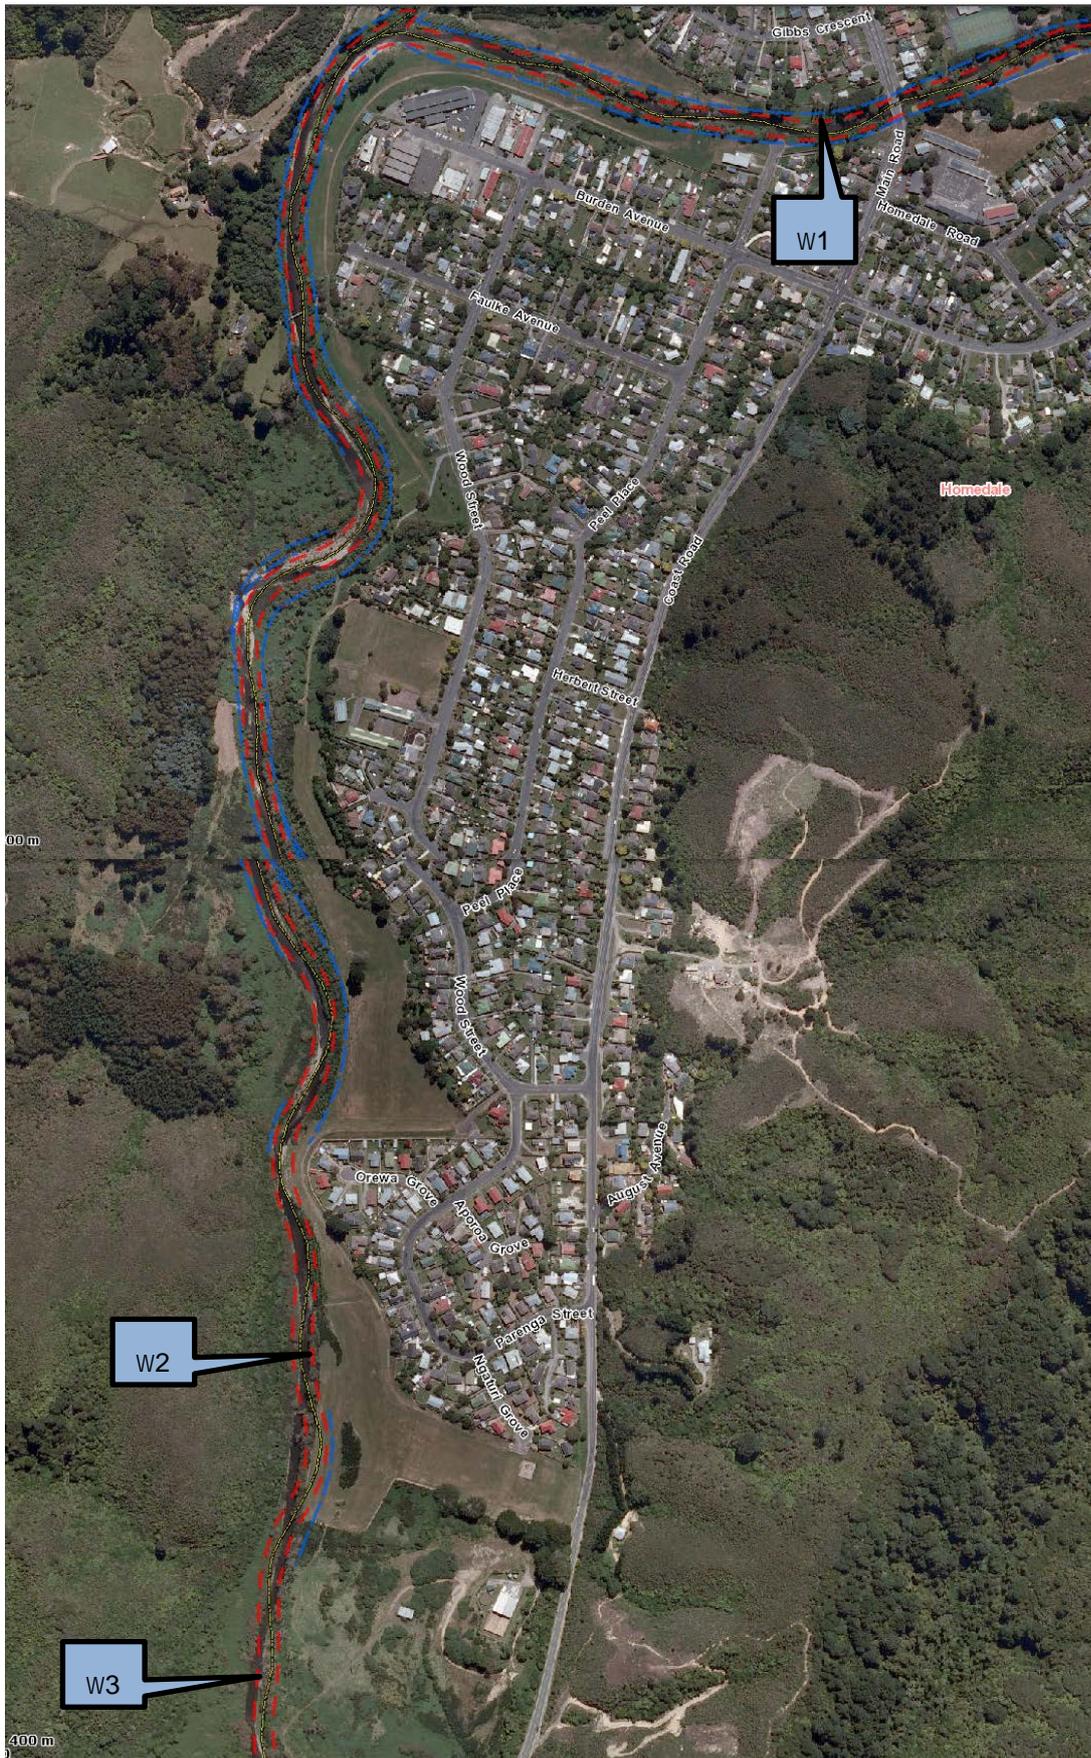
Figure 3-2: View of Wainuiomata application area (lower reach) showing design channel (red dash) and buffer zone (blue dash) and monitoring sites W1, W2 and W3 (from Cameron, 2015)

Wainuiomata River sites W2 and W3 are subject to similar influences as W1, but they receive run-off from a much larger urban area; Wainuiomata township, via Black Creek. The invertebrate communities at W2 and W3 are, nevertheless, little different from that found at W1, being dominated by *Aoteapsyche* and *Potamopyrgus*, constituting a ‘tolerant’ invertebrate community. Site RS29, located approximately 16km downstream of the application area, has a similar a macroinvertebrate community composition to that recorded at sites W1 to W3, although the relative abundance of two winged flies (Diptera) is somewhat higher and caddisflies (Trichoptera) lower.

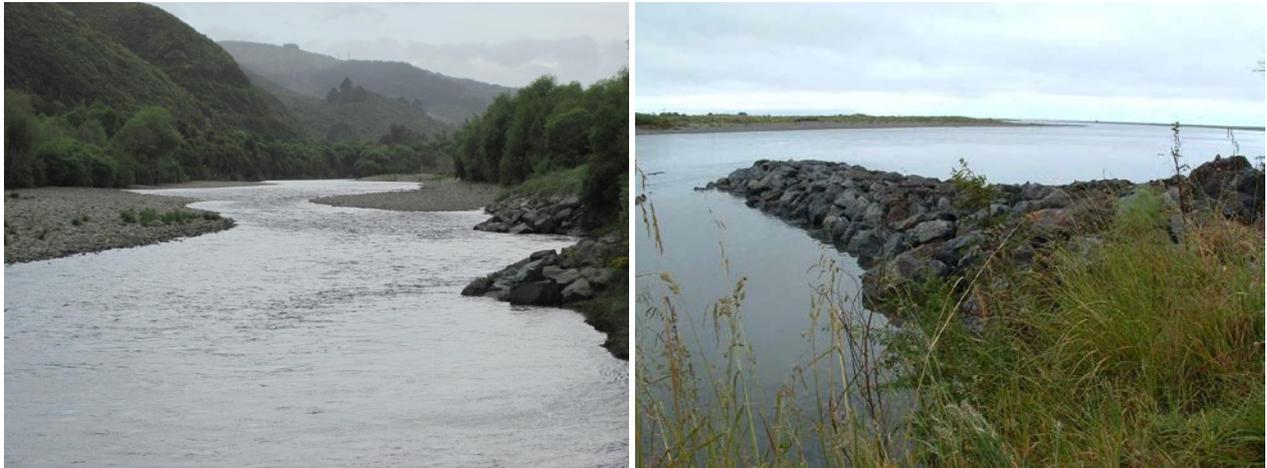
Figure 5-1: Rock groyne, Hutt River (left) and a large rock groyne near Otaki River mouth (right)

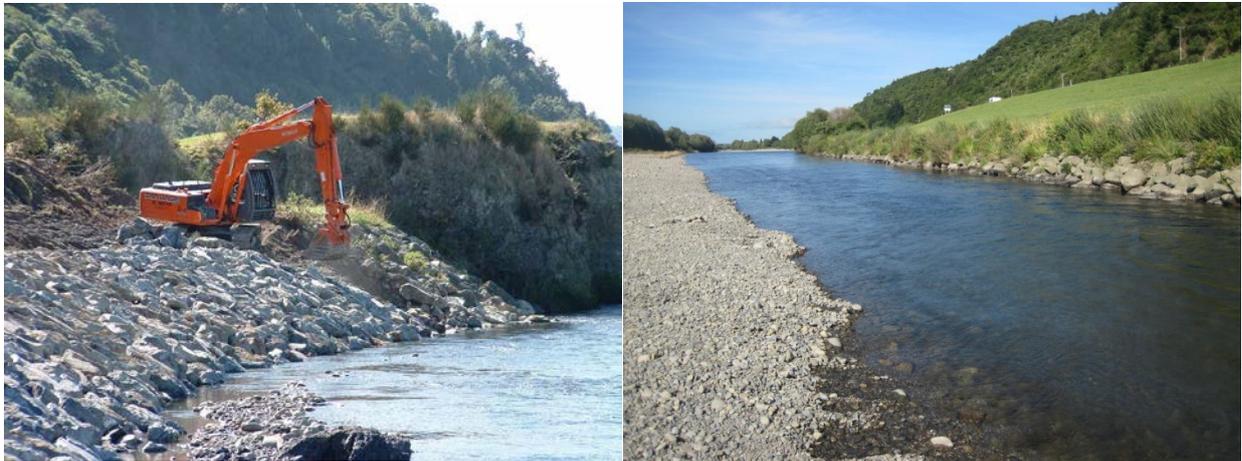
Figure 5-2: Rock rip-rap linings, Hutt River

In areas requiring lesser amounts of protection, rock lining may be placed at the toe of a bank; this is constructed in a similar way except that the structure generally does not extend higher than approximately 1m above the low flow water level and is not deeply founded into the riverbed.

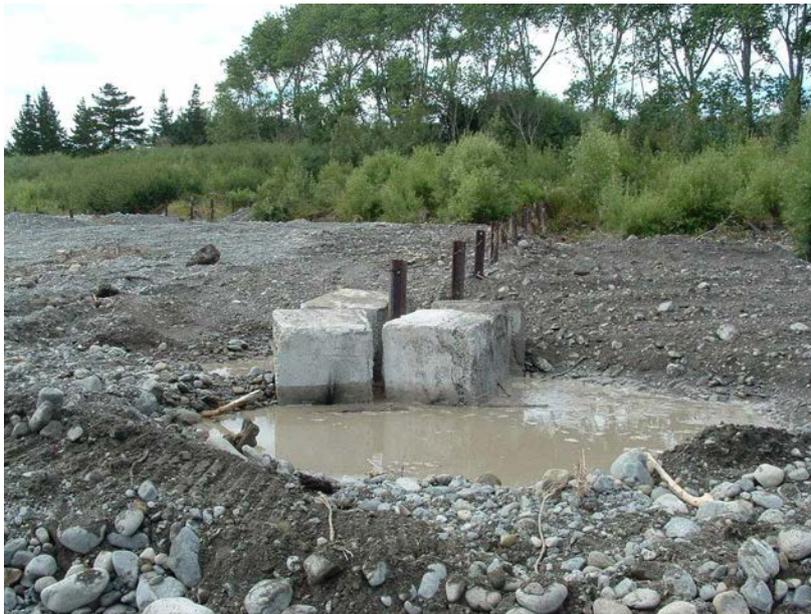
Figure 5-3: Completed debris fence, Otaki River.

Debris arresters are generally constructed from railway irons driven into the bed and tied together with horizontal irons and in general would entail some mechanical disturbance of river bed material as described for debris fences. These structures are used at relatively few locations in the Wainuiomata River but remain a useful tool in the right situation.

Timber groynes are constructed in a similar way to debris fences, but typically consist of round hardwood timber piles with two horizontal hardwood cross members.

These structures work as sediment and debris traps so that flood borne debris snags on the rails or cables and rapidly accumulates. At high flows turbulence causes scour on the lee of the structure, often creating a gutter which leads downstream to intersect with the main channel. When this gutter remains full of water at normal flows it can provide sheltered rearing habitat for juvenile fish. Larger eels, trout and a range of native fish may also find cover beneath the debris trapped on the cables, provided the hole is both stable and large enough (Mitchell, 1997).

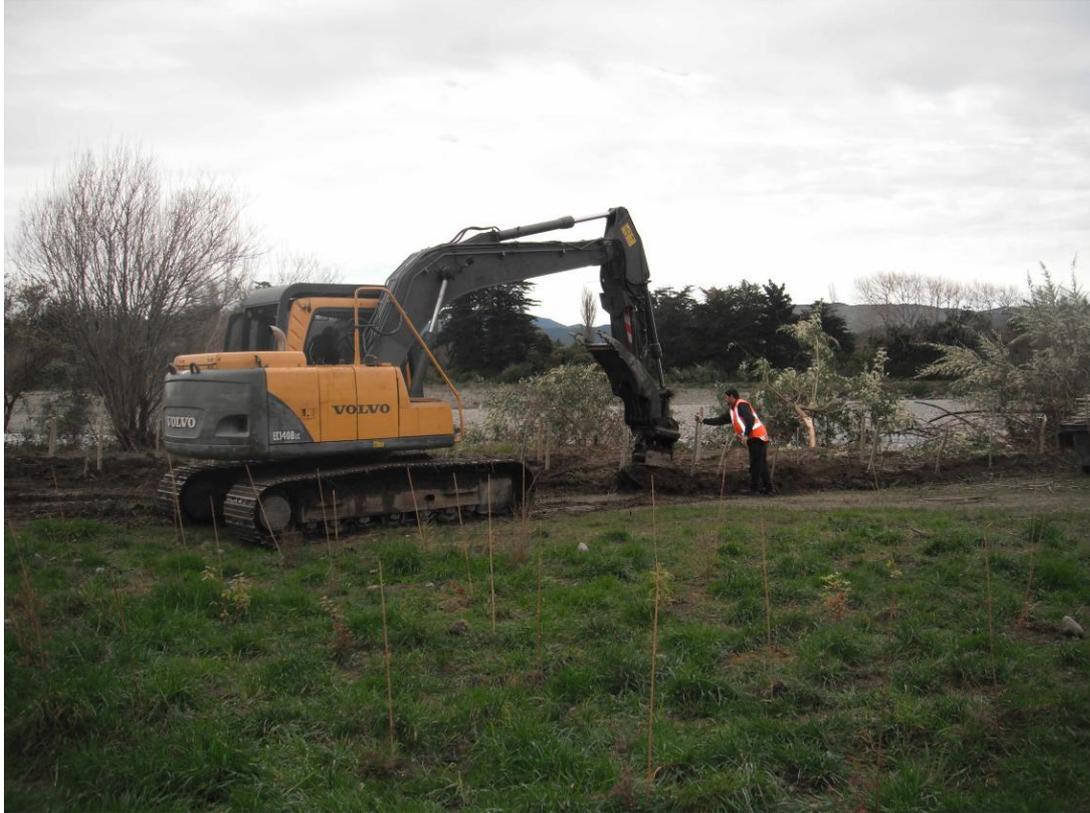
Figure 5-4: Willow pole planting (note native plantings in foreground)

- By hand, using a crow bar. Willow stakes are cuttings approximately 1.5 m long and 2.5 cm in diameter.
- Planting using an excavator or planting tine. The tine is dragged through the soil at up to 1 m depth and the stakes or rooted stock planted behind the moving tine. The movable arm of the excavator allows planting to be undertaken on quite steep banks and amongst established trees. This is most commonly used where large areas of planting are required.
- Planting using a digger. Willow poles (large cuttings of 3 m long or more) are planted in a trench dug and backfilled by the excavator. This method is used where willows are planted in very dry areas or immediately adjacent to fast flowing water.
- Planting using a mechanical auger to prepare holes for stakes or poles (Figure 5-4).

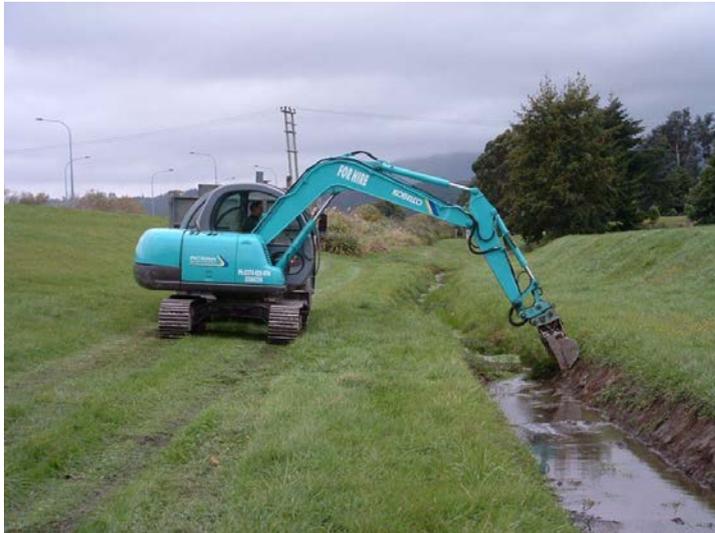
Figure 5-5: Vegetation and silt clearing from a drain beside the Hutt River

This activity includes the clearance of aquatic macrophytes (aquatic plants) and silt from low gradient watercourses so as to maintain channel capacity (Figure 5-5). High densities of these plants can increase sediment deposition, reduce flows and potentially flood surrounding land. Clearance may be done by mechanical or manual extraction of plant material.

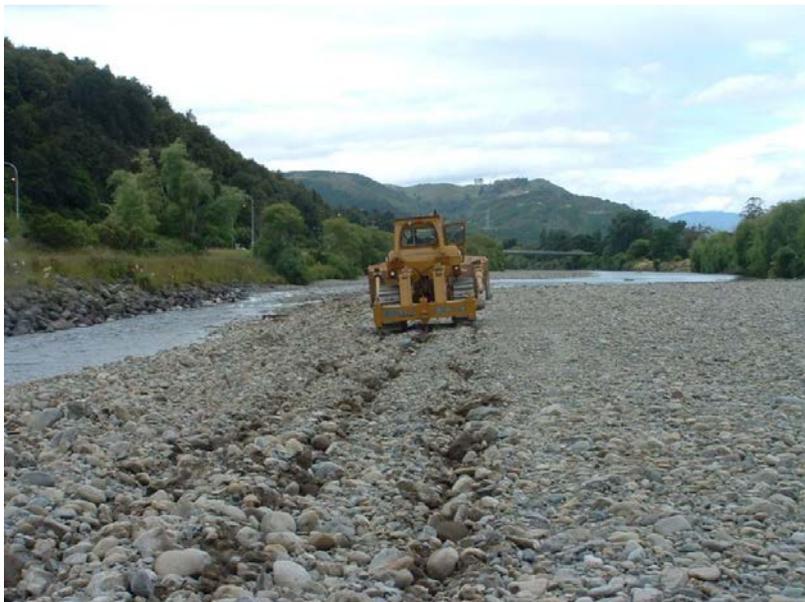
Figure 5-6: Beach ripping, Hutt River.

Ripping involves loosening of the gravel armouring layer by dragging a tine through it. This facilitates the mobilisation of the gravel during floods (Figure 5-6). Both activities involve excavation or disturbance of bed material but do not typically result in a discharge of sediment to the flowing channel.
