Inanga spawning habitat quality, remediation and management in the Wellington Region

AEL Report No. 138

Final Report

November 2016

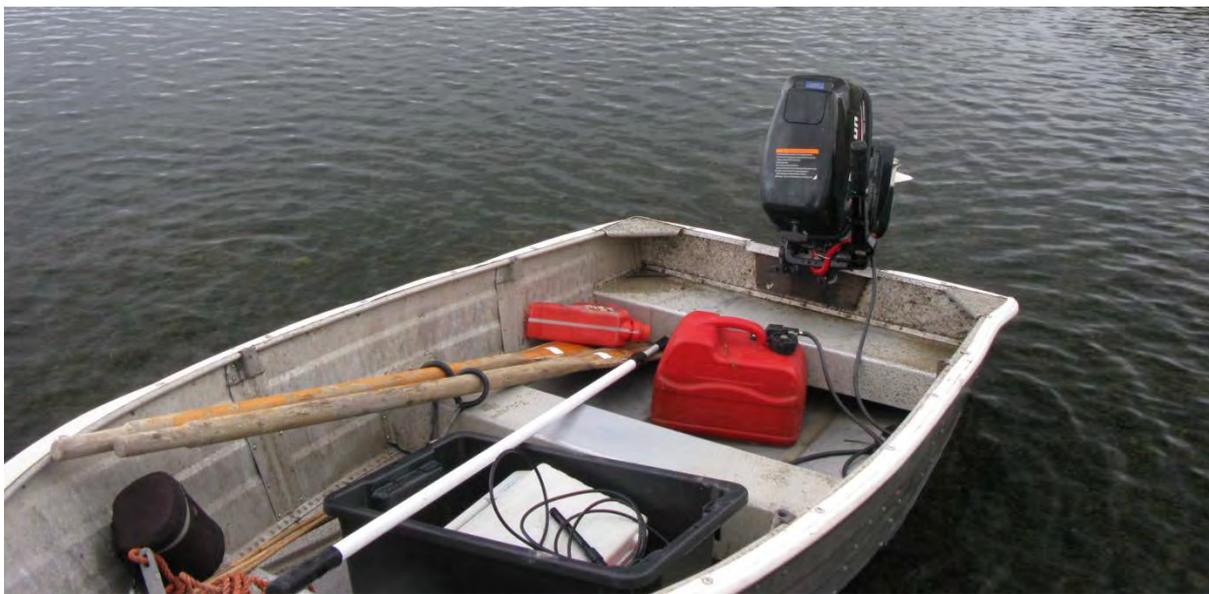
Figure 1. A small aluminium dinghy was used to survey rivers. The long-cabled salinity sensor can be seen coiled in the black plastic box.

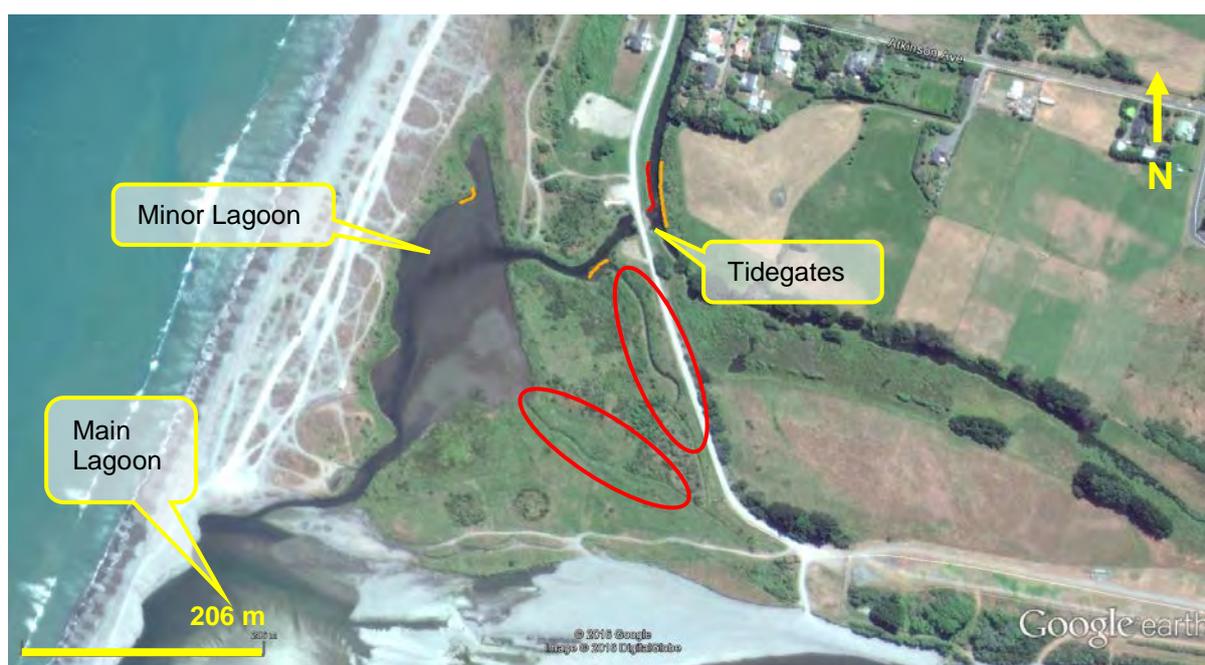
Figure 2a. Otaki River, northern tributary, Otaki. Orange line indicates the area that was unsuccessfully searched, but still considered suitable. Red line indicates the area that was searched, but considered unsuitable for spawning. Red circles indicate where further surveys may be productive.

The conductivity of the lagoon and its outlet at mid-high tide was fresh and ranged from 148- 250 $\mu\text{S}/\text{cm}$. A large school of inanga were seen scouting the shallows at the northern tip of the lagoon (Fig. 2a), but while a brief egg search was undertaken, no eggs were found in otherwise suitable vegetation.

Time limitations for this survey meant that both of the extensive areas downstream of the tidegates were unable to be thoroughly searched, and searching the raupo stand by boat would have been beneficial. Due to time limitations, additional surveys are recommended in the ringed tributaries in Fig. 2a.

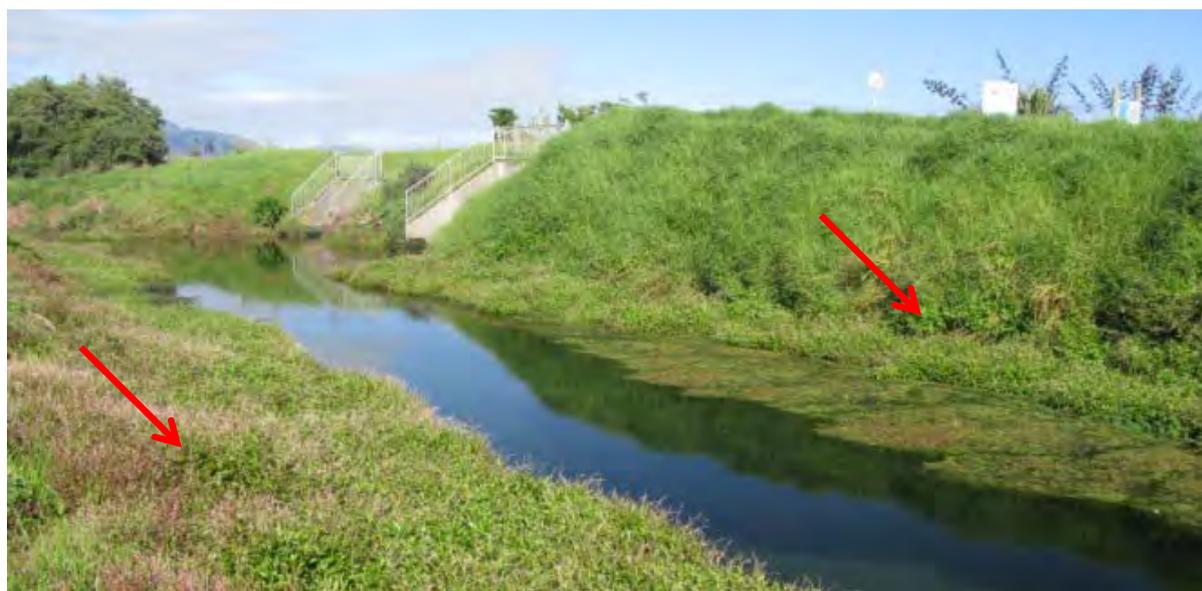
Figure 2b. Looking downstream at the area upstream of the tidegates that was unsuccessfully searched for spawning. Note the thick rafts of weed extending out from each bank. The approximate location of bank edges are indicated by red arrows.

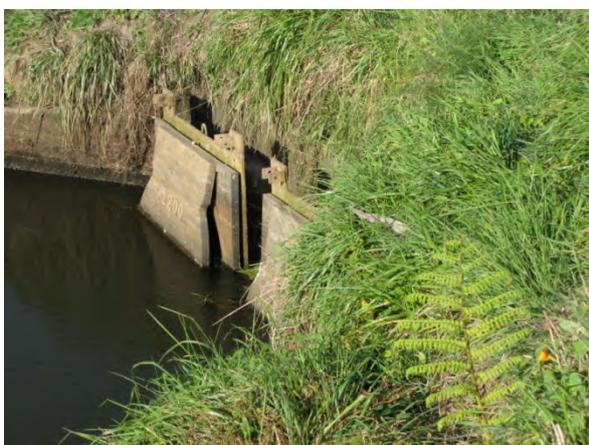
Figure 3d. Looking upstream at the old-style flap valves that protect the southern tributary.

A conventional double-culvert and double-flap valve assembly probably impedes tidal influence beyond the levee (Fig. 3 d). However, we did not take water salinity readings here, given that the Otaki lagoon waters downstream were clearly fresh on the high tide. Large numbers of mostly juvenile inanga were observed in the channel upstream of the flap-valves, indicating that passage is not significantly impeded. The true right bank was considered unsuitable for spawning as it was very steep, dry and had little- no root hair matrix (left bank in Fig. 3 e). The vegetation on this bank consisted of creeping jenny, willow weed and buttercup. The true left bank was shallower than the right bank, boggy, and possessed a low sparse sward of plant that resembled willow weed (right bank in Fig. 3 e). It is possible that this bank has been sprayed in the recent past. The vegetation was not characteristic of inanga spawning sites, and its suitability is unknown. We consider it worthwhile that this reach be re-checked at a later date. Currently, this site is probably of large size, but a mixture of low and unknown quality owing to the sparse root matrix and uncharacteristic vegetation.

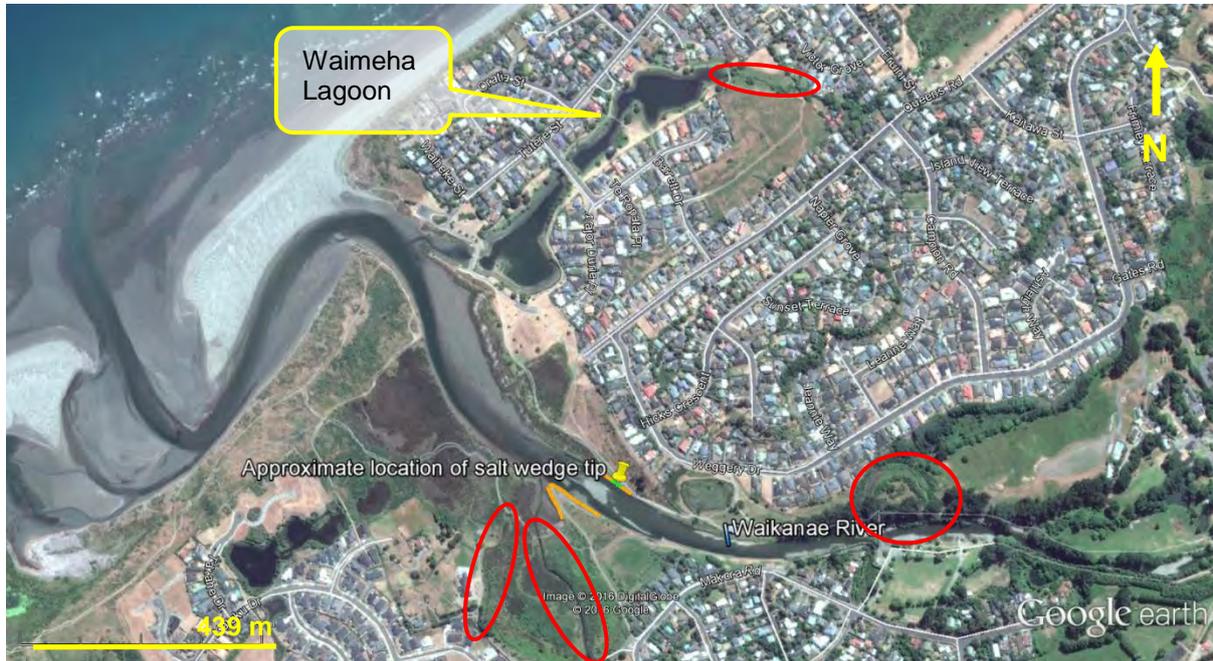
Figure 4a. Waikanae River, Waikanae. Green line indicates spawning reach, while orange line indicates the area that was unsuccessfully searched, but still considered suitable. Red circles indicate possible other habitats where spawning may occur.

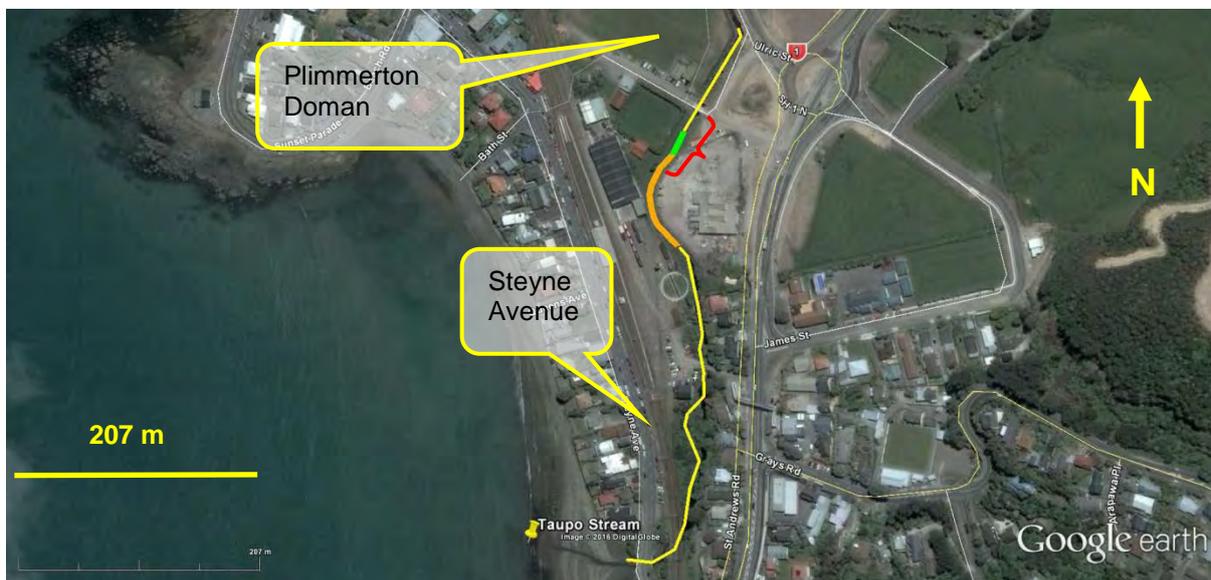
Figure 5a. Taupo Stream, Porirua. Yellow line indicates the length that was searched and suitability for spawning may be dependent on remediation. Red bracket = area recommended for re-survey, green section=possible post-survey egg identification, orange=suitable vegetation but eggs not found.

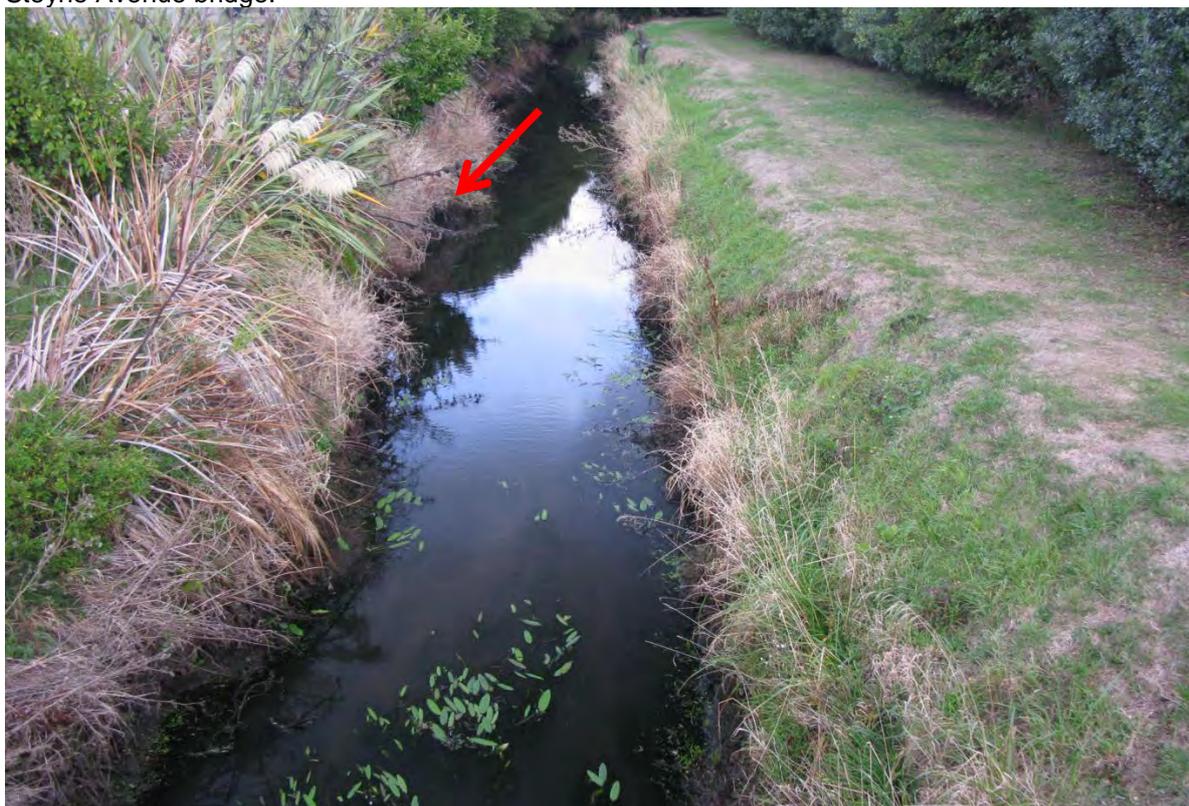
Figure 5d. Riparian vegetation looking downstream from the Plimmerton Station access bridge. Some of the vegetation may have been recently sprayed. Note the cape pondweed, a pest species in the Greater Wellington Region (Greater Wellington Regional Council und.). Red arrow = a possible egg nest location, based on a habitat photo.

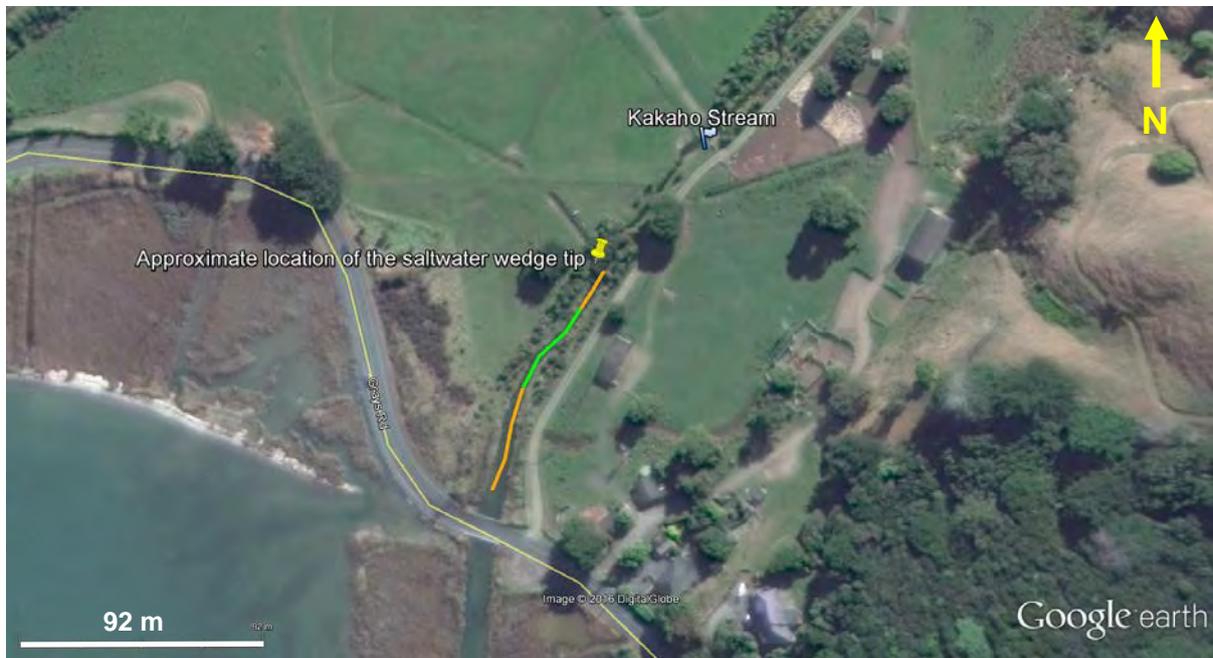
Figure 6a. Kakaho Stream, Pauatahanui Inlet. Green line indicates spawning reach, while orange line indicates the area that was unsuccessfully searched, but still considered suitable.

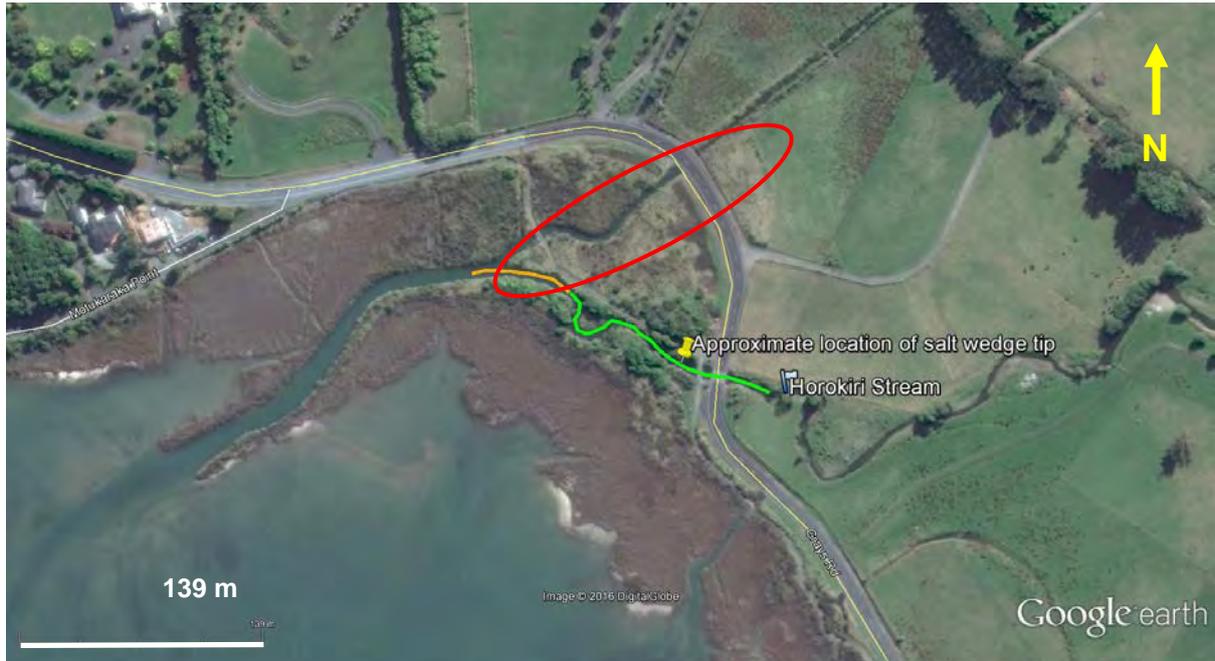
Figure 7a. Horokiri Stream, Pauatahanui Inlet. Green line indicates spawning reach, while orange line indicates the area that was unsuccessfully searched, but still considered suitable. Red circle indicates where a further survey may be valid.

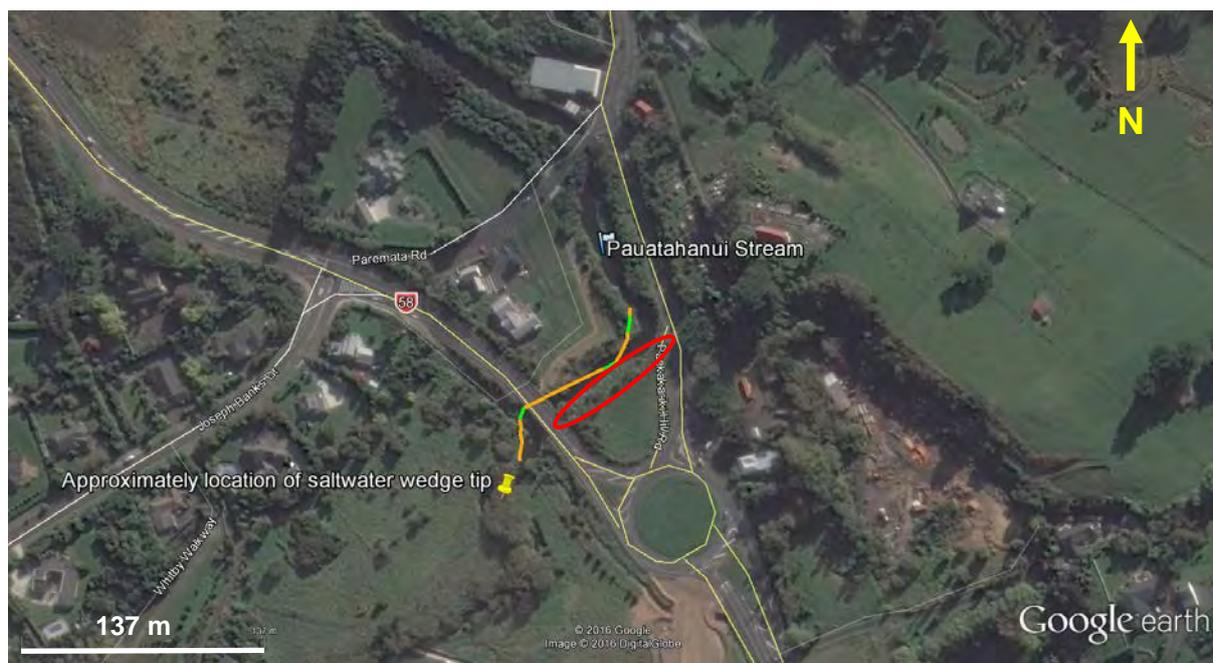
Figure 8. Pauatahanui Stream, eastern edge of the Pauatahanui Inlet. Green line indicates spawning reach, while orange line indicates the area that was unsuccessfully searched, but still considered suitable. Red circle indicates where a further survey may be valid.

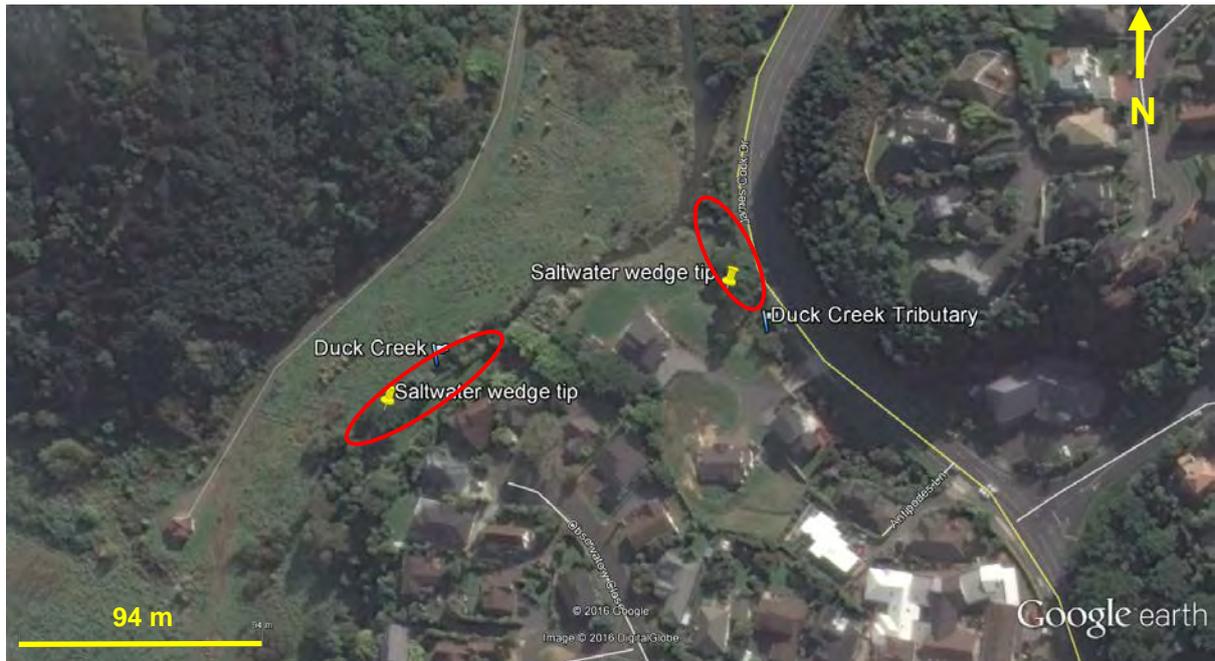
Figure 9a. Duck Creek (mainstem and tributary), Whitby. Red circle indicates where a further survey may be valid.

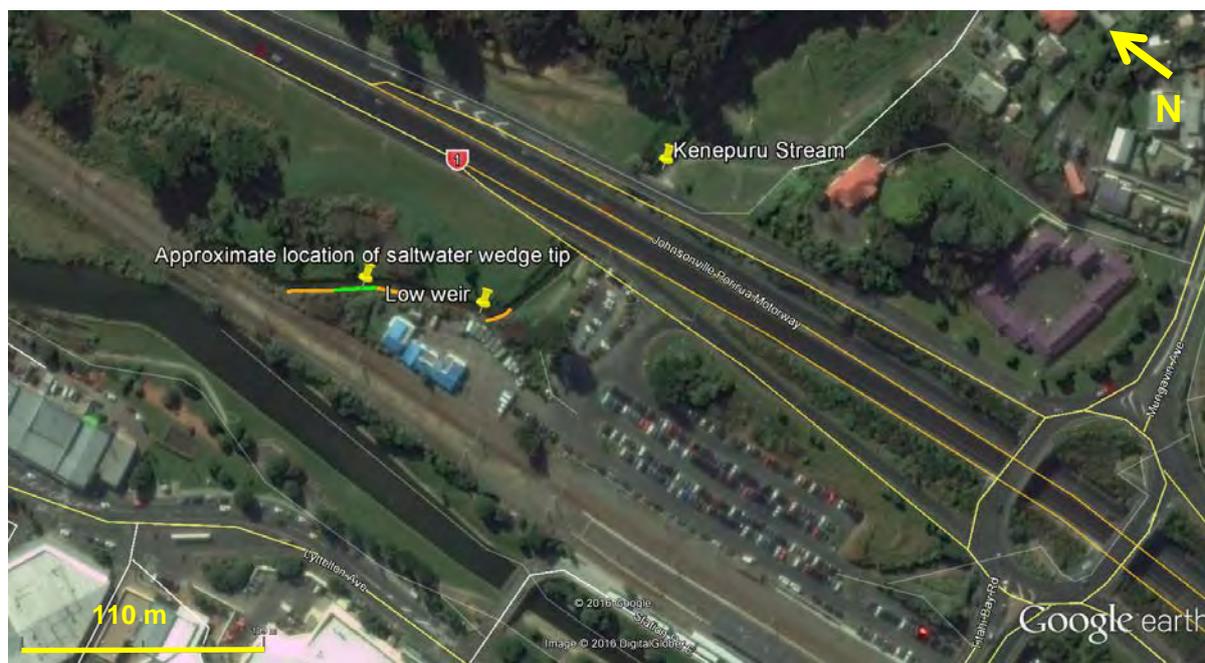
Figure 11a. Kenepuru Stream, Porirua. Green line = spawning reach, orange line = suitable but no eggs. Google™ Earth imagery date December 2015.

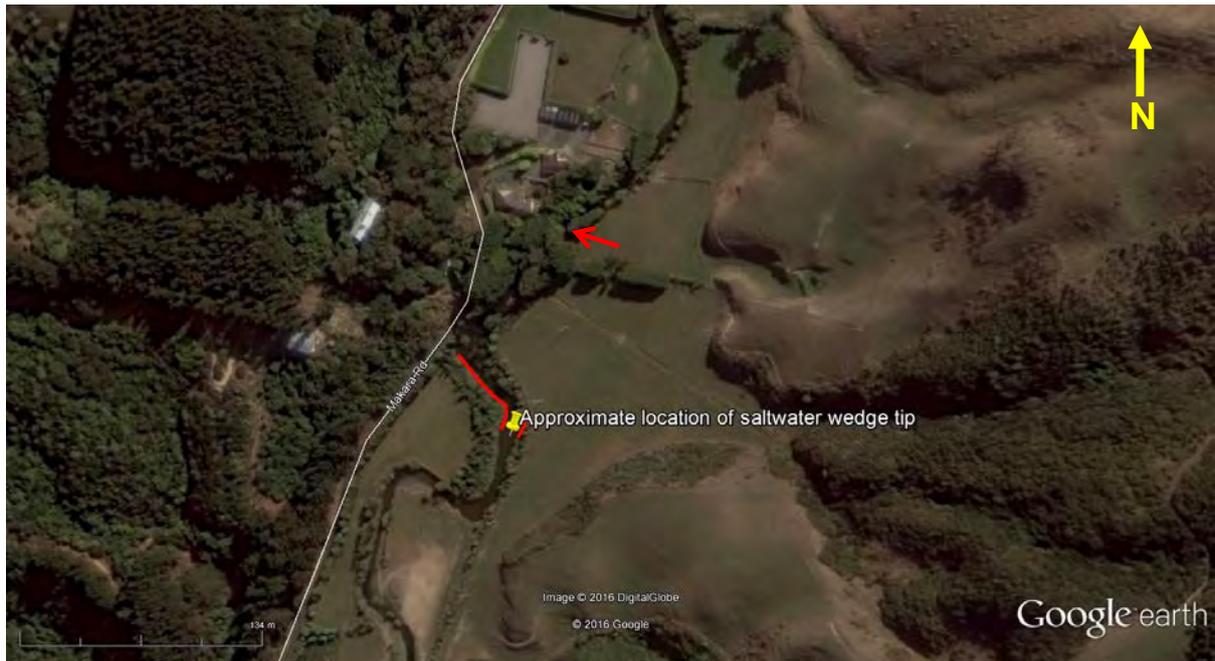
Figure 12a. Makara Stream, Makara Beach. Red line indicates the area that was searched, but considered unsuitable for spawning. Location of bamboo thicket is arrowed.

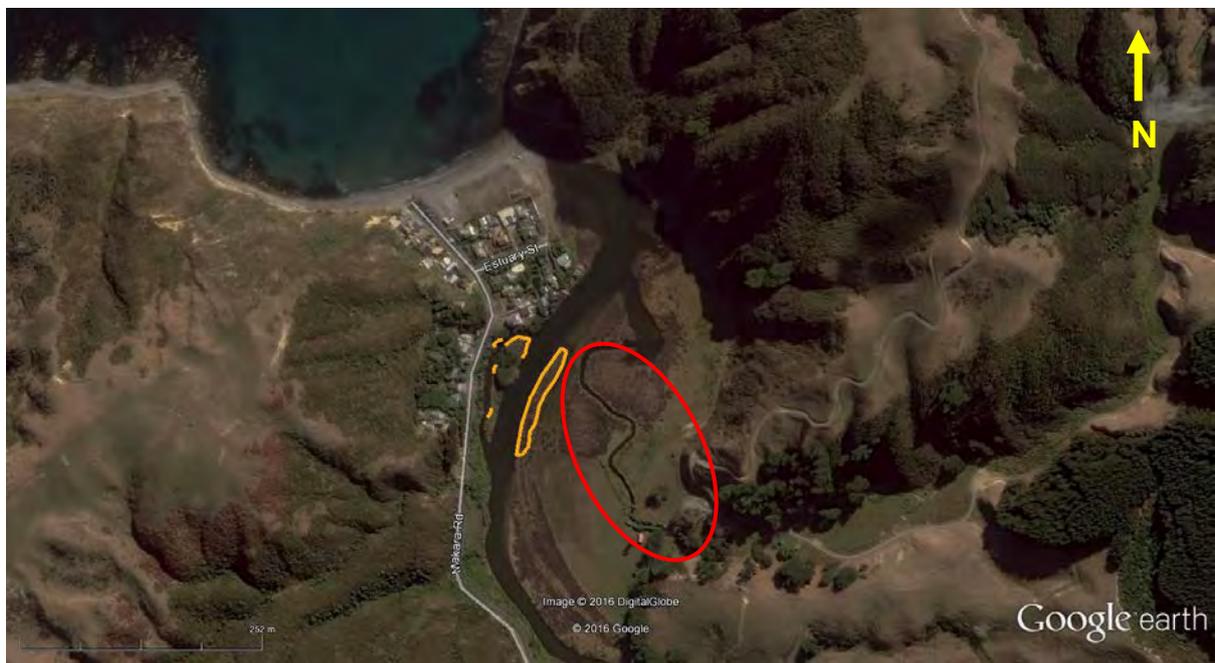
Figure 12b. Makara Stream, Makara Beach. Orange lines indicate the area that was unsuccessfully searched, but the vegetation was still considered suitable. Red circle indicates where a further survey may be valid.

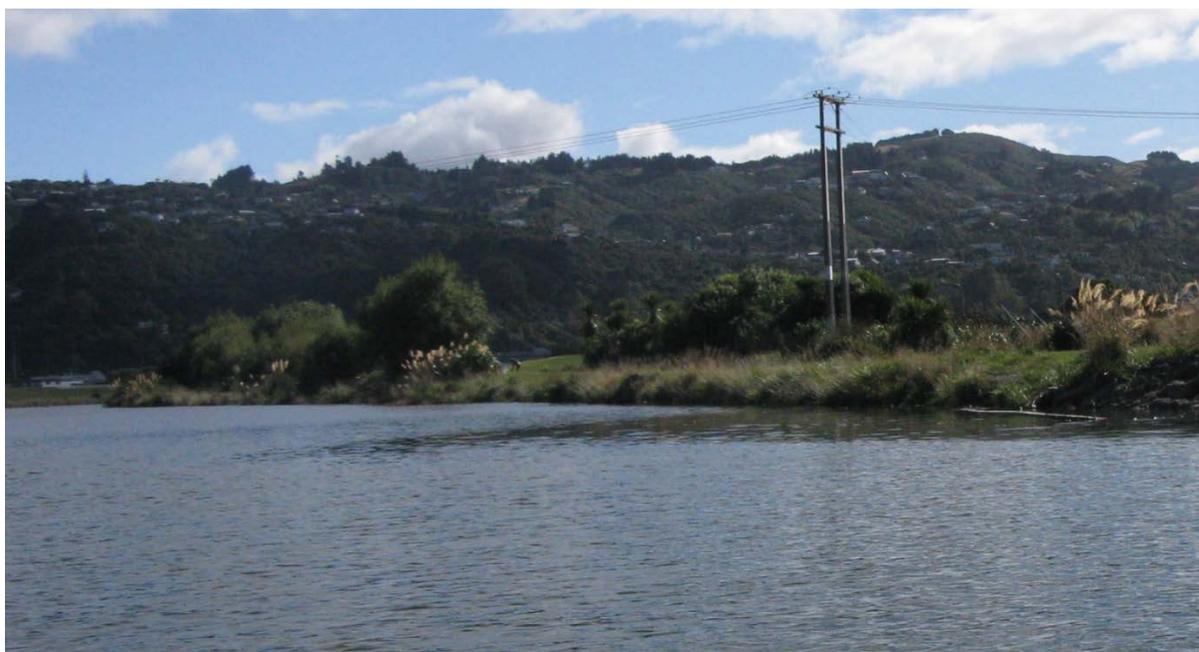
Figure 13. The Hutt River at high tide upstream of the Opahu River mouth. This is the true left (east) bank which has vegetation superficially suitable for inanga spawning.

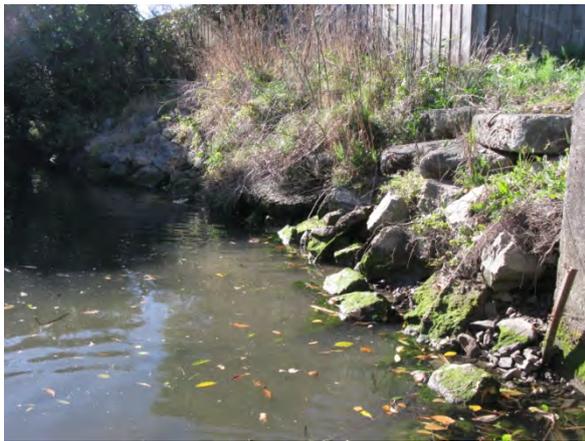
Figure 16b. Looking upstream at Opahu Stream, note the steep, rock-clad banks and minimal vegetation.

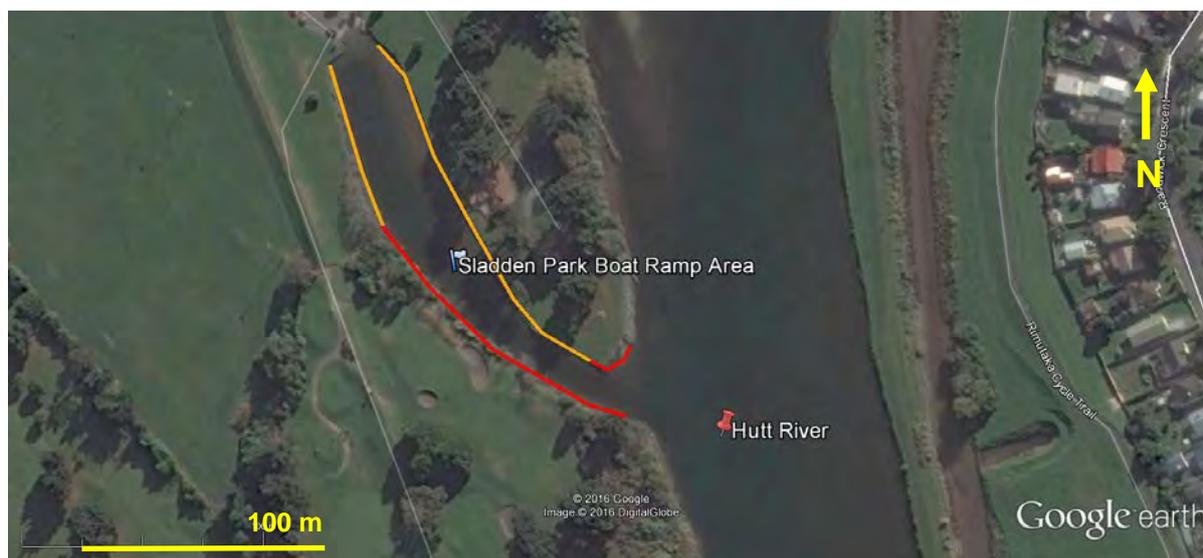
Figure 18a. Sladden Park boat ramp area, Lower Hutt. Orange lines indicate the area that was unsuccessfully searched, but the vegetation was still considered suitable; red lines indicate the area that was searched, but considered unsuitable for spawning.

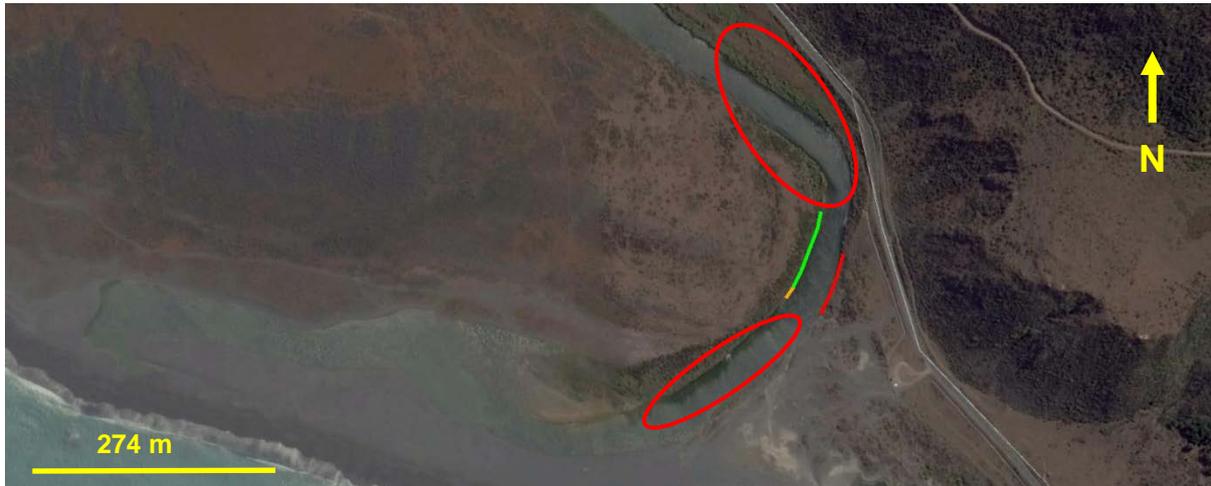
Figure 20a. Wainuiomata River, Wainuiomata. Green line indicates spawning reach, while orange line indicates the area that was unsuccessfully searched, but still considered suitable. Red line indicates the area that was searched, but considered unsuitable for spawning. Red circles indicate where a further survey may be warranted.

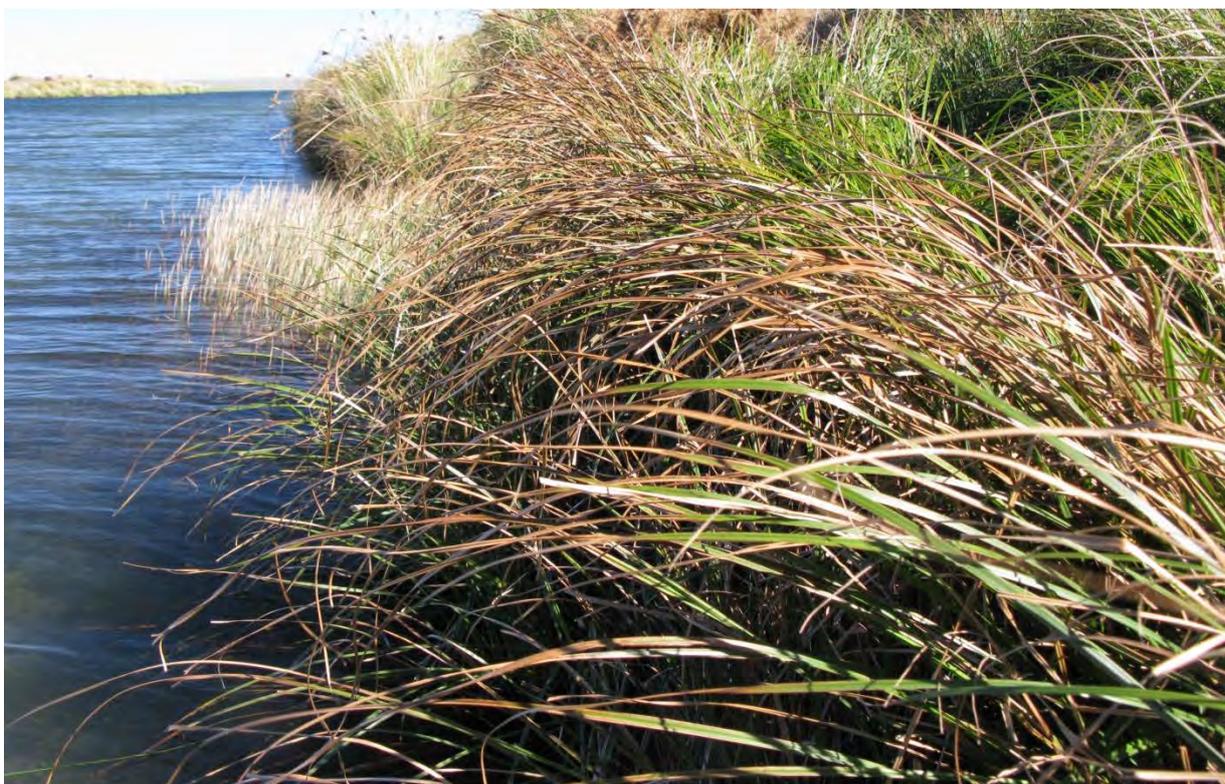
Figure 20c. Inanga eggs were found at the bases of giant umbrella sedge (background) and another, unidentified sedge, possibly *Carex geminata* (foreground). Most of the stock-palatable grasses had been close-grazed and therefore unsuitable for inanga spawning.

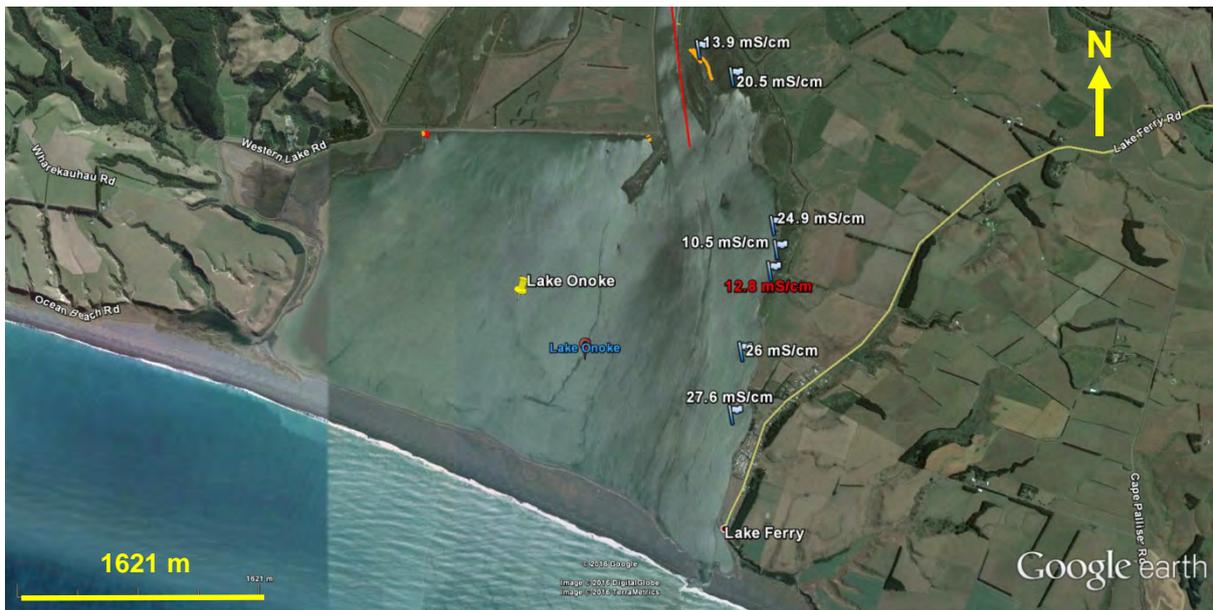
Figure 22b. Conductivity of waters in Lake Onoke illustrating the lower readings in the vicinity of freshwater seeps along the north and eastern shoreline. Red line = Ruamahanga River course. Red value is conductivity in an occluded lagoon formed by a historic old braid, separated from the lake by a gravel bund.

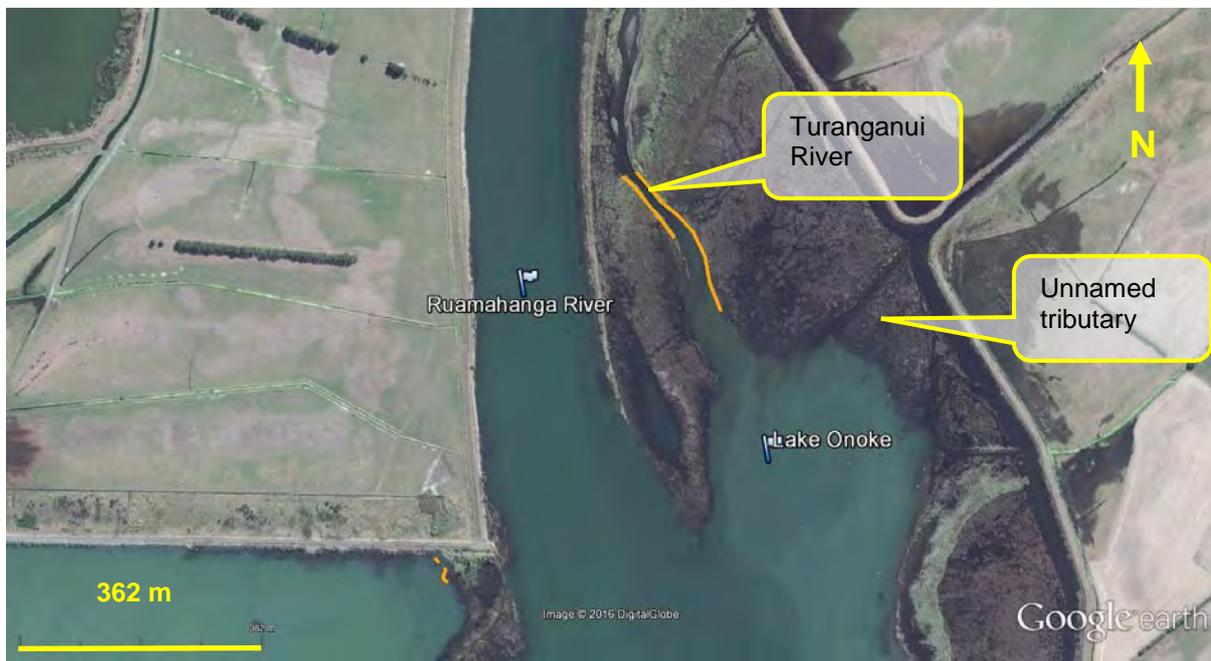
Figure 22c. Turanganui River, and north-east bank of Lake Onoke. Orange lines = the area that was unsuccessfully searched, but still considered suitable

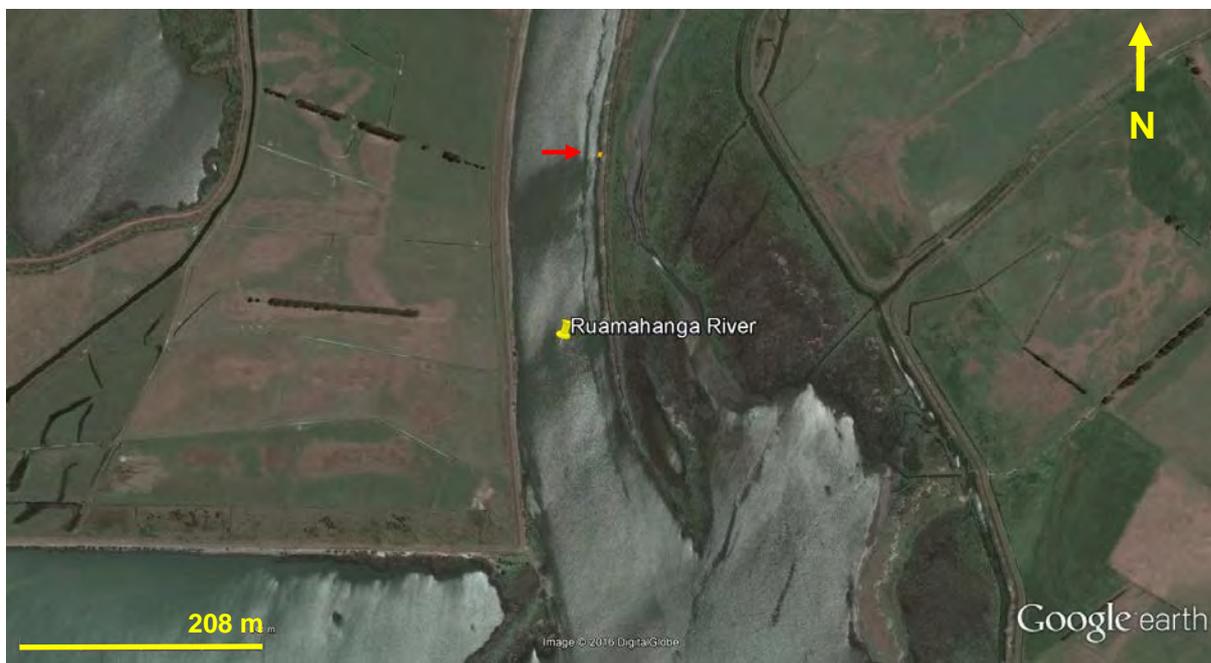
Figure 23b. Ruamahanga River, Wairarapa. Orange location (arrowed) indicates the area that was searched for eggs, the vegetation was considered suitable, but the water salinity was uniformly high.

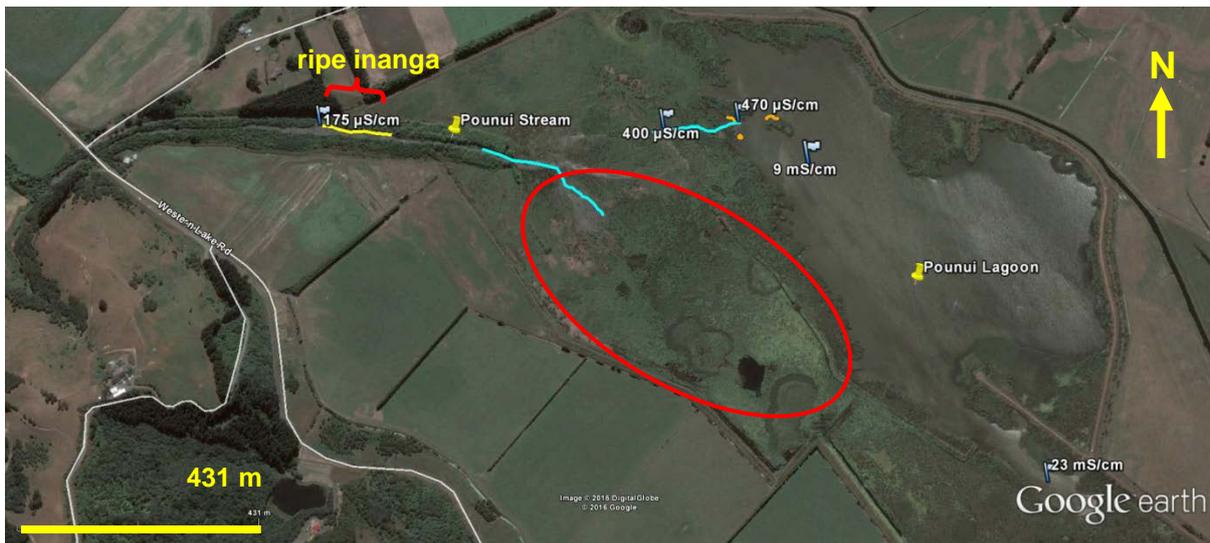
Figure 25a. Pounui Stream and Pounui Lagoon, with water conductivity (salinity) readings, and reconnoitred water path (light blue). Ripe inanga were identified within the bracketed region, with potential spawning habitat ringed in red.

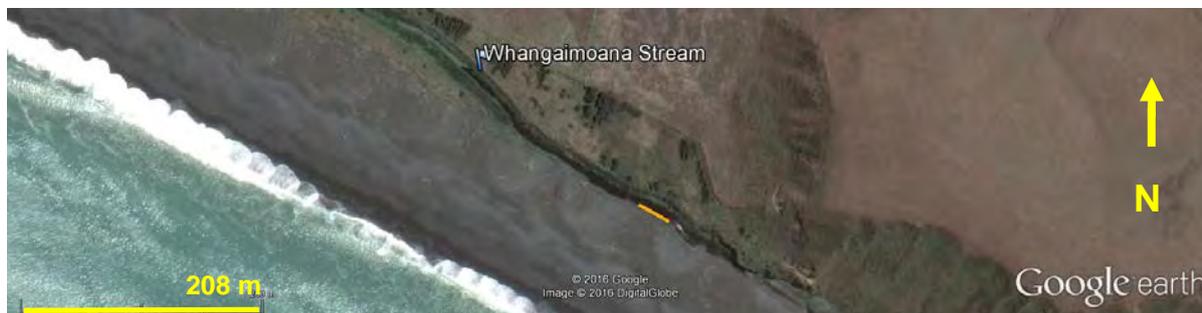
Figure 26a. Whangaimoana Stream, Whangaimoana. Orange line indicates the area that was unsuccessfully searched, but still considered suitable for inanga spawning.

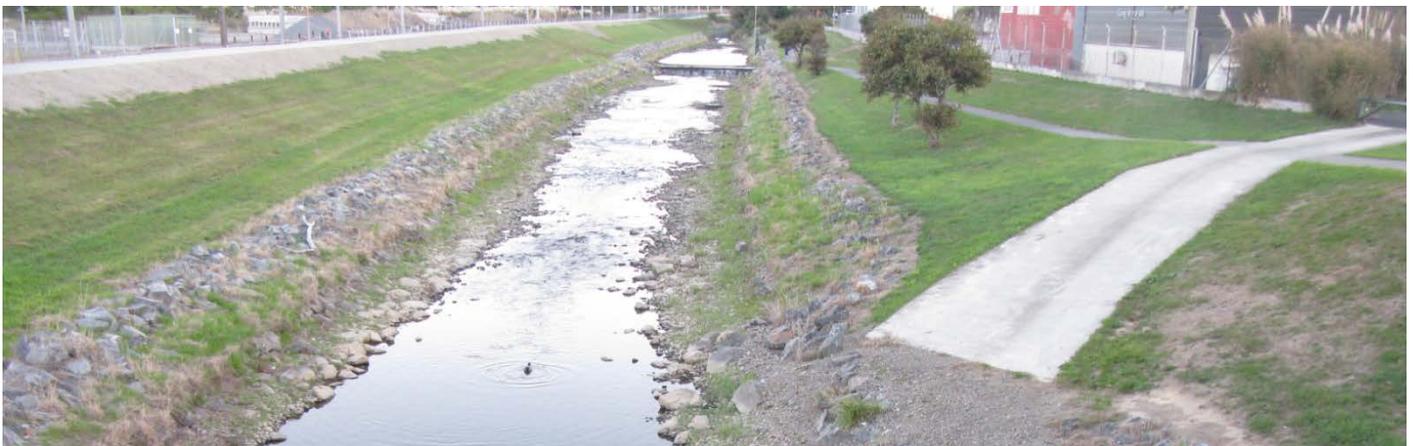
Figure 11. Looking upstream at the weir in Porirua Stream (Porirua), photo taken about one hour before high tide.

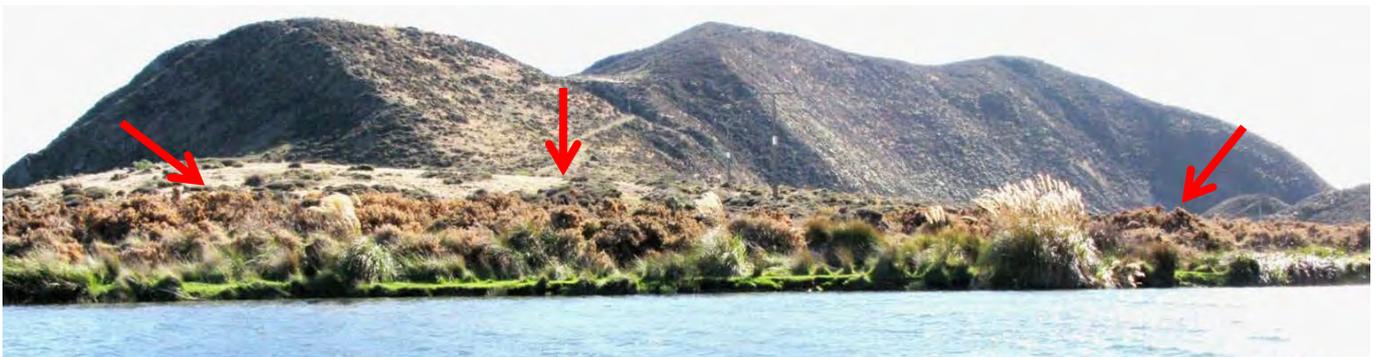
Figure 26. The grazed section in the middle of the spawning grounds on Wainuiomata River. Note the thicket of gorse behind it (arrowed).

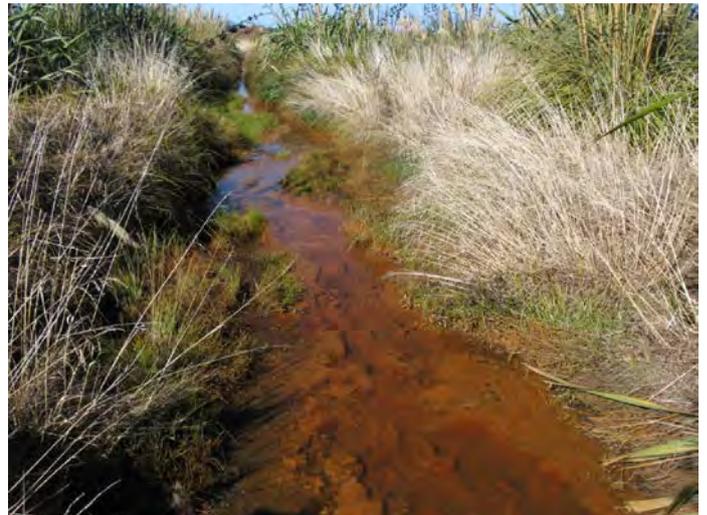
Figure 32. Looking upstream into Pounui Stream, about 130 m upstream of Pounui Lagoon. The orange substance is iron floc, considered to be an occasionally encountered natural phenomenon.

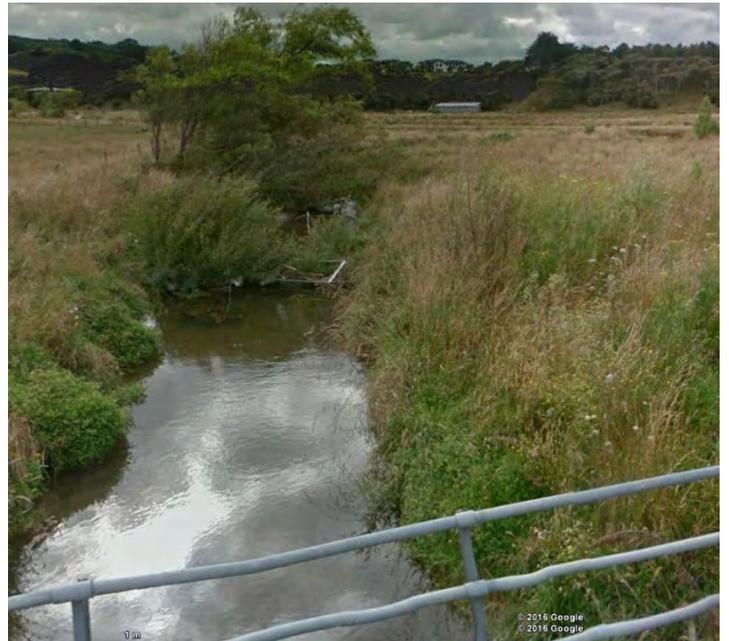
Figure 3b. The Horokiri River in January 2015 (Google™ Earth imagery). Largely fenced. However some collapsed bank obscured on the right bank suggests some stock access (see Fig. 4c).

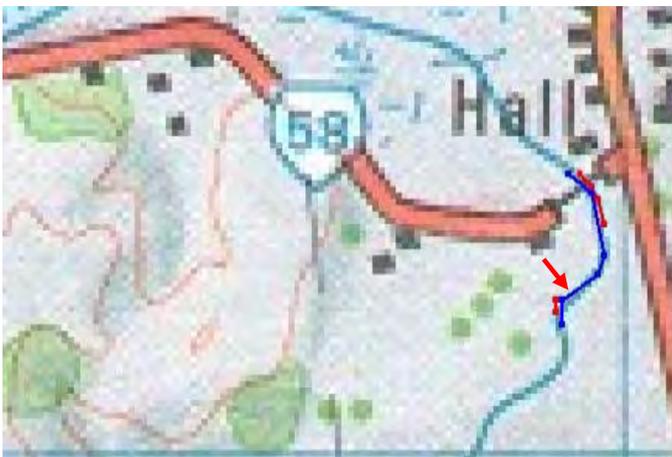
Figure 8a. Reaches on the Pauatahanui Stream deemed suitable in 2001 (map from Taylor & Kelly 2001). Red=suitable, but no eggs found. The location of the new bridge is arrowed

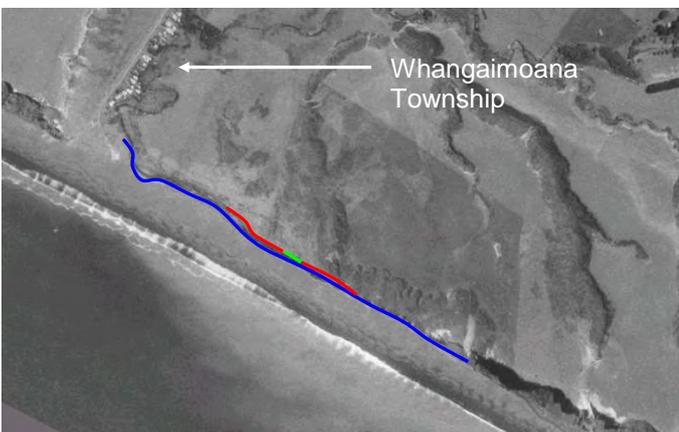
Figure 10a. The lower reaches of the Whangaimoana Stream, the blue line indicates the extent of the foot survey, the red section indicates area of suitable vegetation, and the green section an area where inanga eggs were found.

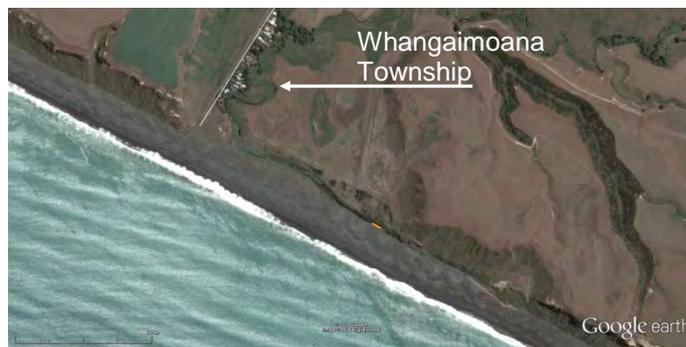
Figure 10b. The suitable vegetation search in 2016. There is marginally more vegetation on the bluffs and gullies, the latter appearing to be production forest (imagery 4/1/16).
