ENVIRONMENTAL MONITORING ANNUAL REPORT

PREPARED FOR T&T LANDFILL LTD.

July 2018

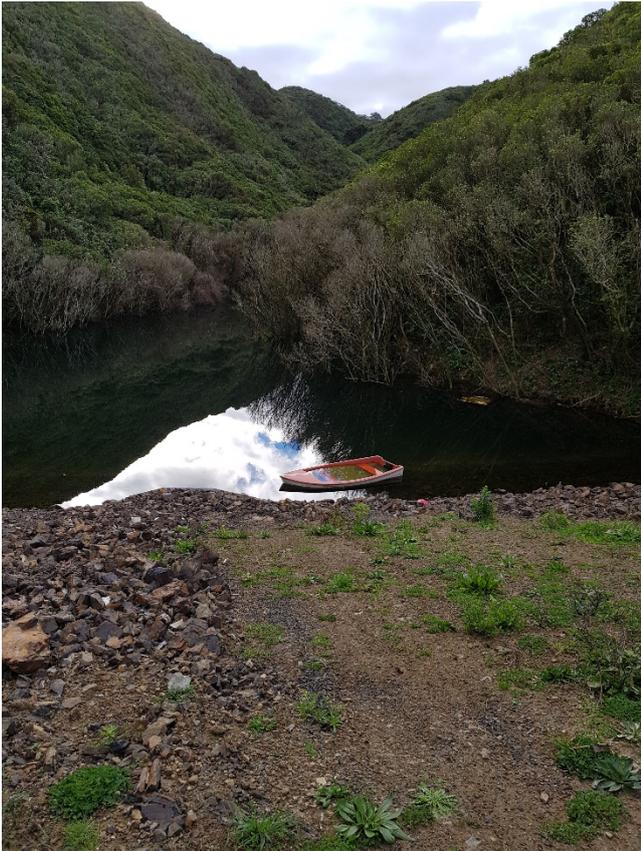
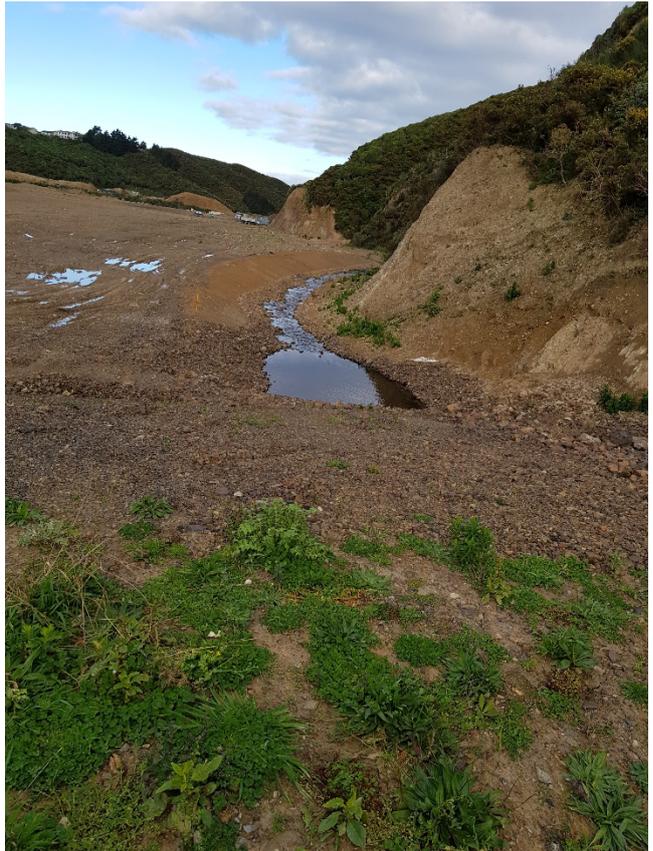
Figure 3-2: Western dam and diversion flow as of June 2018

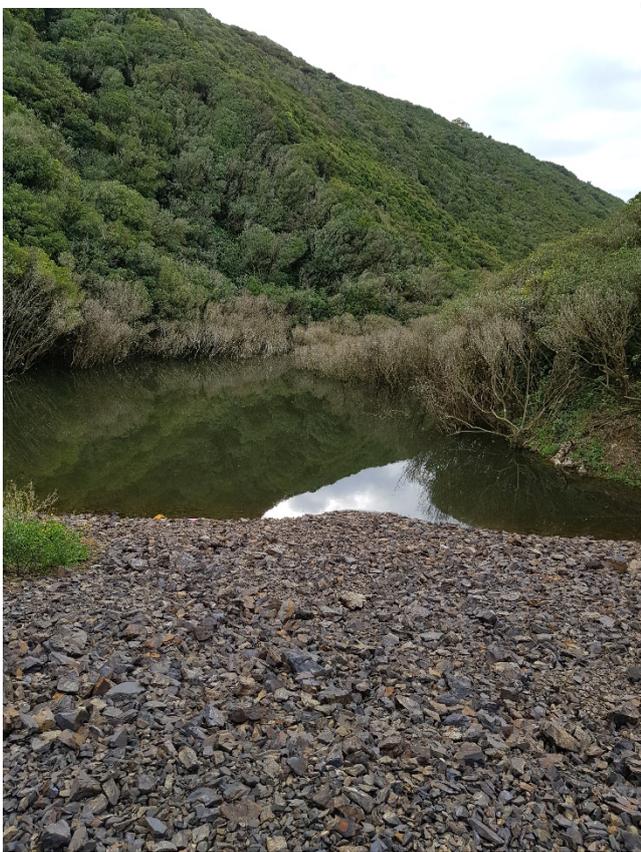
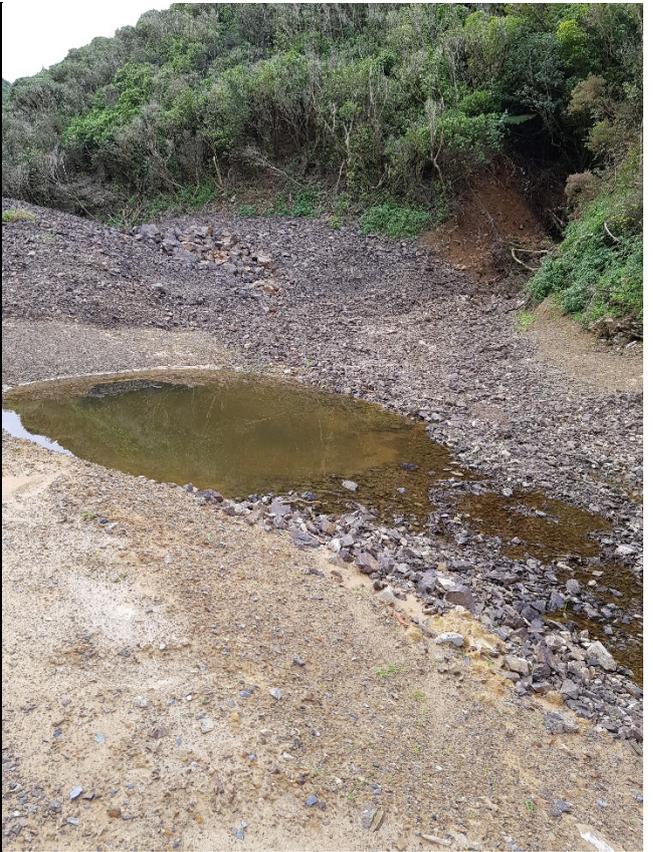
Figure 3-3: Eastern dam and diversion flow as of June 2018

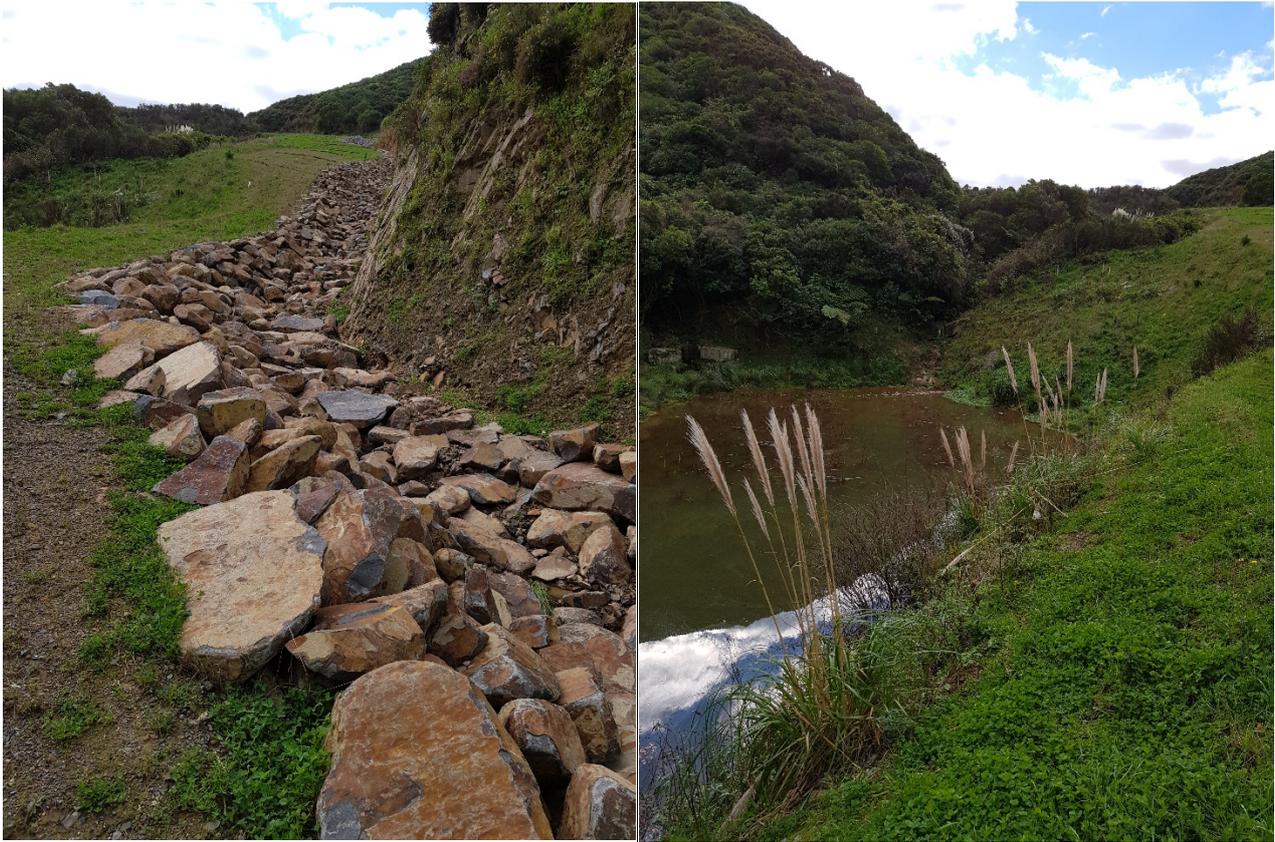
Figure 3-4: Diversion channel downstream (left) and wetland as of June 2018 (right)

By the end of June 2018 it was apparent that the diversion channels were effectively diverting wet weather stream flows around the landfill, however considerable quantities of water continued to seep through the base of both dams into the landfill, eventually exiting from the toe of the landfill into the wetland treatment system. It is our observation that in dry weather the entire base flow seeps under the landfill, with no surface flow in the diversion channels.

The diversion of stream water and local stormwater around the landfill has already reduced leachate volumes, but diversion of a greater proportion of the stream flow is needed. It is recommended that mitigation actions should include the following:

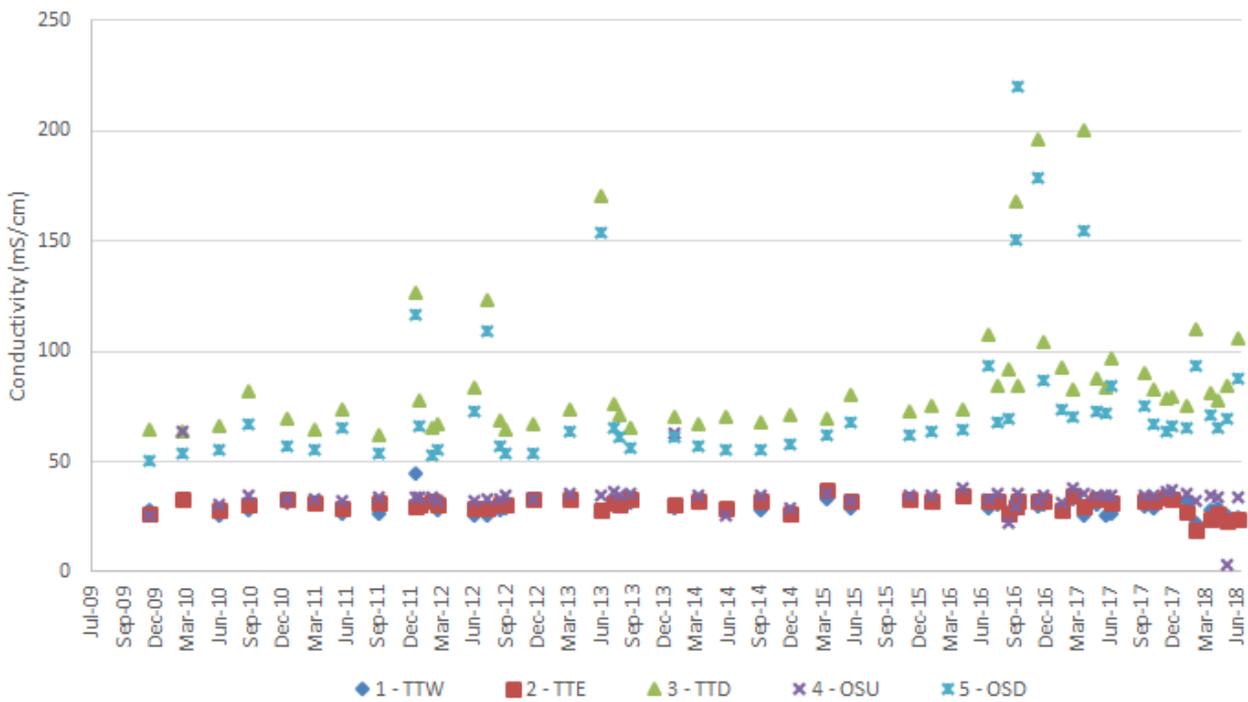
Figure D3: Conductivity for quarterly surface water quality monitoring sites.

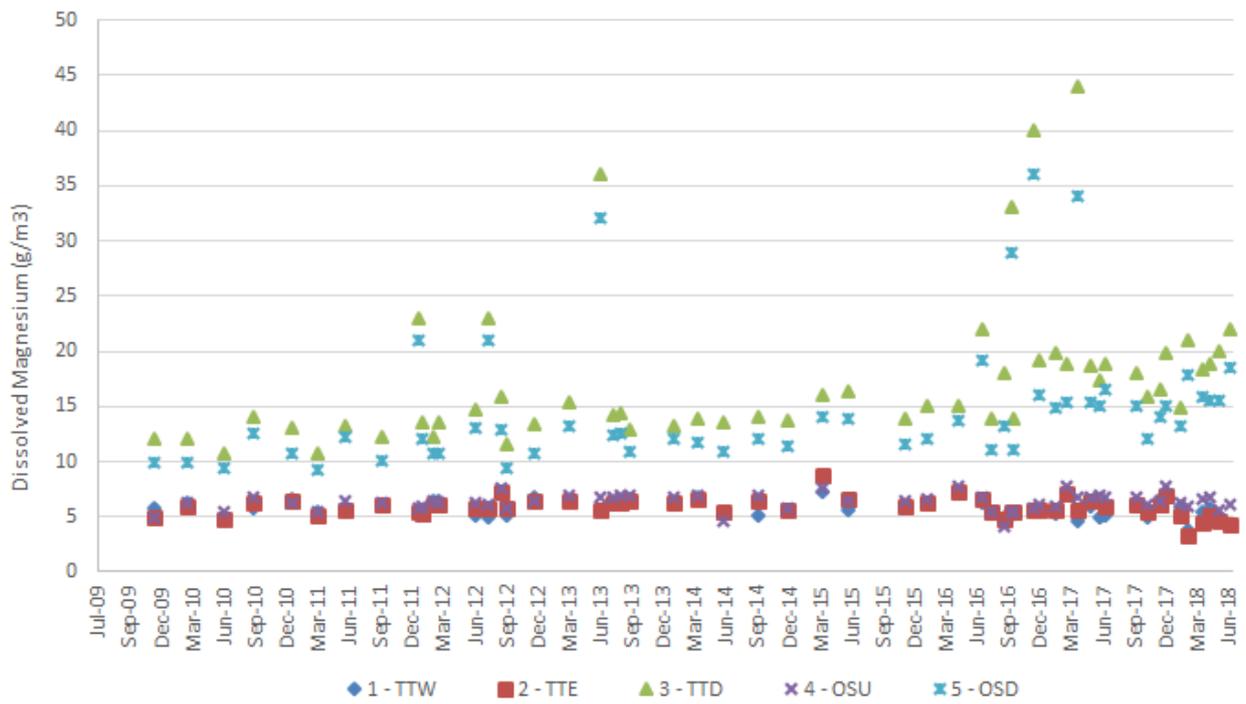
Figure D13: Dissolved Magnesium for quarterly surface water quality monitoring sites.

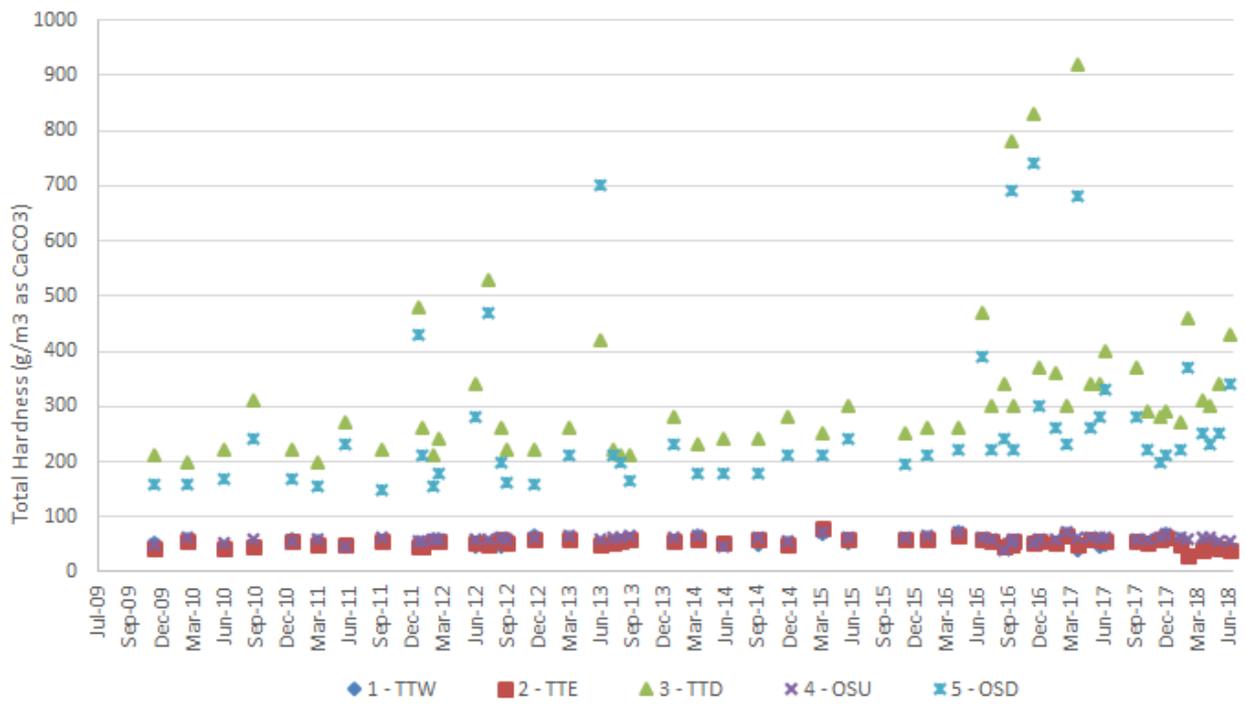
Figure D15: Total hardness for quarterly surface water quality monitoring sites.
