ENVIRONMENTAL MONITORING ANNUAL REPORT

PREPARED FOR T&T LANDFILL LTD

July 2019

Environmental Monitoring Annual Report

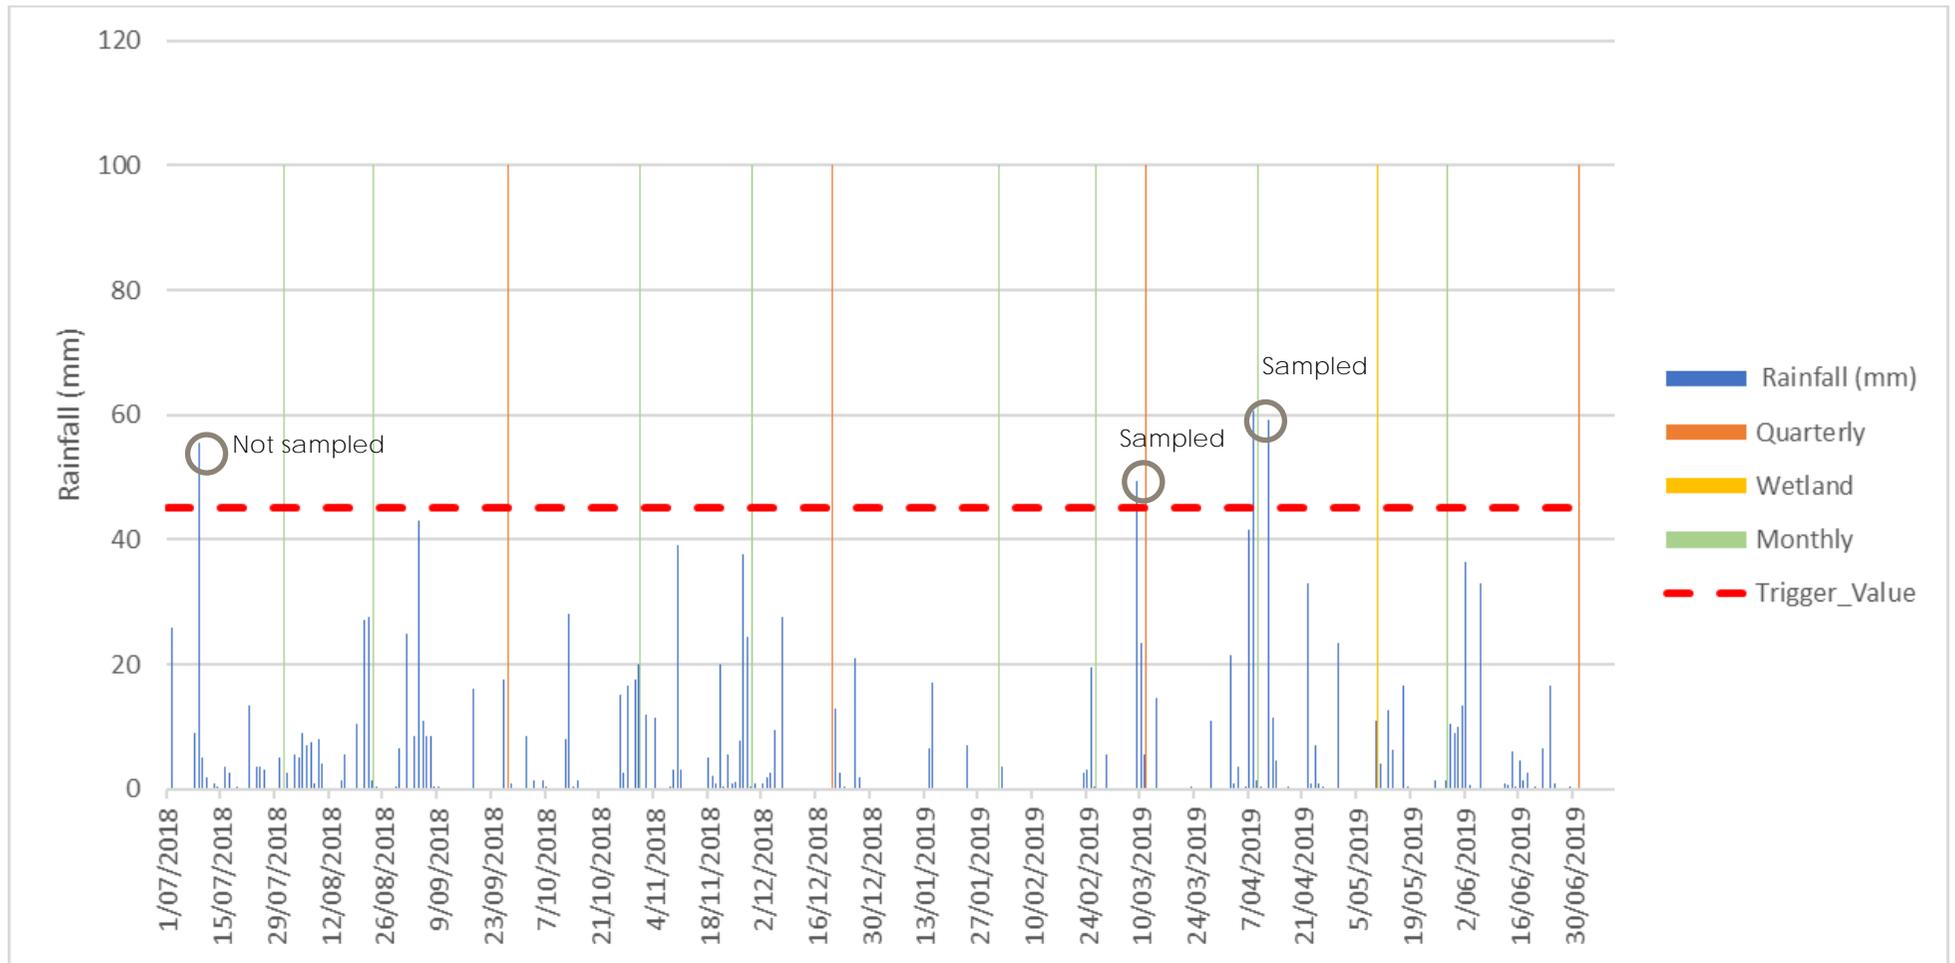
Figure 3-1 shows when monitoring samples were taken along with the daily rainfall at Karori Reservoir. Most sampling was carried out during dry weather as the rainfall trigger was not reached. The first rainfall trigger was activated in July 2018, however, due to a complication in the alerting system, sampling was not carried out within the 7-day period following rainfall. The next rainfall triggers were reached in March 2019 and April 2019, with successful sampling within the timeframe. A fourth rainfall trigger was reached a few days after sampling in April 2019 however, this was considered to be part of the same weather event as the April event already sampled.

Figure 3-1: Daily rainfall at Karori Reservoir and the types of monitoring from July 2018 to July 2019. Vertical bars indicated quarterly and monthly sampling events, as well as wetland sampling events. The grey circles represent rainfall triggered sampling.

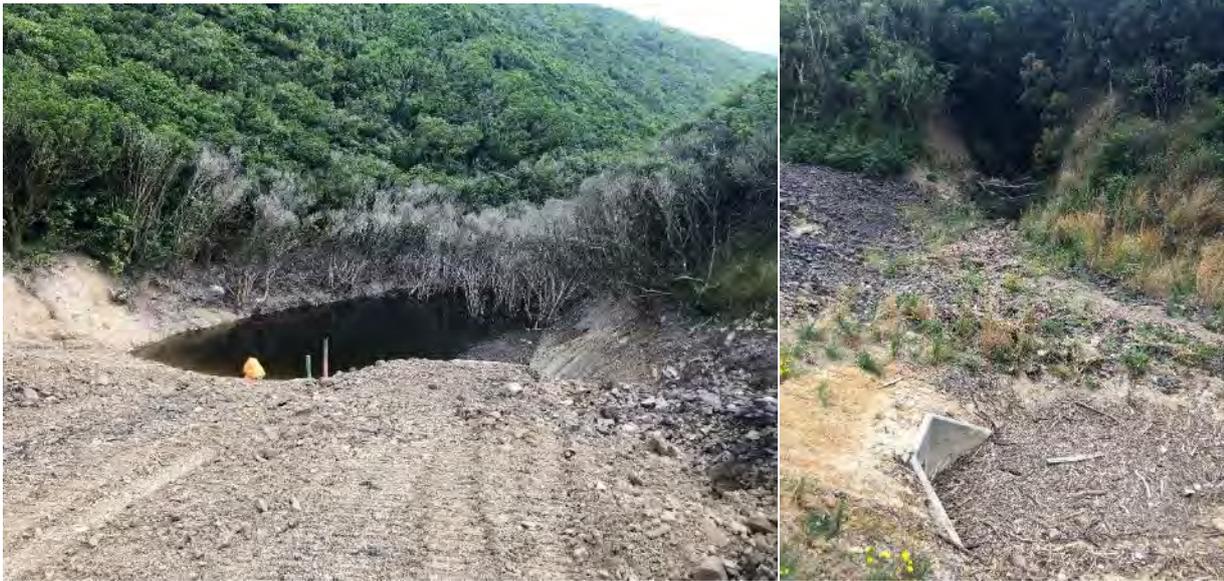
Figure 3-2: TTE dam (left) and outlet culvert (right) as of January 2019

By the end of June 2019, the diversion channels were effectively diverting wet weather stream flows around the landfill, however considerable quantities of water continued to seep through the base of both dams into the landfill, eventually exiting from the toe of the landfill into the wetland treatment system. As of January 2019, our observation was that in dry weather the entire base flow seeps under the landfill, with no surface flow in the diversion channels reaching the landfill stream.

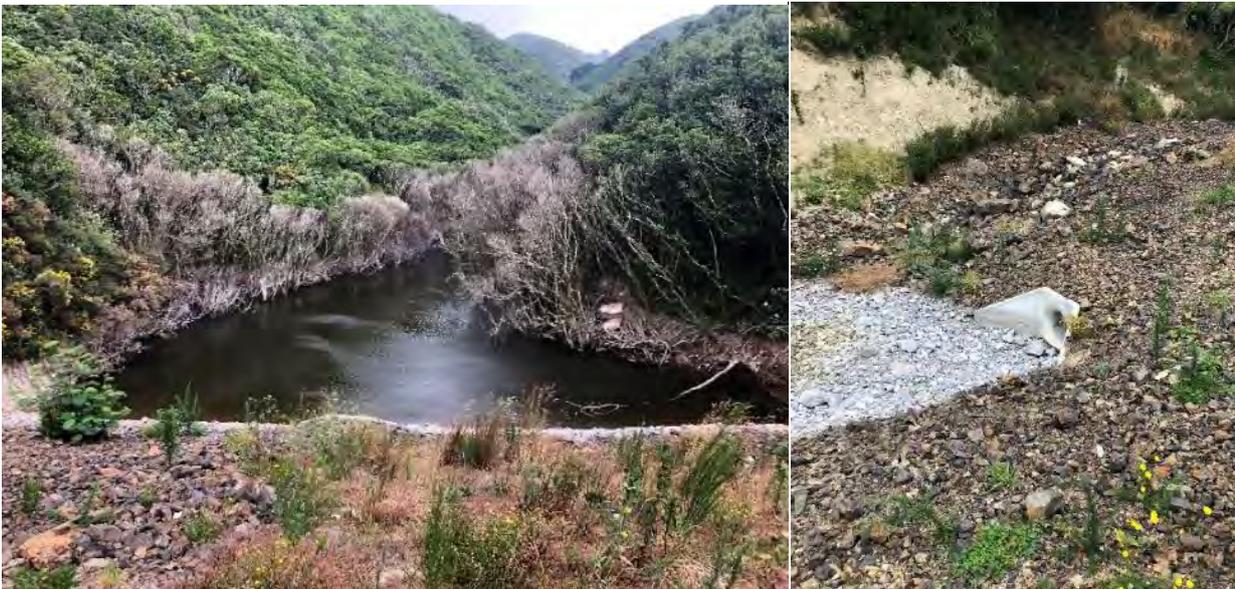
Figure 3-3: TTW Dam (left) and the outlet culvert (left) as of January 2019

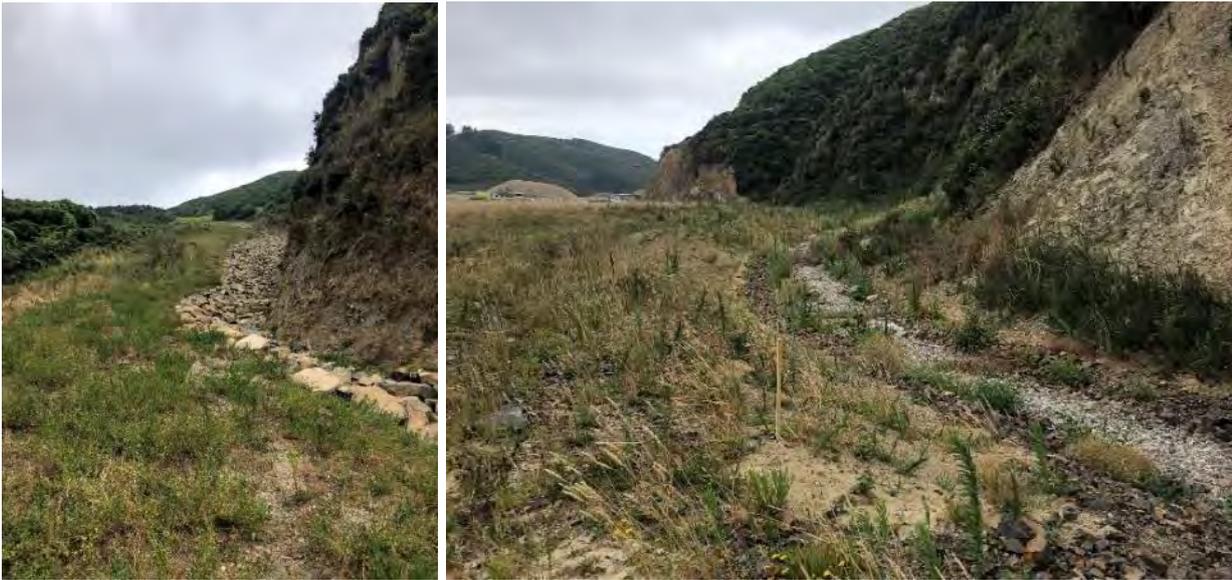
Figure 3-4: Diversion flow near wetland (left) and near TTW (Right) as of January 2019

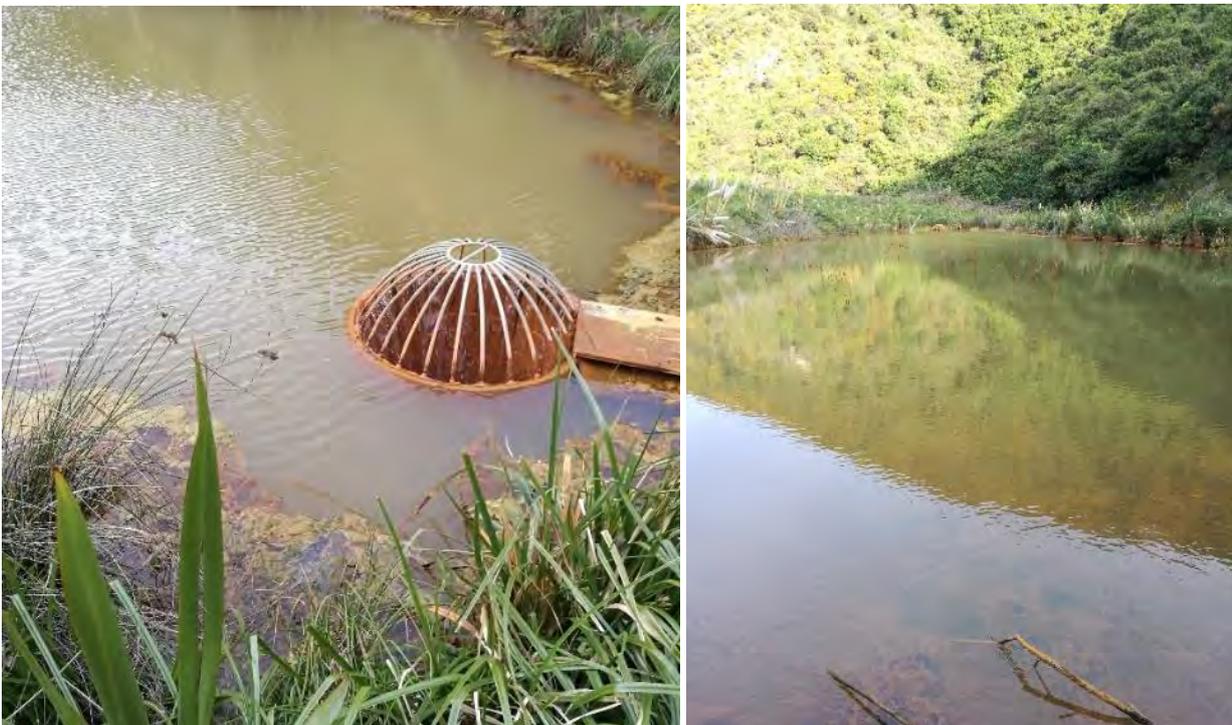
Figure 3-5: Wetland outflow (left) and wetland (right) as of June 2019

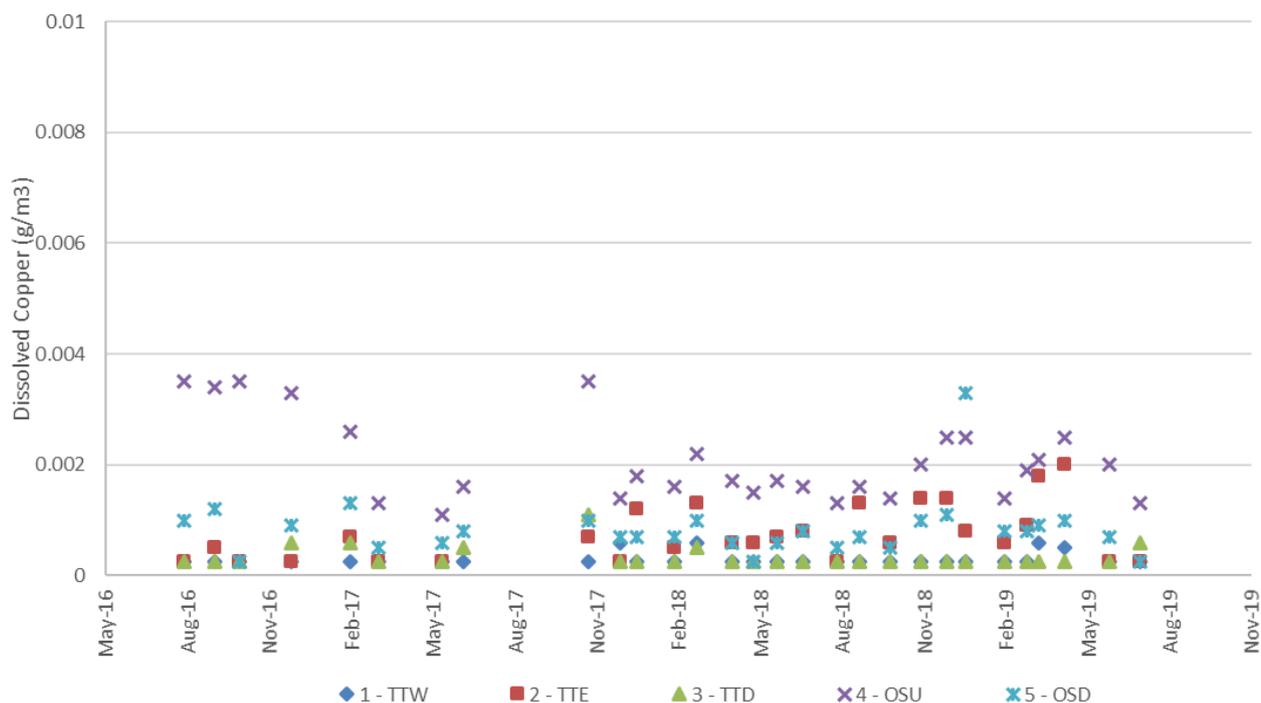
Total and dissolved copper, and dissolved lead and zinc concentrations were all highest in Owhiro Stream upstream of the landfill tributary, at site OSU (Figure 3-6). The likely source of these contaminants is stormwater runoff from road and roofs from the urban area of Brooklyn. Concentration of these contaminants in the landfill tributary at site TTD are consistently lower than in Owhiro Stream. Over the last two years no clear trend can be discerned for these constituents at any of the monitoring sites.

Figure 3-6: Dissolved copper from July 2016 through to June 2019.

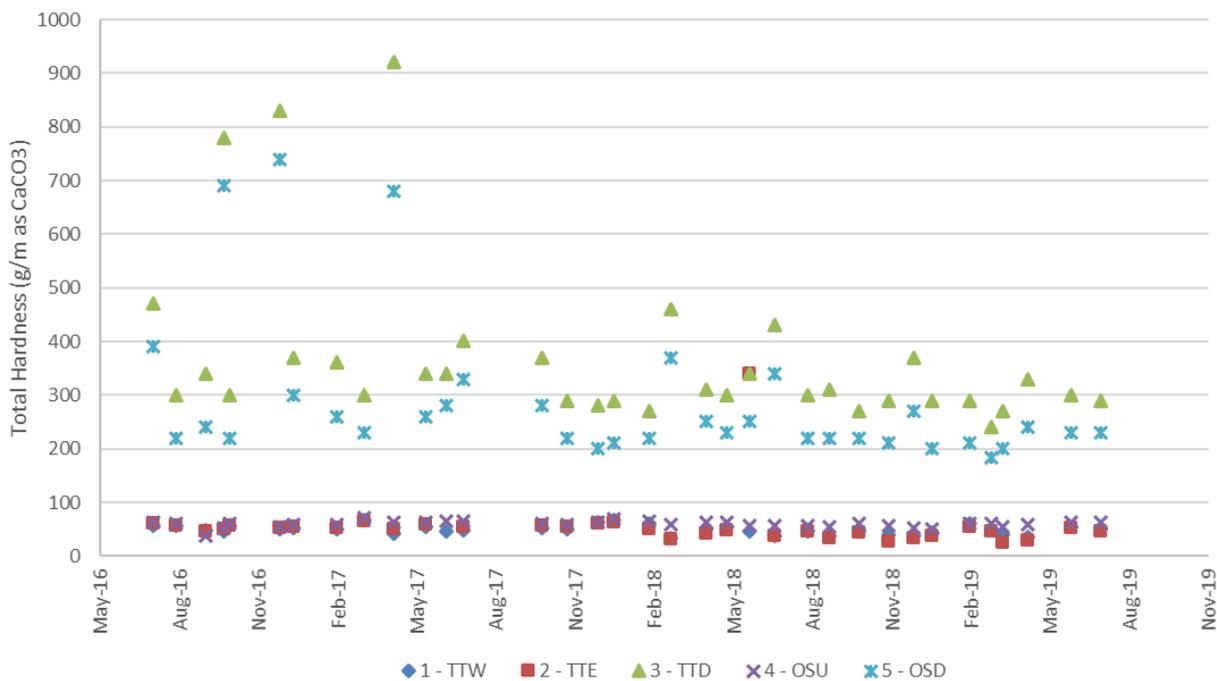
Water hardness at TDD appears to be stable from August 2017 through to July 2019 (Figure 3-7). There is some fluctuation though this is small. Between July 2016 and August 2017, the concentrations observed, fluctuated more with a couple of spikes throughout this time. This is attributed to the channel diversion and wetland construction works. It is expected that completion of these works will divert a greater proportion of the stream flow around the landfill and further reduce leachate quantities and consequent impacts on downstream habitats.

Figure 3-7: Total hardness July 2009 through to June 2019.

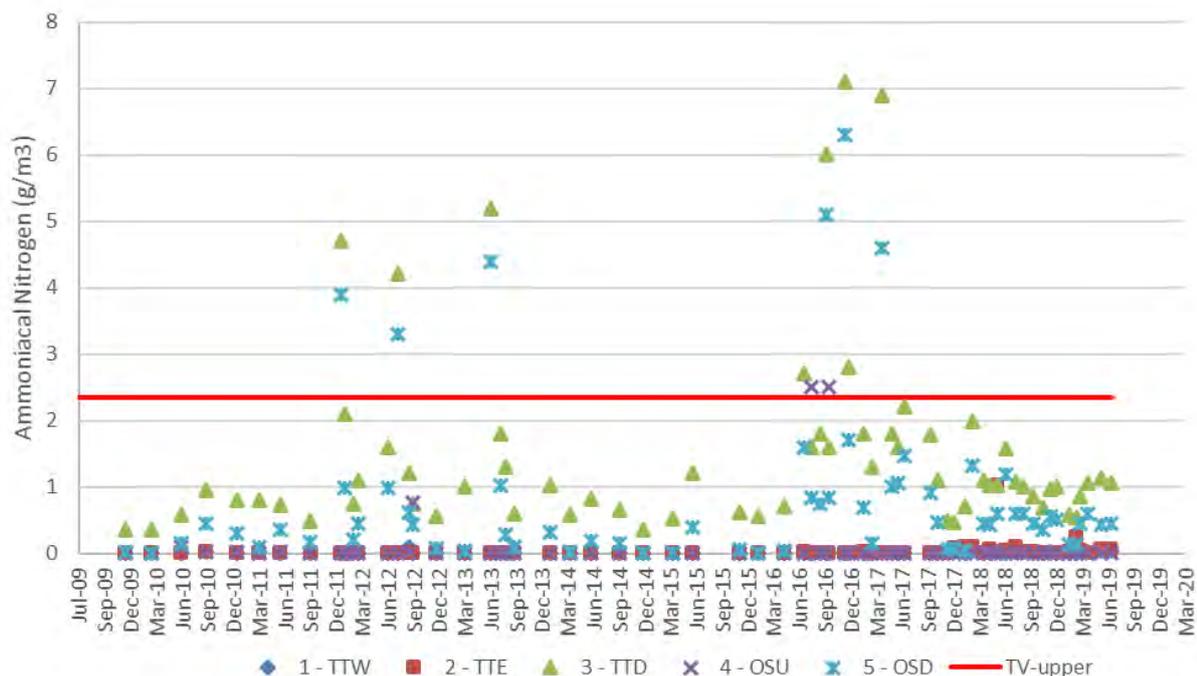
During 2016 total ammoniacal nitrogen concentrations increased sharply after a heavy rainfall event and then remained high until a decline in the first quarter 2017. Throughout 2017, 2018, and 2019 total ammoniacal nitrogen concentrations remained below the site specific ANZECC (2000) 90% trigger level despite significant rainfall events in that period (Figure 3-9).

Figure 3-8: Historical total ammoniacal nitrogen from Dec 2010 through to June 2019.

It is likely that the diversion works, and constructed wetland have contributed to lower total ammoniacal nitrogen concentrations, and that there is scope for achieving further reductions by diverting a higher proportion of stream flow around the landfill.

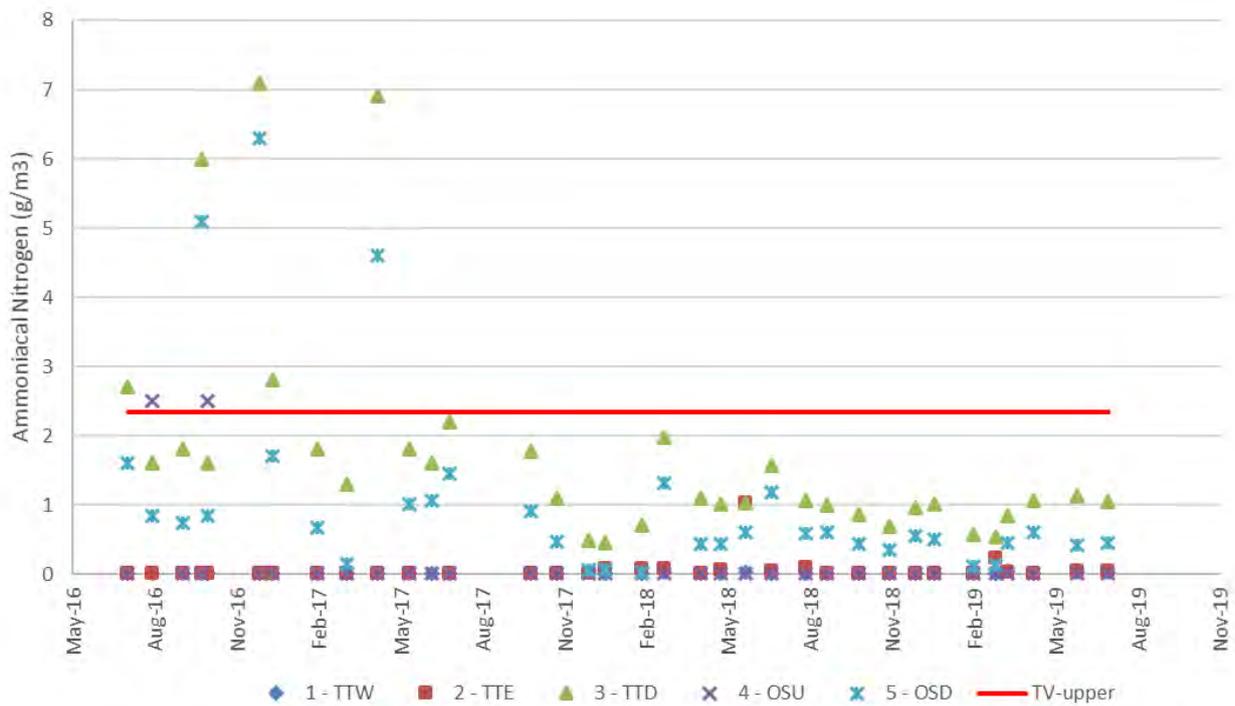
Figure 3-9: Total ammoniacal nitrogen over last two reporting periods (July 2016 – June 2019)

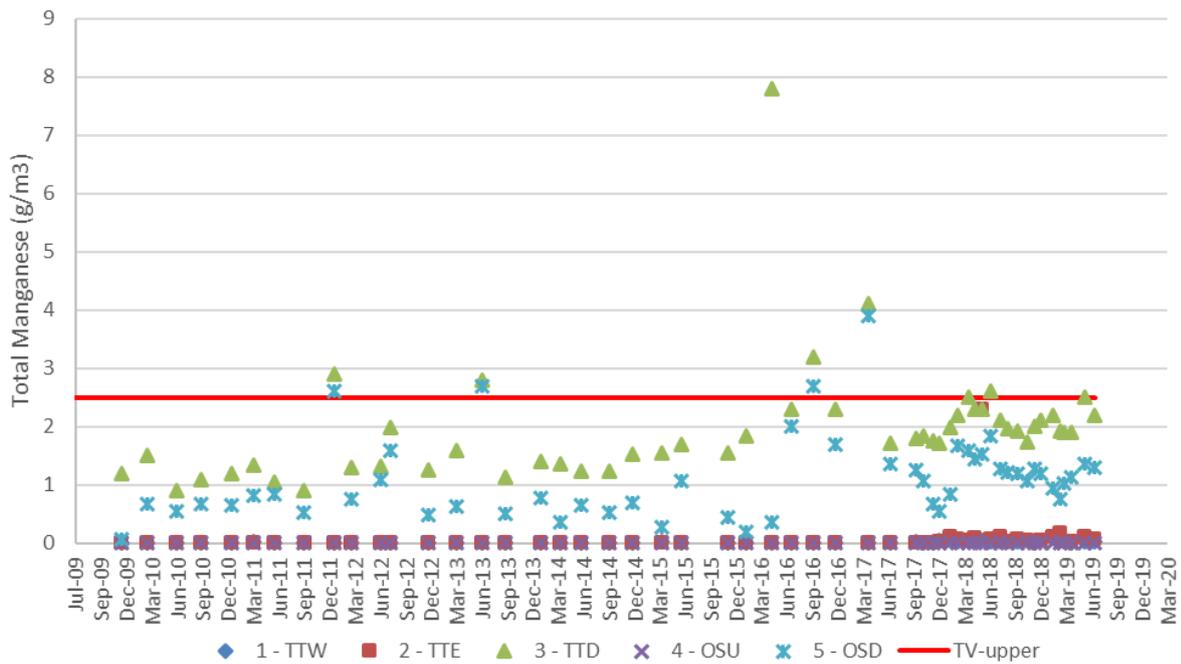
During the current reporting period the sum of dissolved iron and dissolved manganese exceeded the trigger limit of 1.0 g/m³ in all 12 samples collected at TTD.

Figure 3-10: Total Manganese from Dec 2010 through to June 2019

There is no clear evidence from monitoring results to date that the diversion channels and constructed wetland have reduced stream concentrations of manganese. Nevertheless, it is expected that some reduction can be achieved by diverting a greater proportion of the stream flow around the landfill and reducing seepage through the landfill.

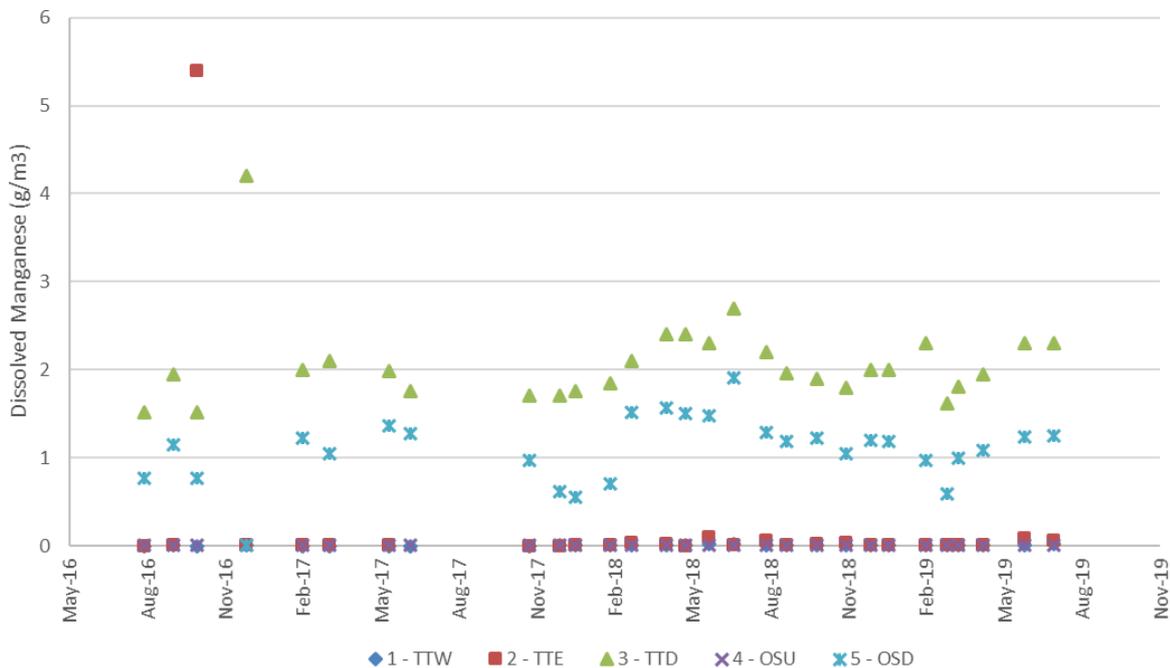
Figure 3-11: Dissolved Manganese over last two reporting periods (July 2016 – June 2019)

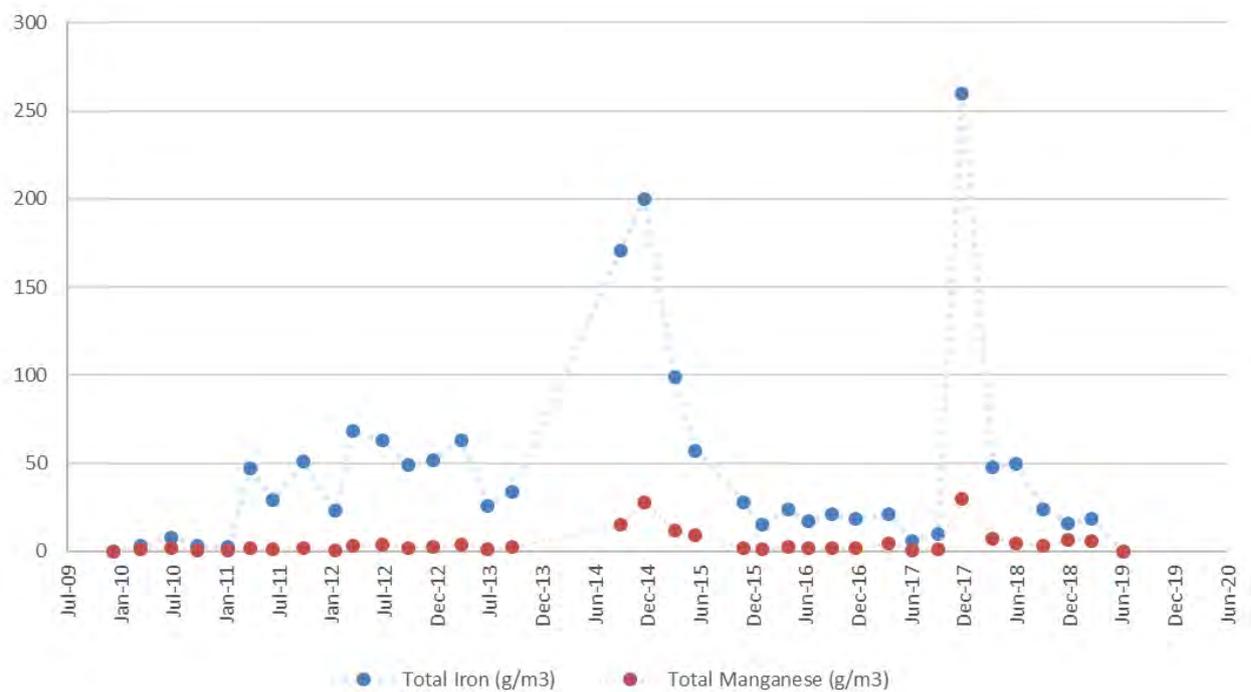
Figure 3-12: Total Iron and Total manganese concentrations in groundwater samples collected downstream of the landfill at site TTG

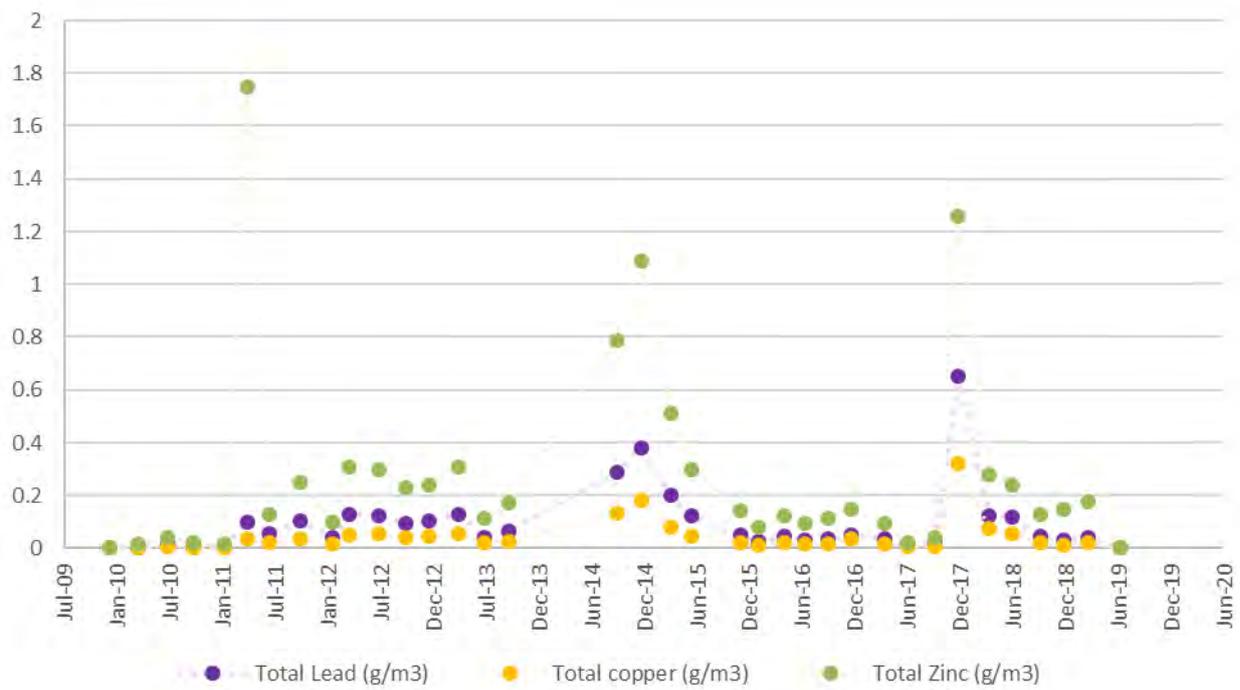
Figure 3-13: Total lead, total copper and total zinc concentrations in groundwater samples collected downstream of the landfill at site TTG

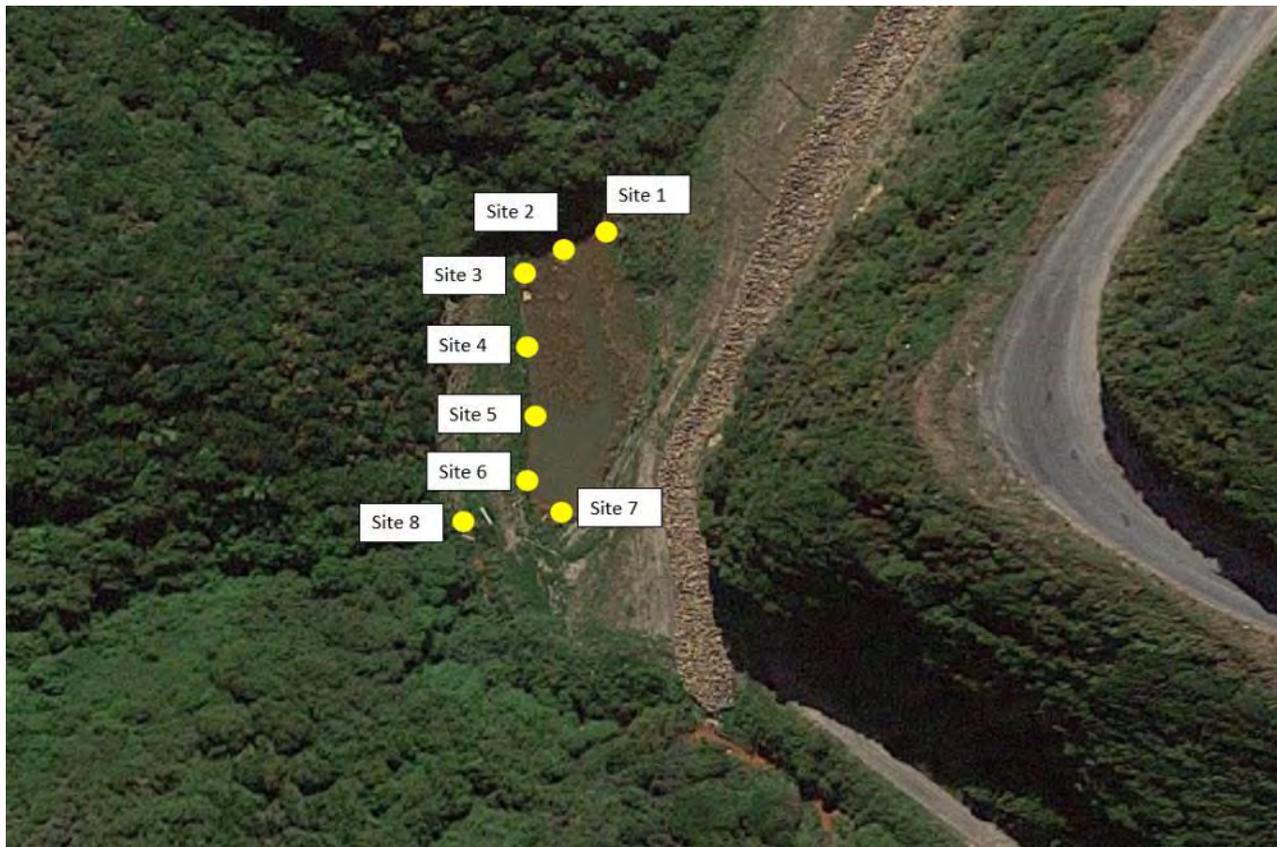
On Thursday 1 August 2019, Stantec undertook in-situ water quality measurements including dissolved oxygen (DO), temperature, pH and conductivity at eight locations around the wetland (Figure 4-1).

Water quality grab samples were taken at the wetland inlet (Site 1) and wetland outlet (Site 8) on 10 May 2019 with a second round of sampling on 1 July 2019 which included a sample at Site 7 immediately prior to water flowing down culvert outlet.

Figure 4-1: Wetland water quality sampling locations

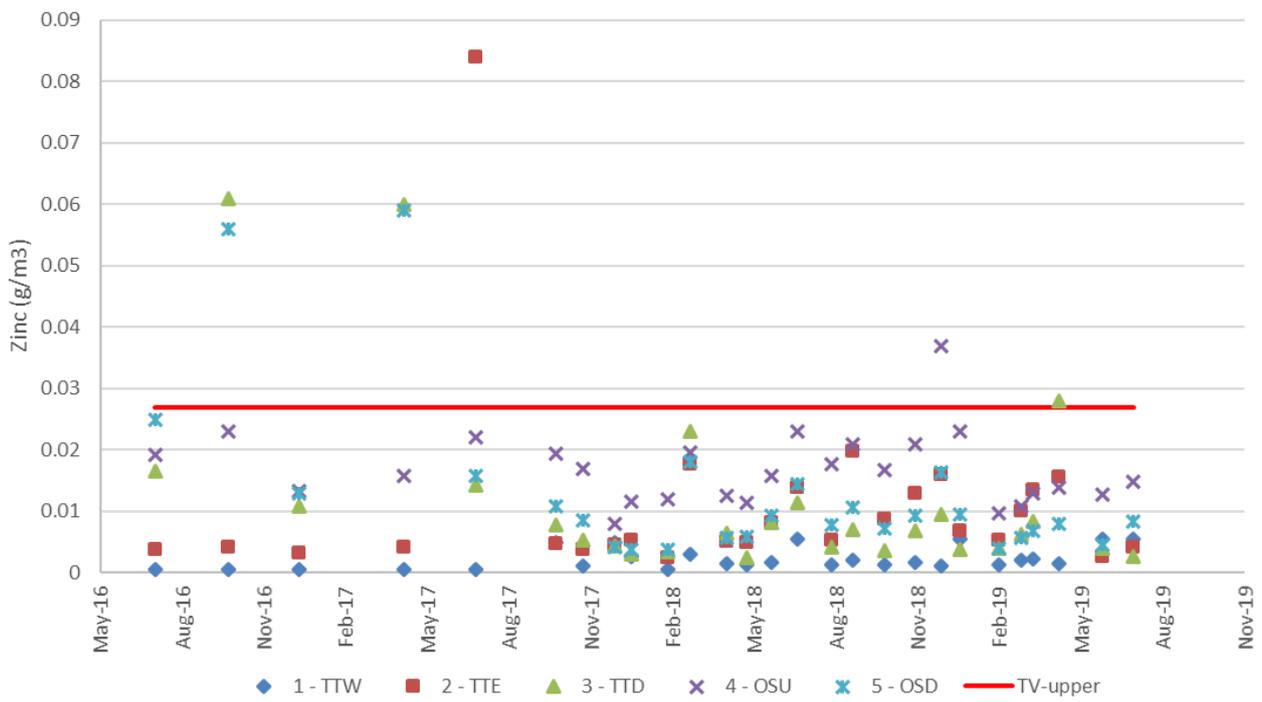
- Concentrations of most contaminants at site TTD including electrical conductivity, alkalinity, total hardness, TSS, total ammonia nitrogen, COD, copper, zinc and lead, have decreased since 2016. For several contaminants including dissolved arsenic, dissolved copper, dissolved chromium, total chromium and dissolved lead there was no measurable change during passage under or around the landfill.
- The contaminants of most concern at TTD are iron and manganese. High levels of dissolved iron and manganese have, in combination with elevated levels of dissolved organic matter (DOM), resulted in ferric iron precipitation covering streambed substrates in the reach below the landfill, extending downstream beyond site OSD. The extent of streambed affected by iron bacteria appears to have stabilised since 2016 but continues to have the potential to smother benthic habits in this reach.

Figure 5-1 Total Zinc concentrations from July 2016 through to June 2019

A benthic ecology survey is required once the stream diversion works and wetland construction is completed, presumably early in 2020.

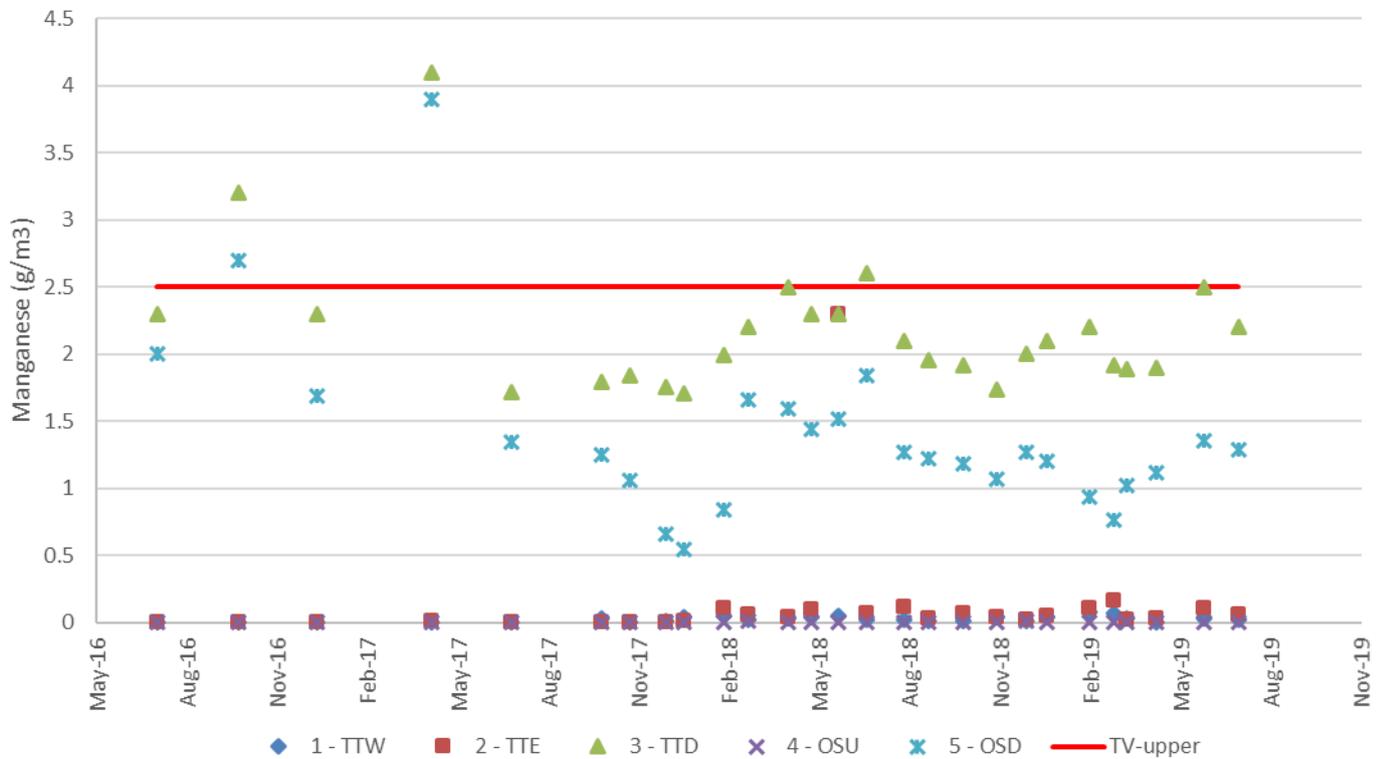
Figure 5-2 Total Manganese from July 2016 through to June 2019

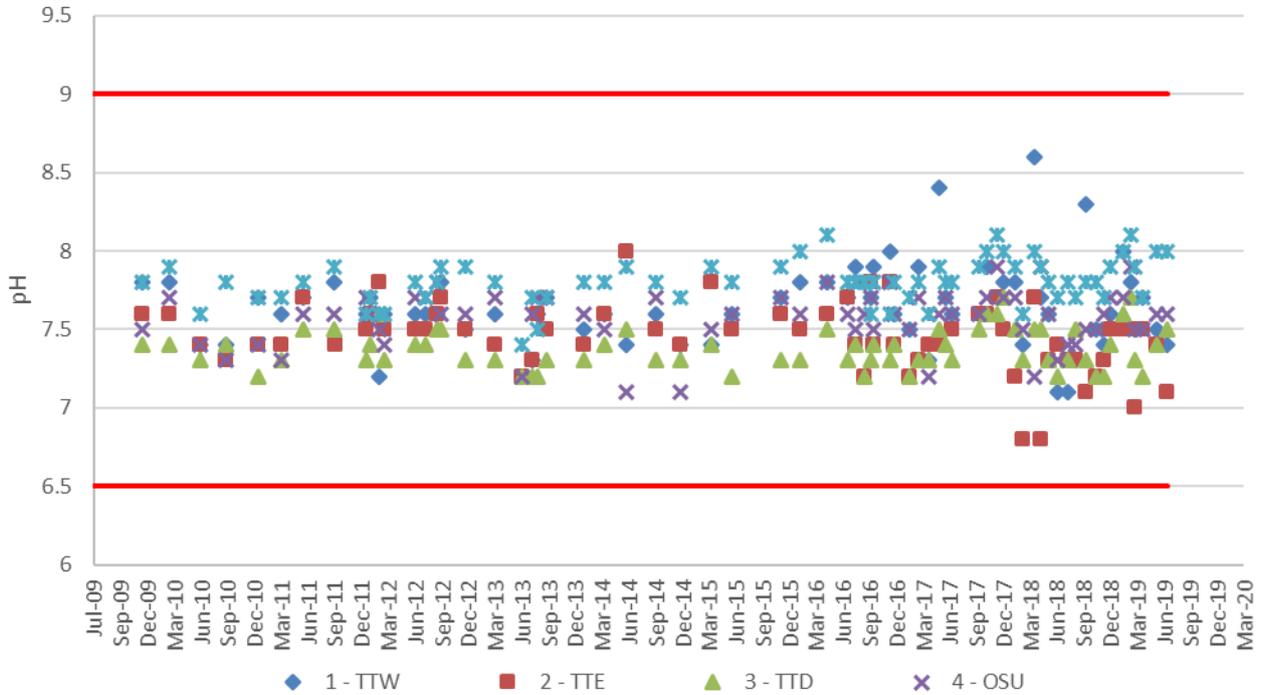
Figure D1: pH for monthly surface water quality monitoring sites. The red lines indicate GWRC recommended guideline levels (Perrie et al, 2012).

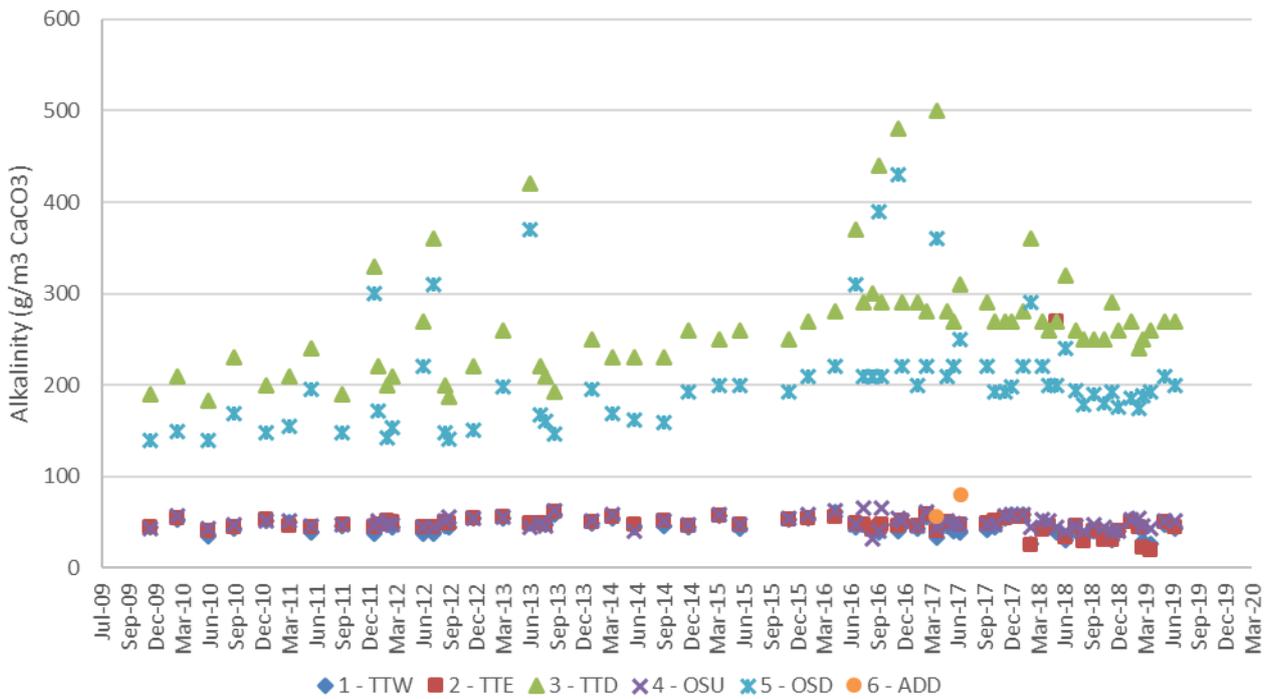
Figure D2: Alkalinity for monthly surface water quality monitoring sites.

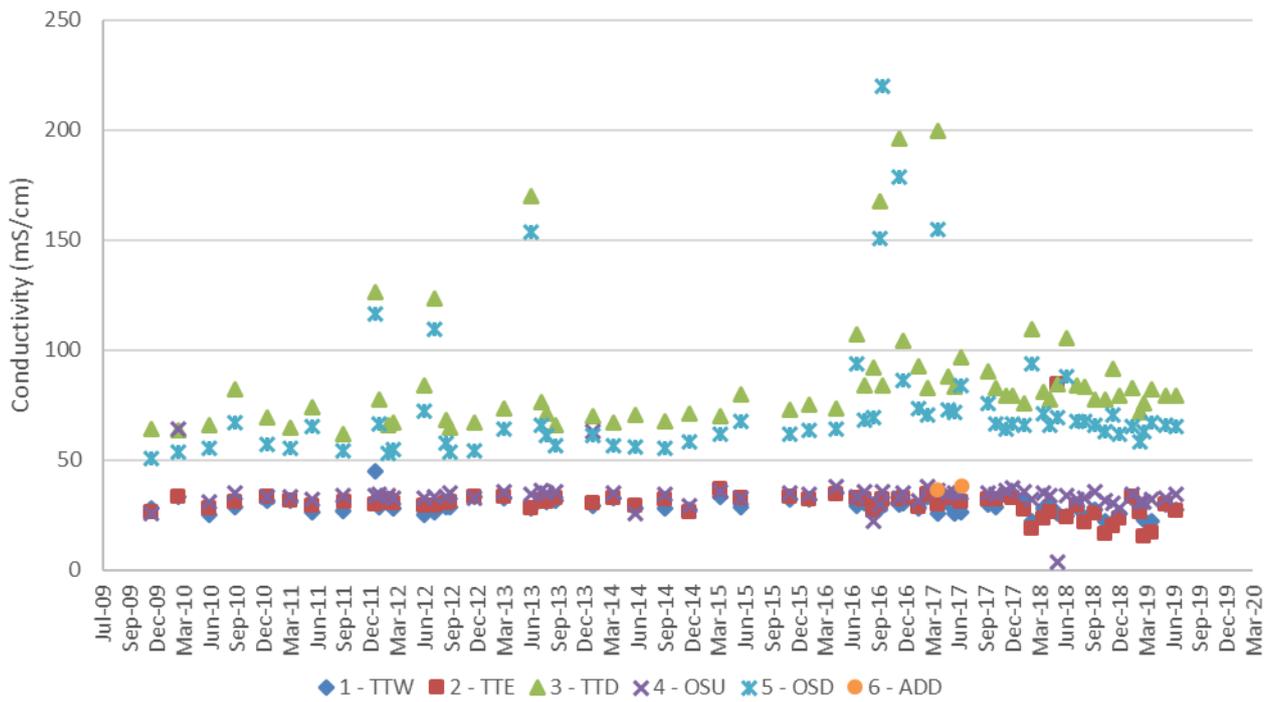
Figure D3: Conductivity for monthly surface water quality monitoring sites.

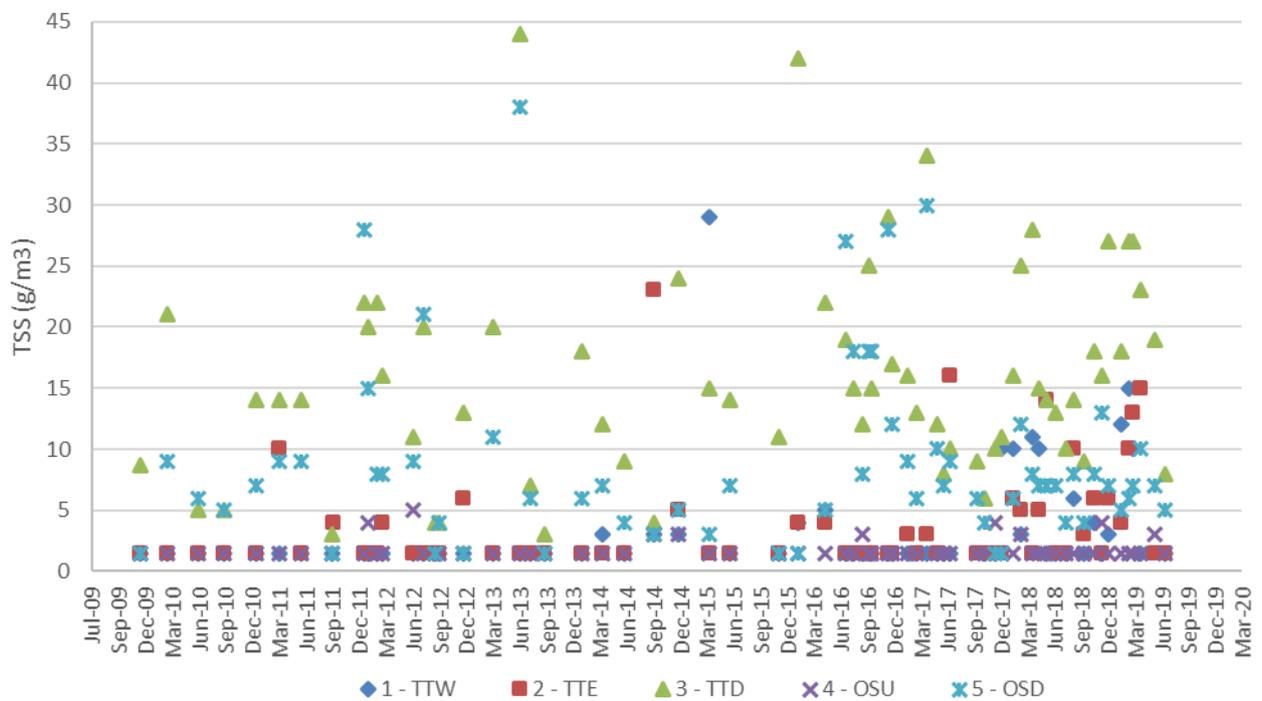
Figure D4: Total Suspended Solids for monthly surface water quality monitoring sites.

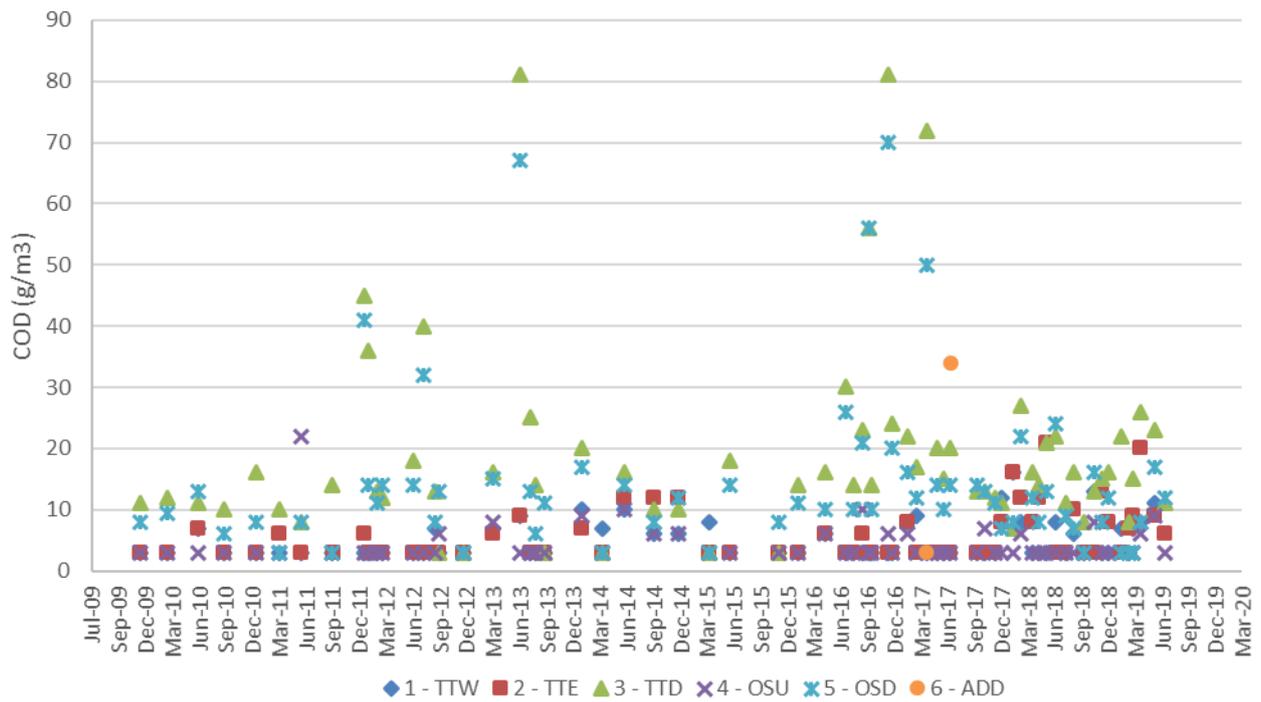
Figure D5: COD for monthly surface water quality monitoring sites.

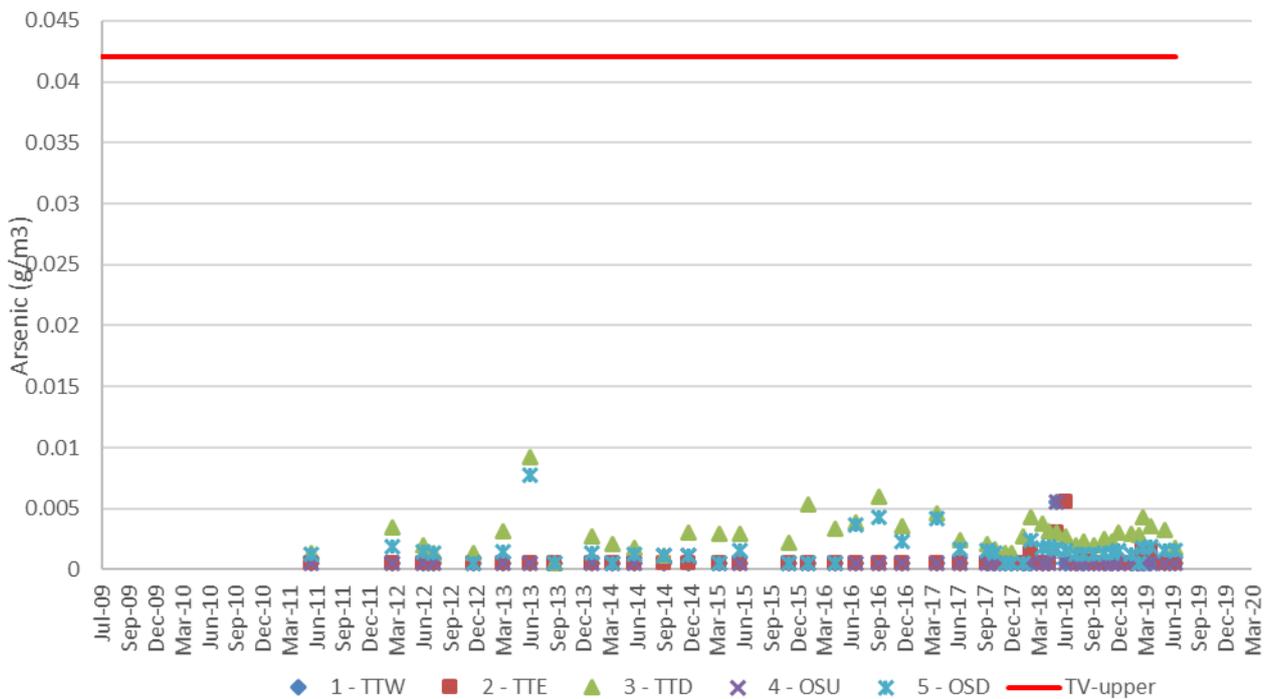
Figure D6: Total arsenic for monthly surface water quality monitoring sites. The red line indicates the ANZECC 90% protection TV as dissolved arsenic V.

Note: Results are shown for total arsenic, while TV is based on dissolved arsenic V.

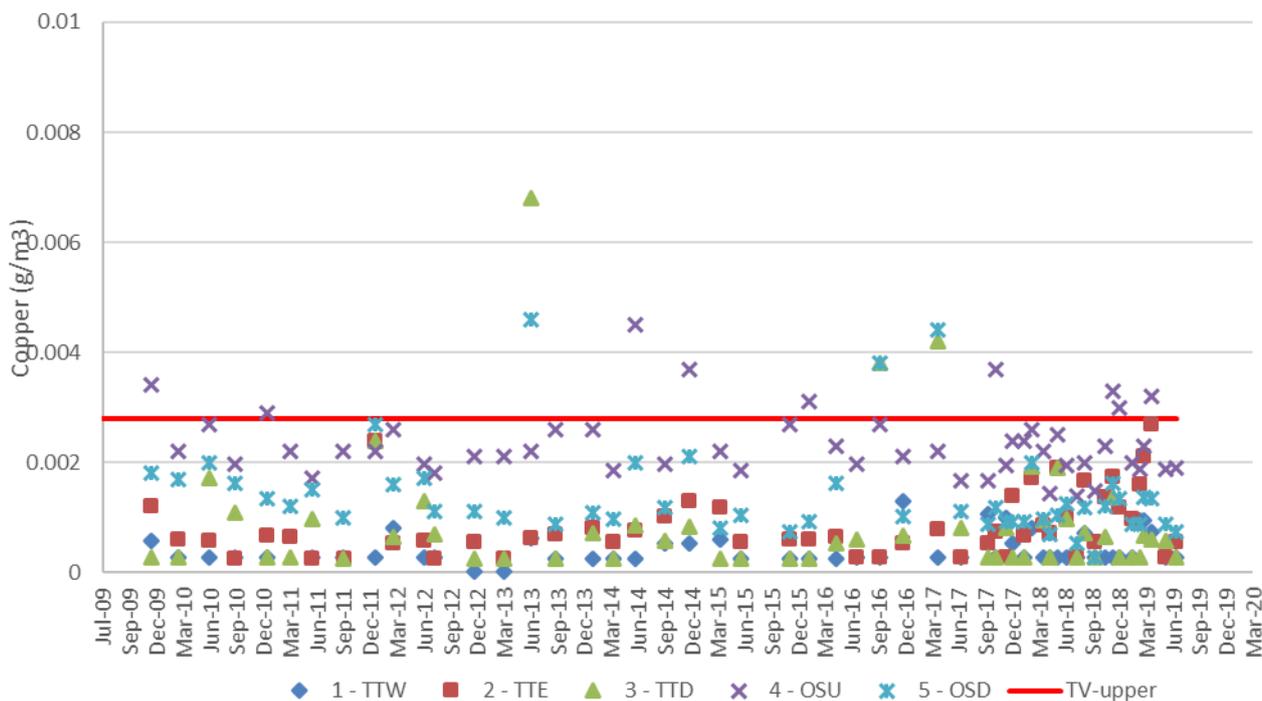
Figure D7: Total copper for monthly surface water quality monitoring sites. The red line indicates site specific TV.

Note: Results are shown for total copper, while TV is based on site specific dissolved copper. One outlier removed in 2011.
