ENVIRONMENTAL MONITORING ANNUAL REPORT

PREPARED FOR T&T LANDFILL LTD

July 2019

Environmental Monitoring Annual Report

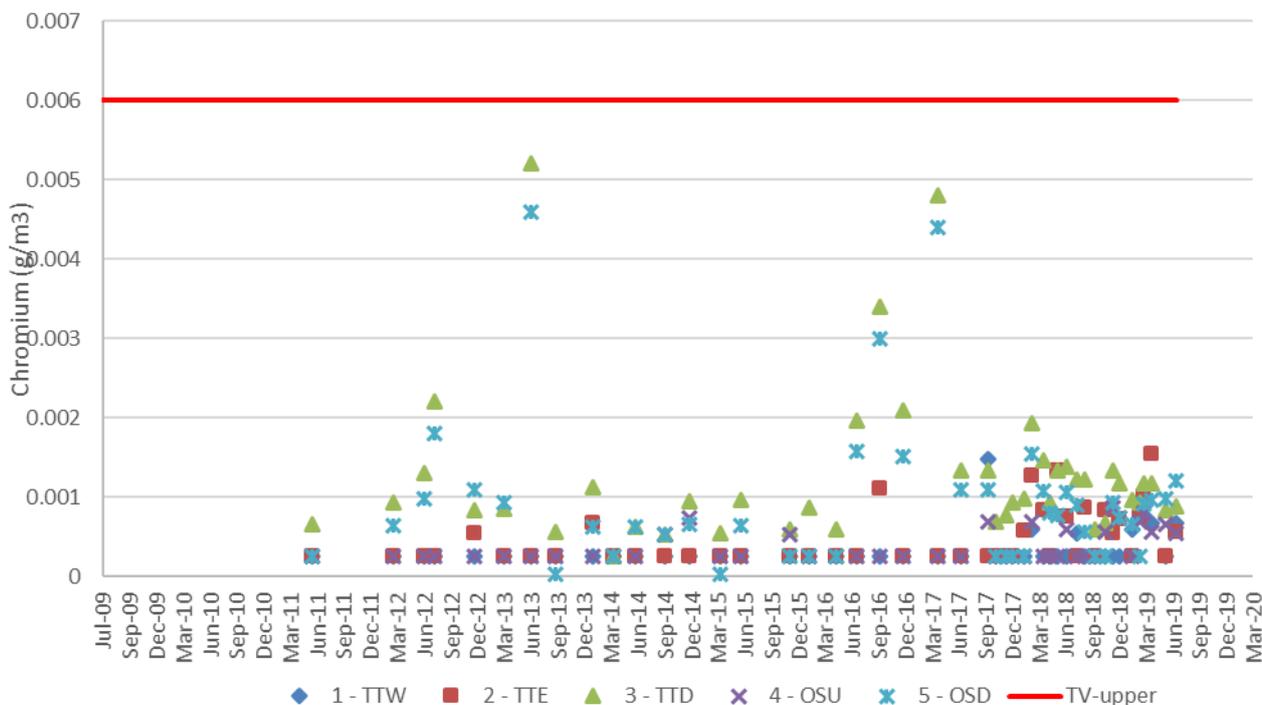
Figure D8: Total chromium for monthly surface water quality monitoring sites. The red line indicates ANZECC 90% protection TVs.

Note: Results are shown for total chromium while TV is based on dissolved chromium.

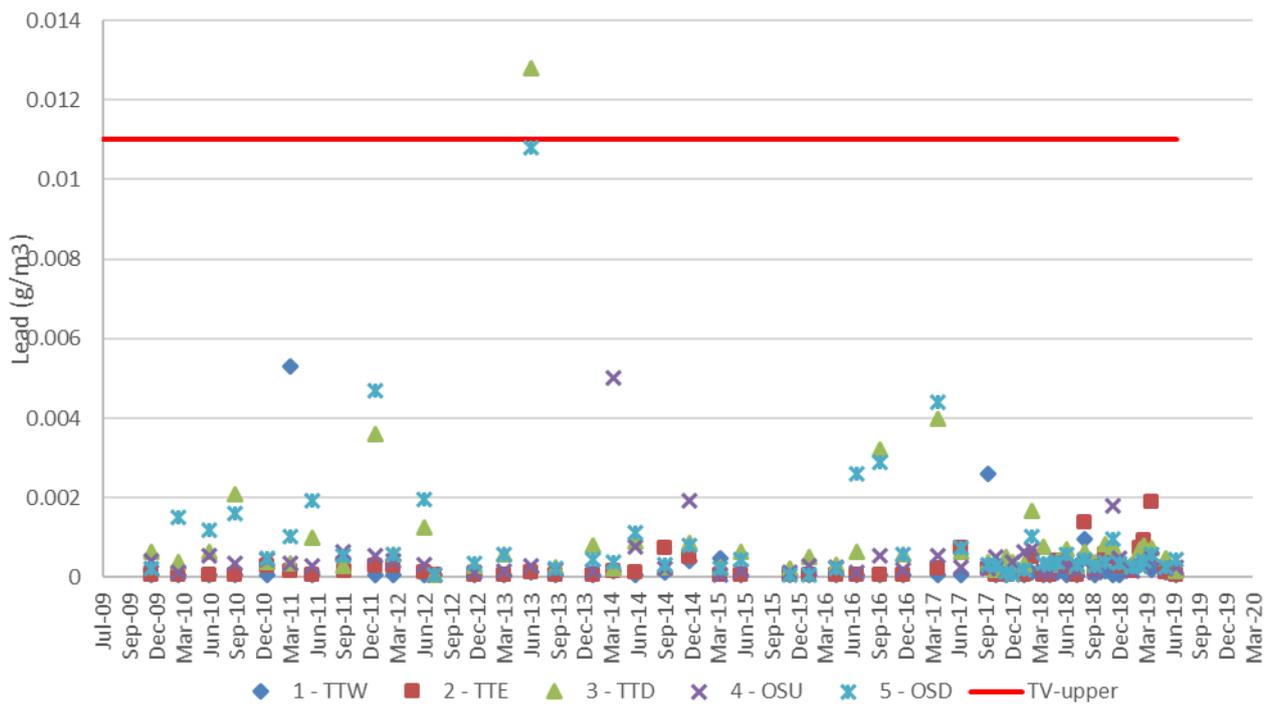
Figure D9: Total Lead for monthly surface water quality monitoring sites. The red line indicates site specific TVs.

Note: Results are shown for total lead, while TV is based on site specific dissolved lead.

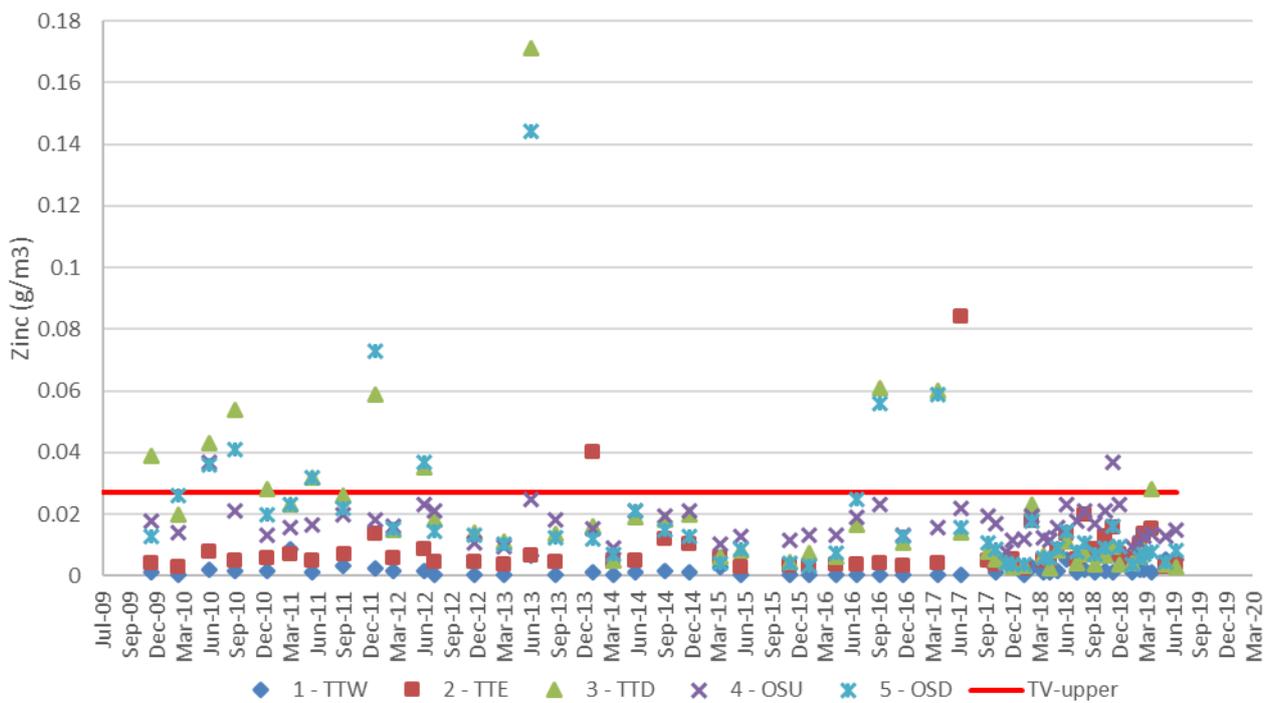
Figure D10: Total zinc for monthly surface water quality monitoring sites. The red line indicates site specific TVs.

Note: Results are shown for total zinc, while TV is based on site specific dissolved zinc.

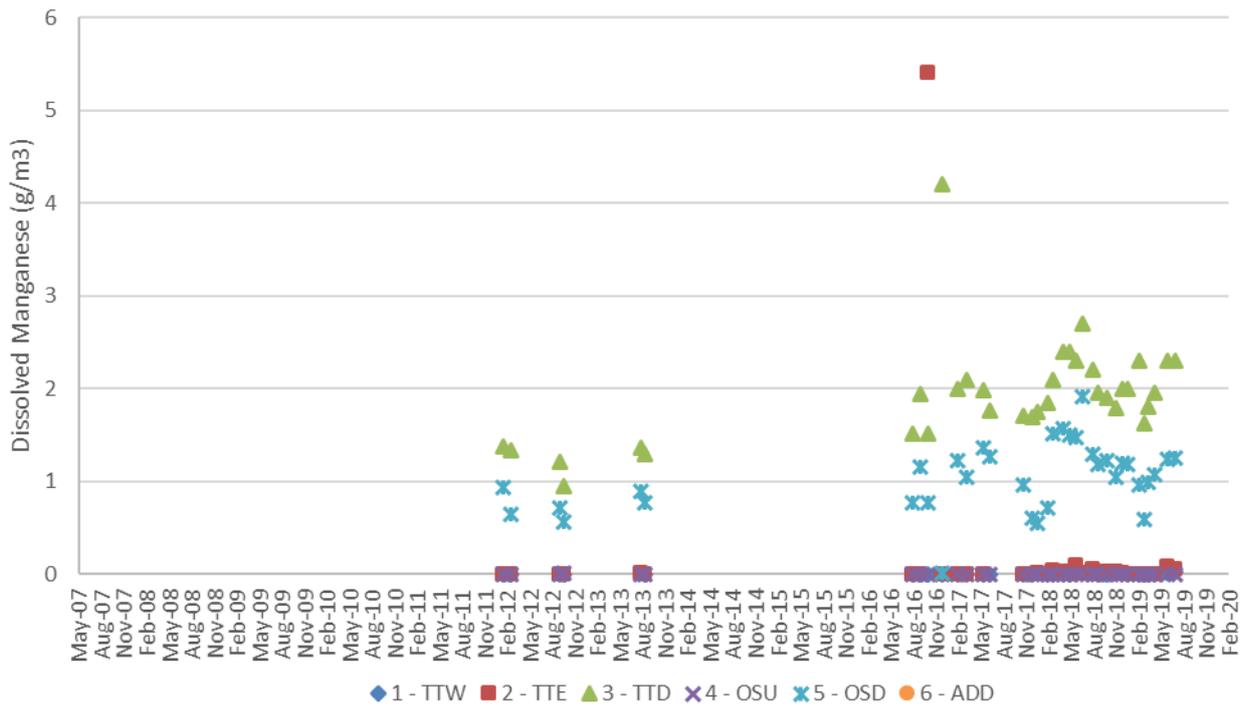
Figure D11: Dissolved manganese for monthly surface water quality monitoring sites. The red line indicates ANZECC 90% protection TVs.

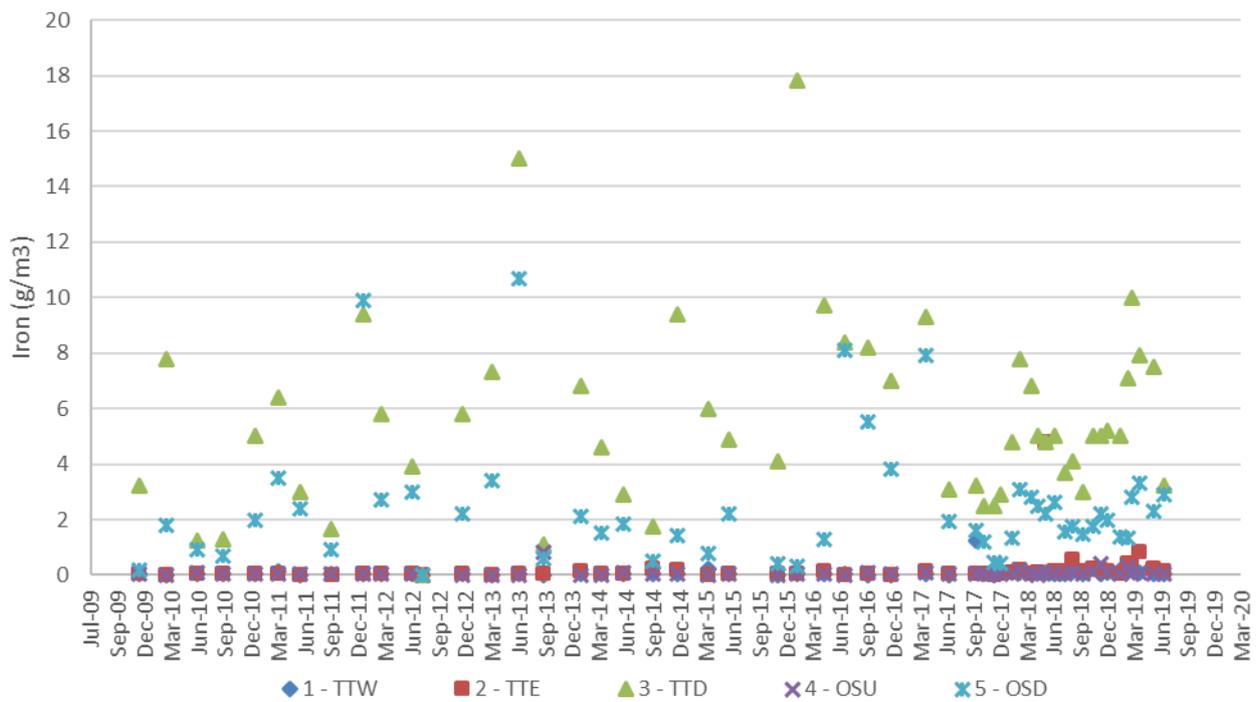
Figure D12: Total iron for monthly surface water quality monitoring sites.

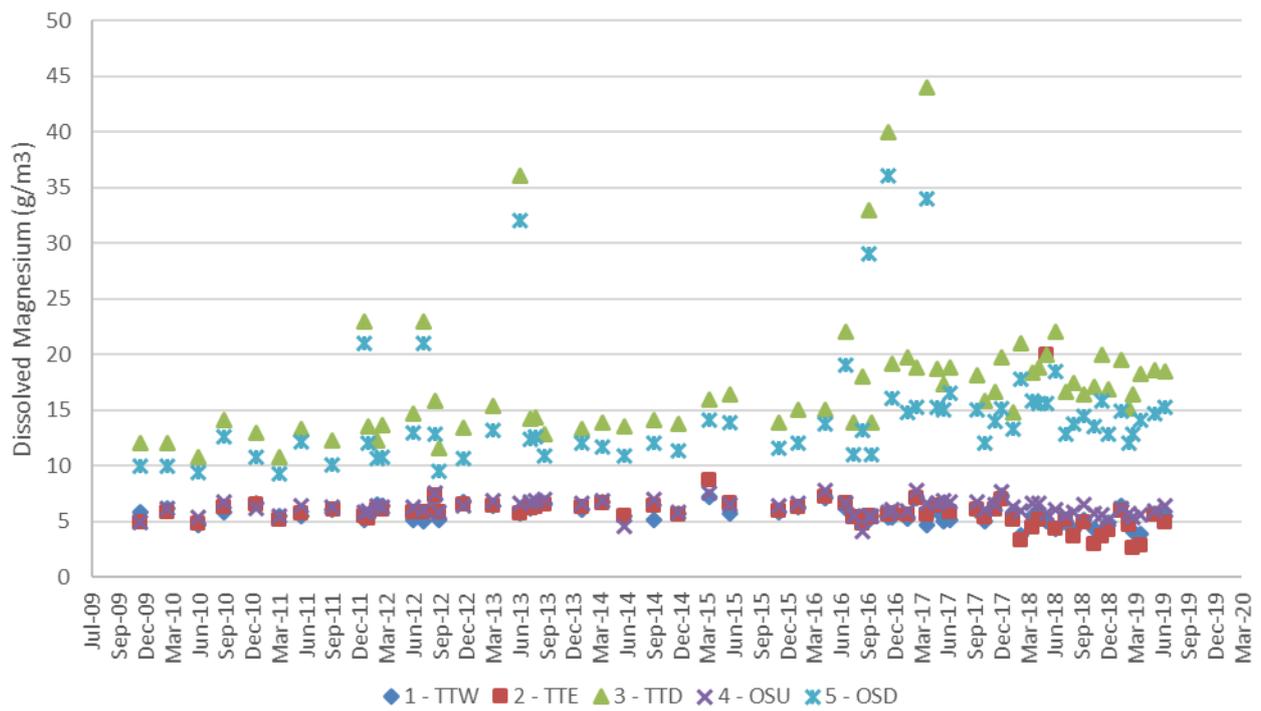
Figure D13: Dissolved Magnesium for monthly surface water quality monitoring sites.

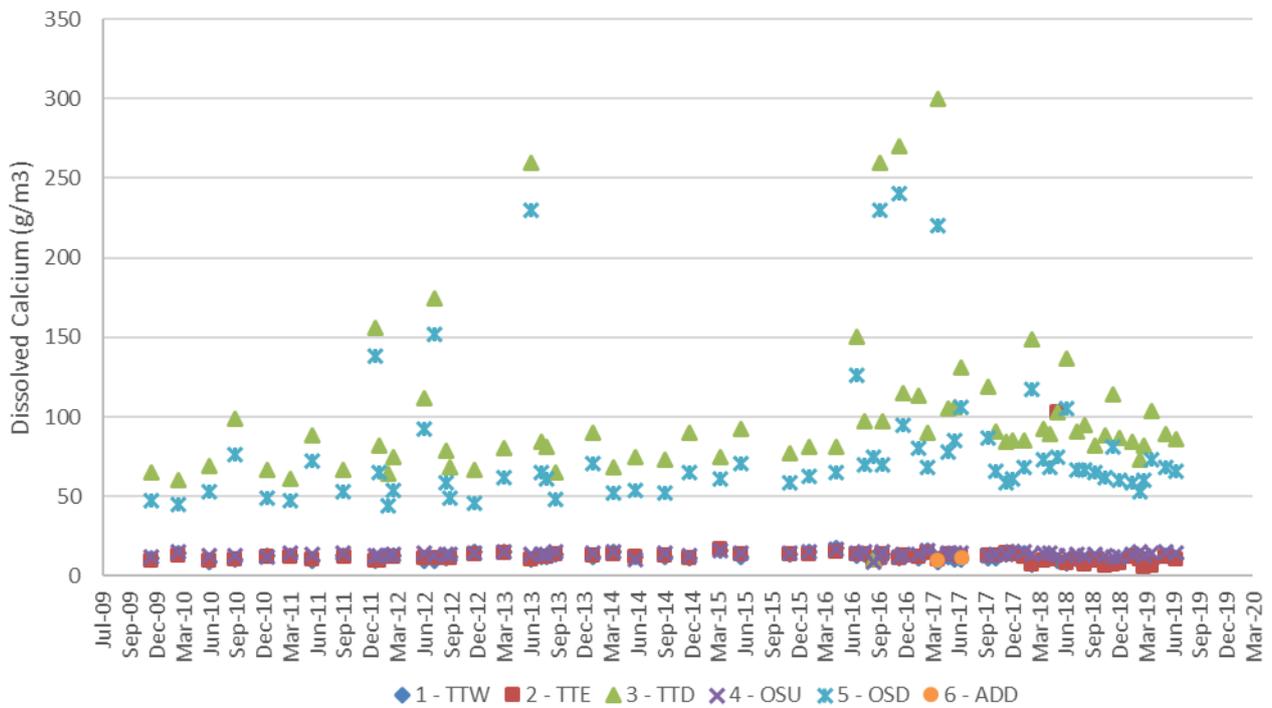
Figure D14: Dissolved Calcium for monthly surface water quality monitoring sites.

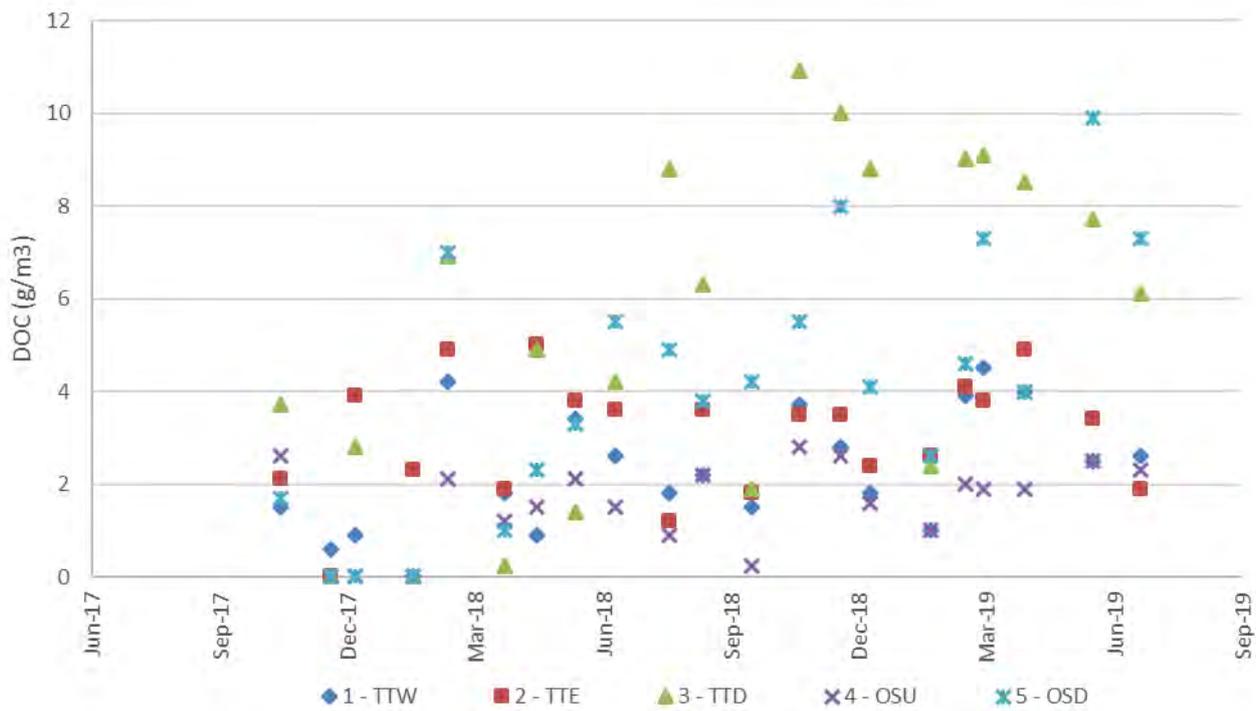
Figure D15: Dissolved Organic Carbon (DOC) for monthly surface water quality monitoring sites.

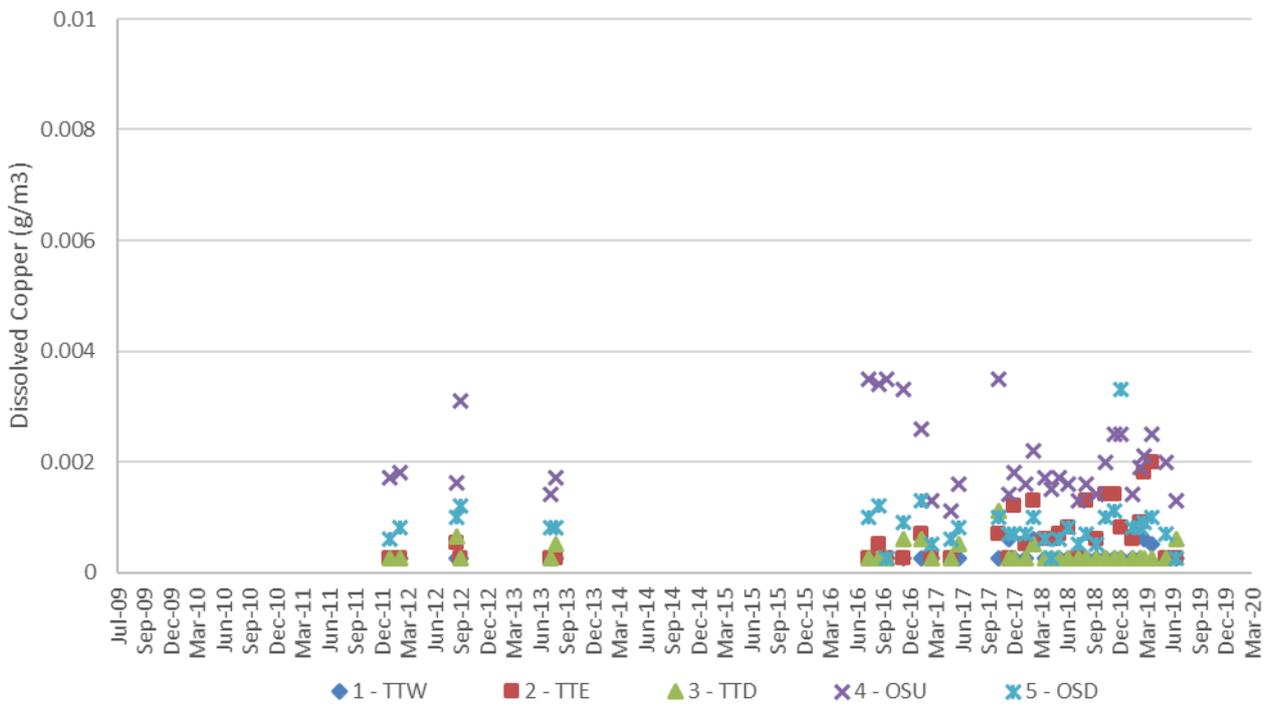
Figure 6-2 Dissolved copper from July 2009 through to June 2019

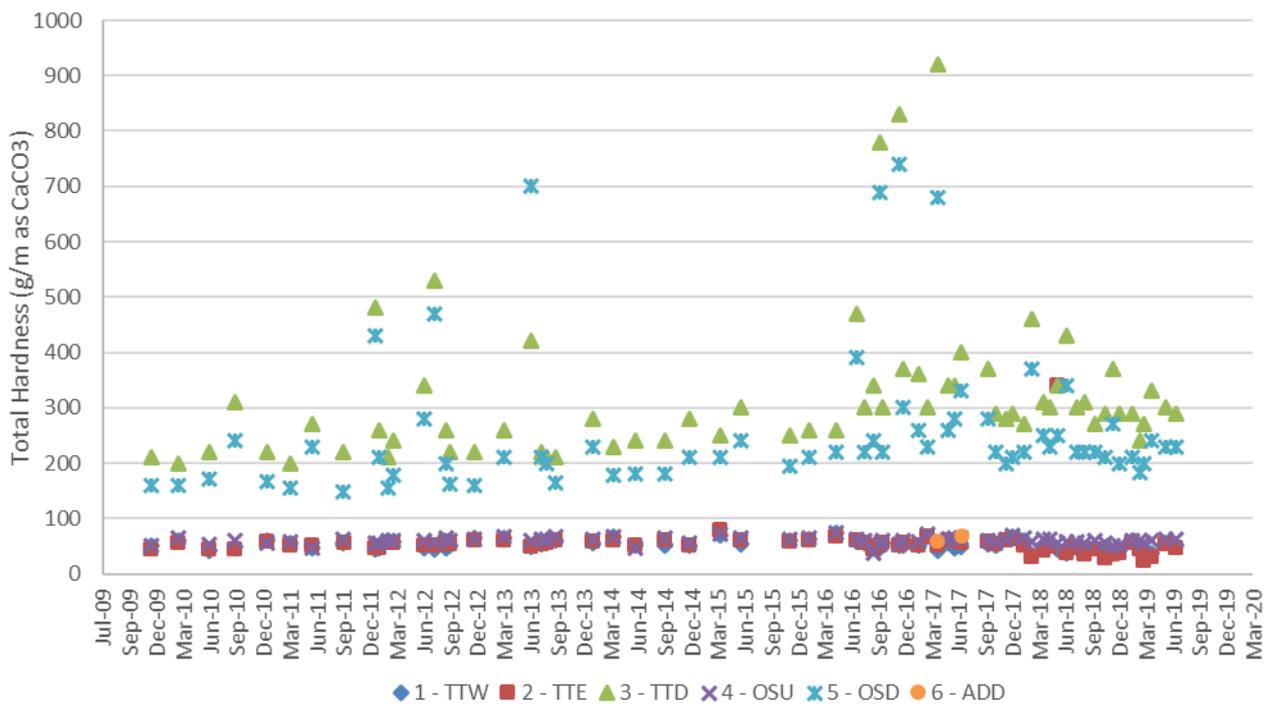
Figure 6-3 Total hardness July 2009 through to June 2019
