Glider Club

Building Inspection

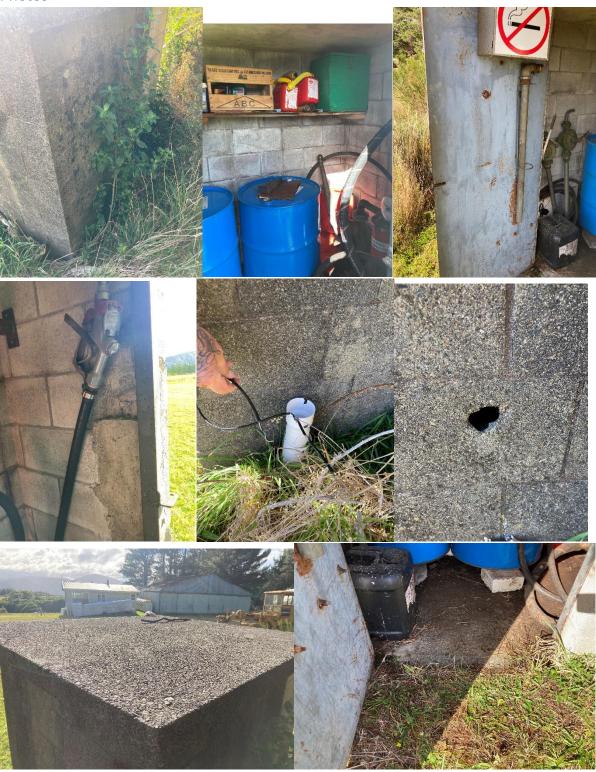
- Un filled block walls
- Holes in block cladding
- No bund in case of fuel leak
- No ventilation
- Roof physically connected
- Disconnected data cables for unknown purpose
- Concrete roof weathered, but appears to be watertight still
- Surface rust on metal door
- Poor quality repair on interior block work

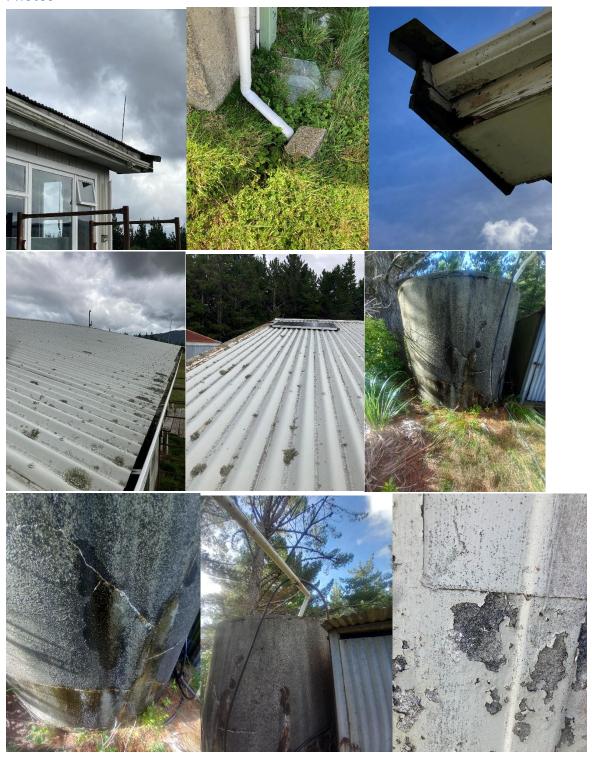
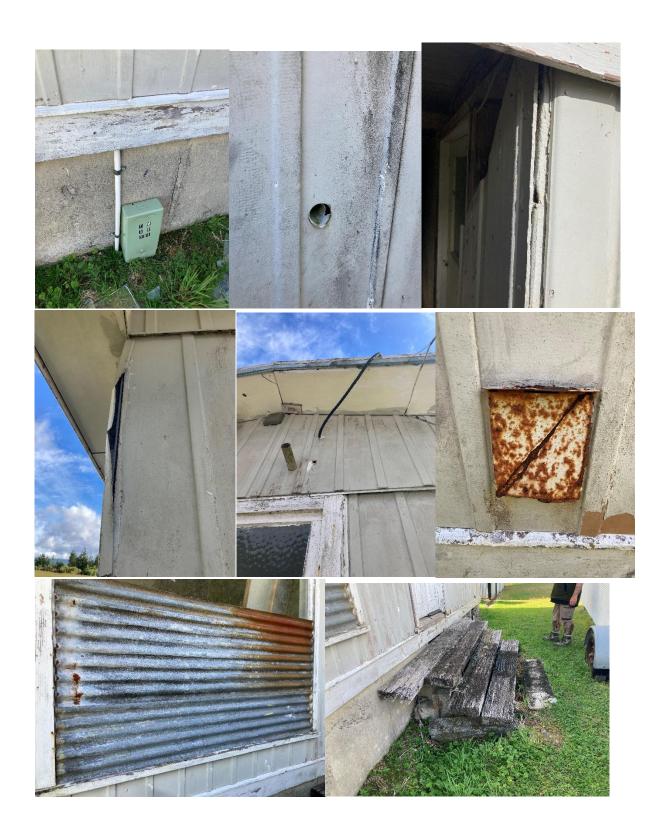
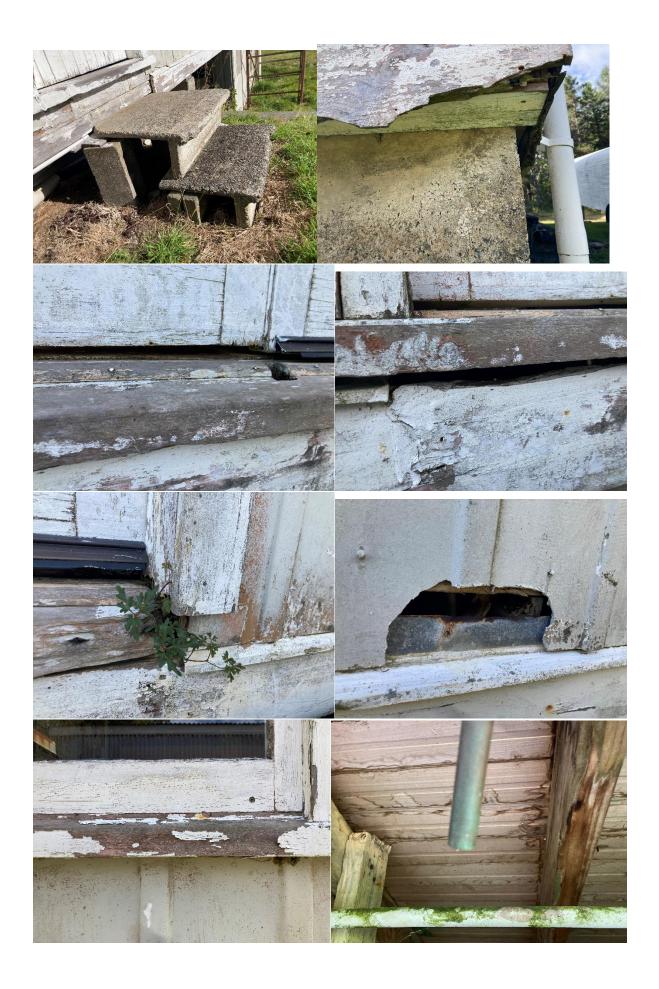
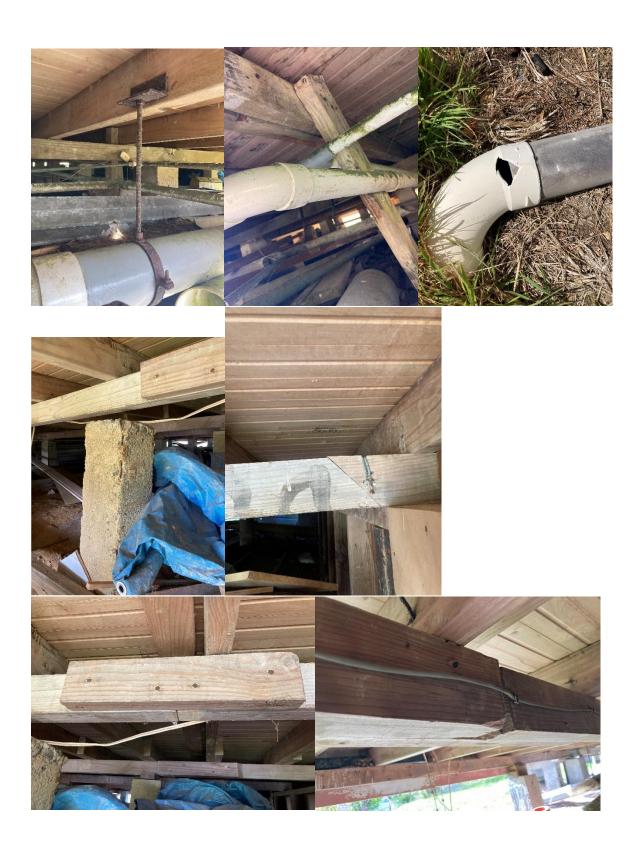
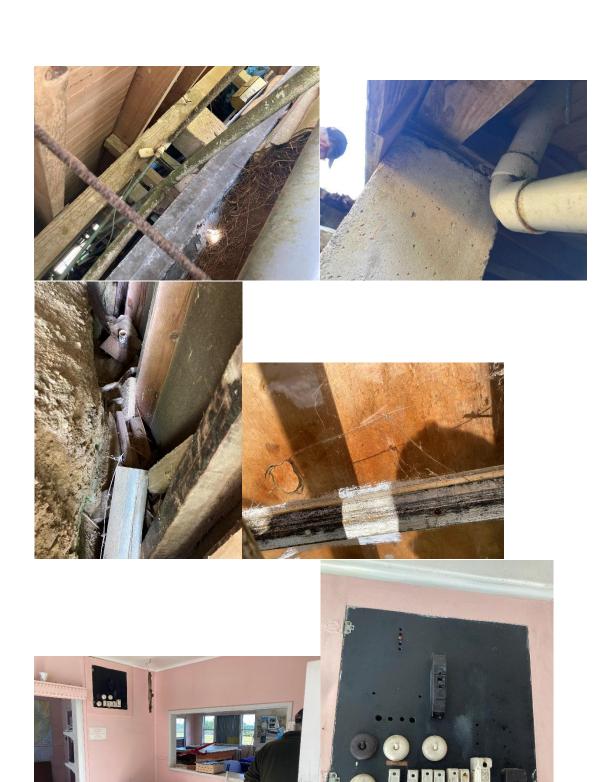
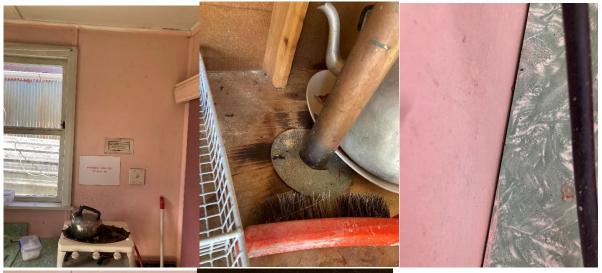
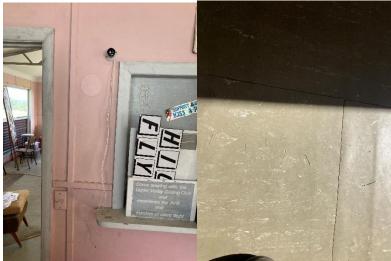
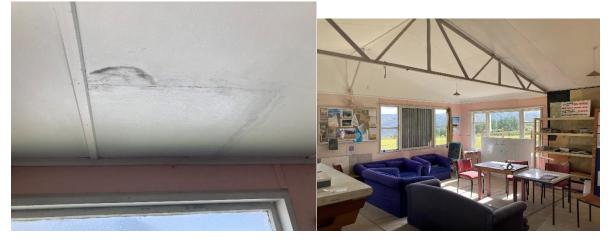
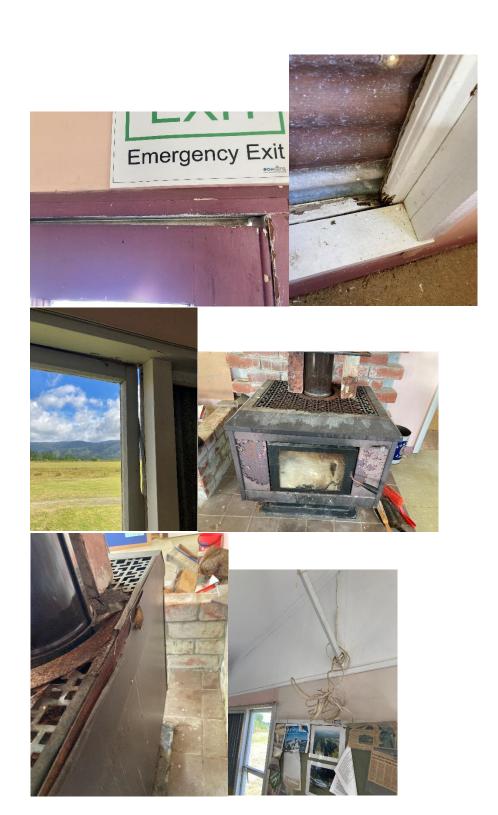
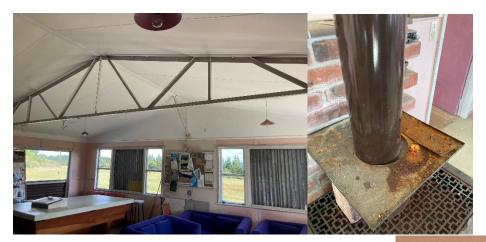
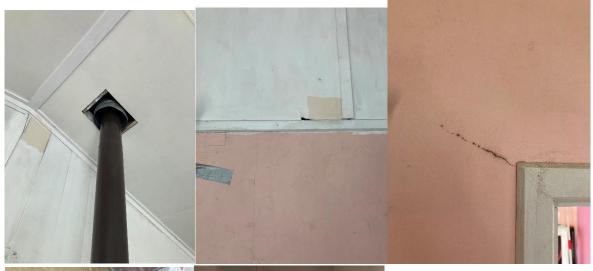
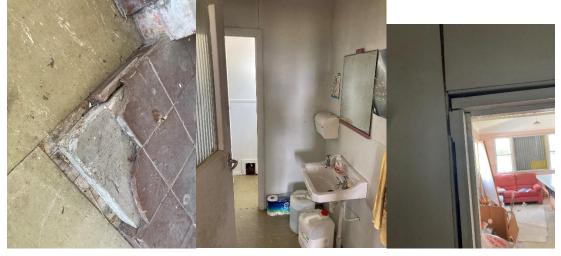
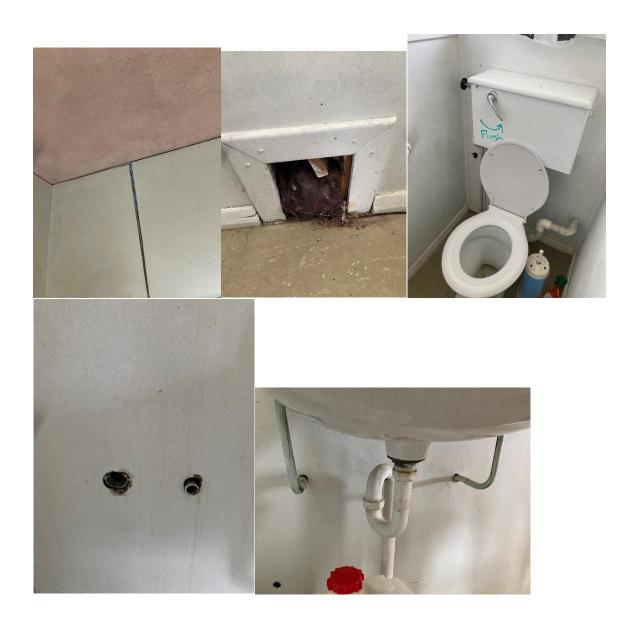
- Basement room lock and unable to be inspected
- Broken windows
- Rotten window frames
- Poorly fitting window casements and external doors
- Asbestos wall cladding

- Holes in cladding
- Roof replaced with coloursteel 10-15 years ago and in good condition
- All cladding needs a clean and paint
- Storm water not compliant or missing or broken

- No drainage between subfloor and basement
- Sewer pipe broken
- Sewer pipe supports significantly corroded
- Toilet and basin not vented
- Grey water goes into drainage trench. This may be discharged into a soak pit in some cases, but must not be discharged on top of the ground

- Zip is only hot water and not tested
- Low pressure cold water from external header tanks
- Main water tank cracked and leaking
- Septic system old, but functions

- Septic drain field condition unknown
- Septic suitable for no more than 10-15 people per day with no grey water, 5-10 if grey water was included
- Cold water not drinking water standard. Roof water, no filters or first flush diverter

- Lino may contain asbestos
- Fireplace rusted through and should be replaced
- Power cables exposed.
- All electrical should be checked by an electrician

- Cracks in internal cladding that show significant moment in past
- Trim missing in toilet room

Re-pile \$40k
Bearers \$20k
Paint and repairs \$40k
Gutters \$15k
Soak pit \$10k
Waste system repair \$5k
Windows \$50k
Access stairs \$5k
Drinking water upgrades to household supply \$20k
Fireplace replace - \$10k

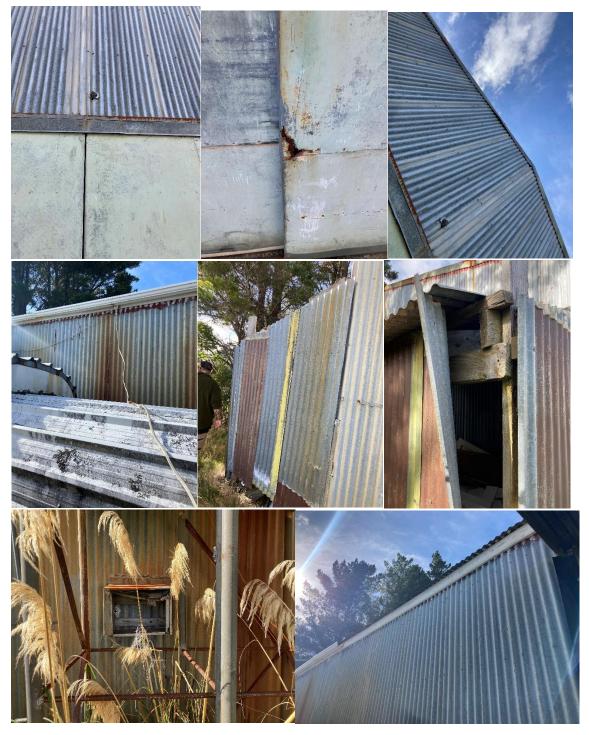
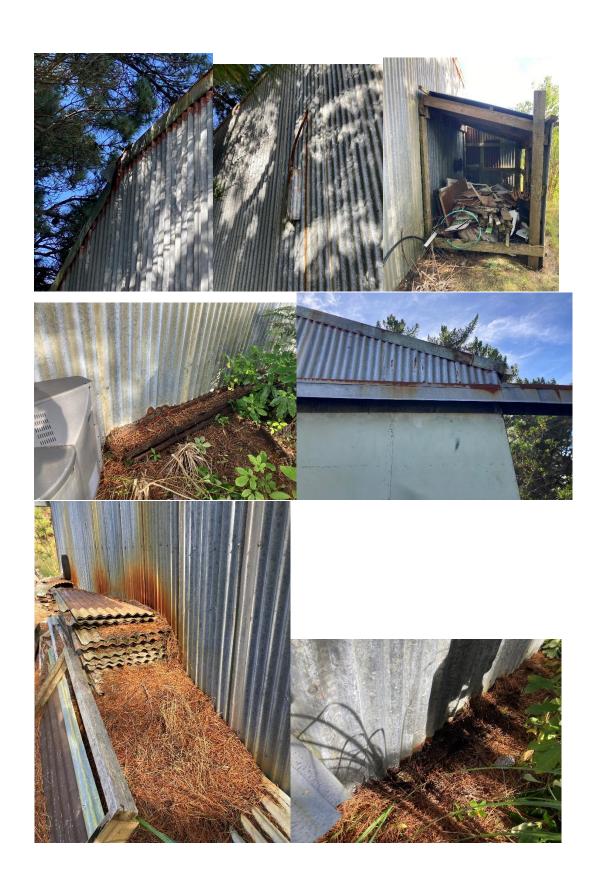
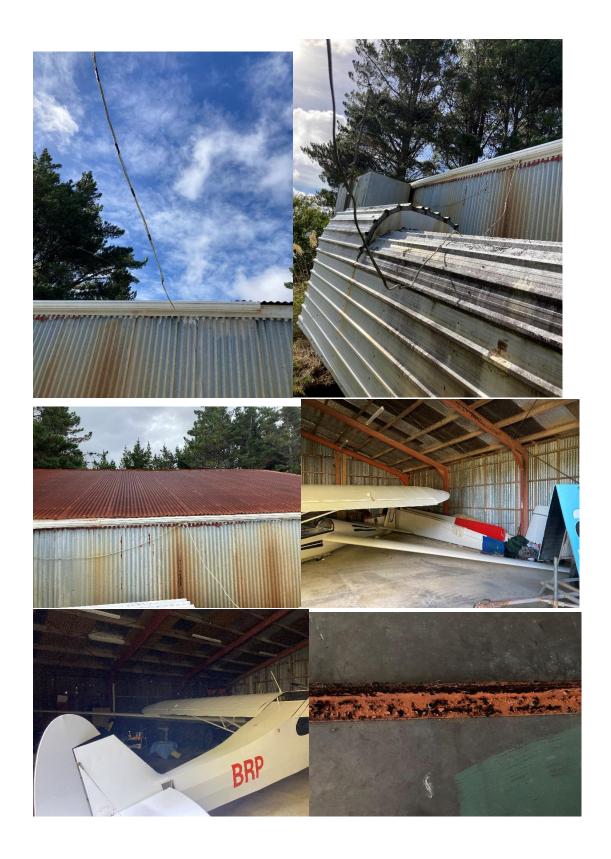
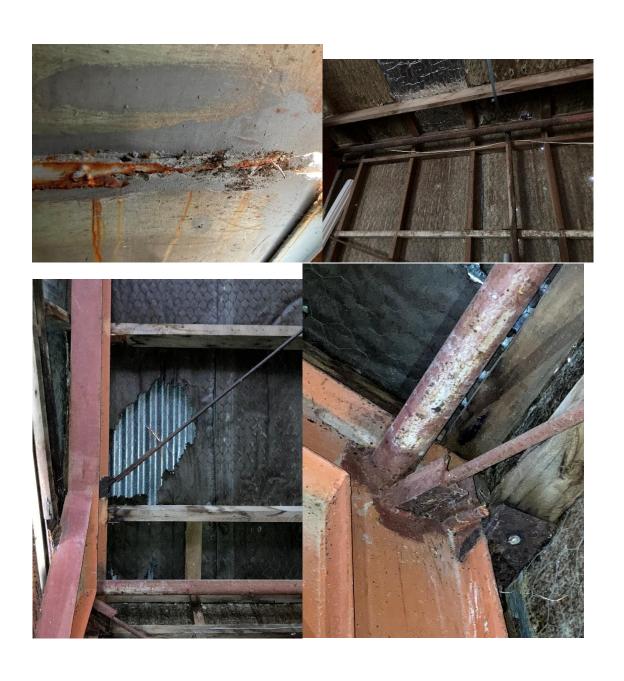
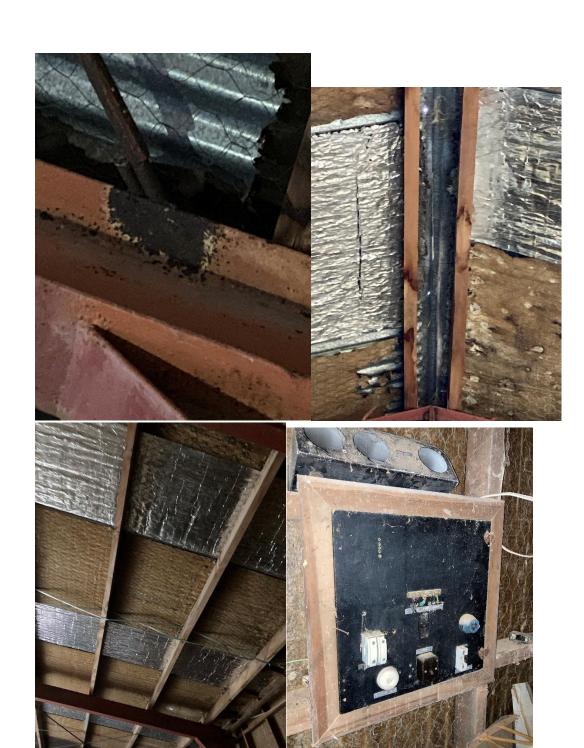
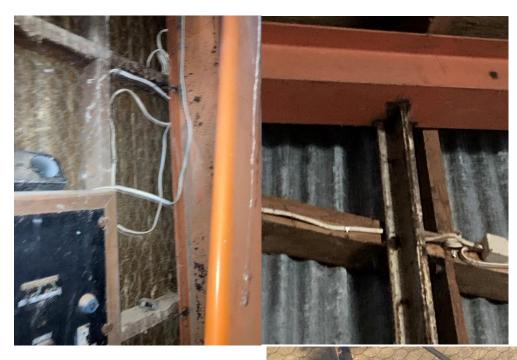
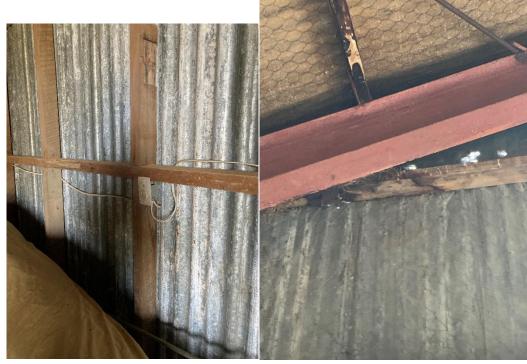
The Hanger is in average condition for its age. The major issue is the roof that may need to be replaced, otherwise only corrosion treatment and minor maintenance required.

- Surface rust across entire roof
- Ridge flashing beyond repair
- Several small holes in roof and wall cladding
- Minor surface rust on wall cladding
- Rust caused by building supplies and earth piled up too high around bottom of wall cladding
- Steel portal frames has minor surface rust around bracing
- Electrics not compliant, recommend electrician inspection
- Gutter not operational
- Corrosion has caused loss of section on section of door frames
- Exposed internal power cable outside
- Footing and slab visible is in good condition
- Roofing paper to stop condensation has many holes

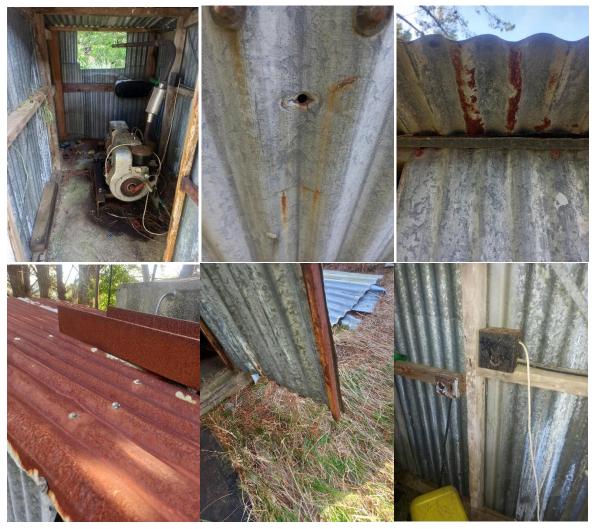
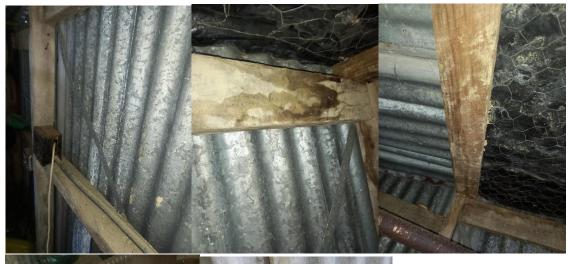
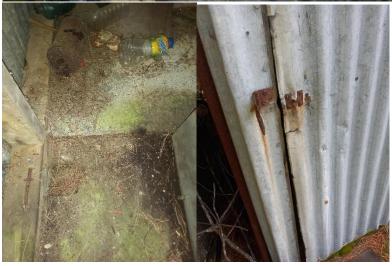
This shed is in poor condition. It is recommended to be replaced.

- Both wall and roof cladding rusted through in places with many holes.
- Open cavity in back wall to let out exhaust.
- Frame of the door is rusted and missing bottom rail.
- Electrical work does likely not comply, would recommend having a qualified electrician.
- Split in concrete floor.
- Signs of moisture in timber framing.
- Spacing of timber frames not to any sort of modern standard.
- Door latch is broken.
